#PIT5457: Service ABS / TCS / Power Steering and/or Suspension Message DTC U0077 U0121 U0126 U0131 U0139 U0401 U0415 U0428 (Circuit 5986 High Resistance) - (Sep 8, 2015)

**Models: 2015 Cadillac Escalade Models
2014 Chevrolet Silverado 1500
2015 Chevrolet Silverado, Suburban, Tahoe
2014 GMC Sierra 1500
2015 GMC Sierra, Yukon Models**

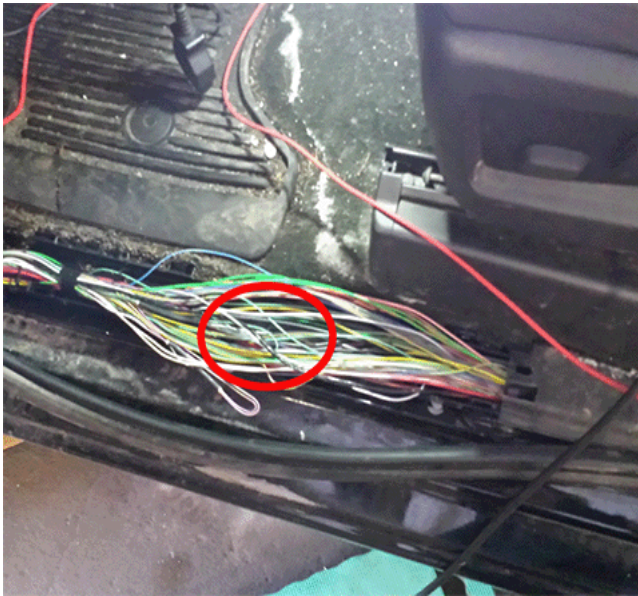
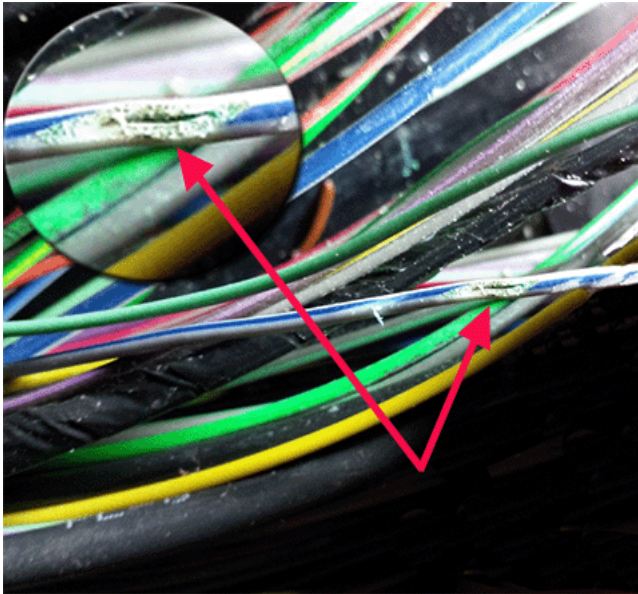
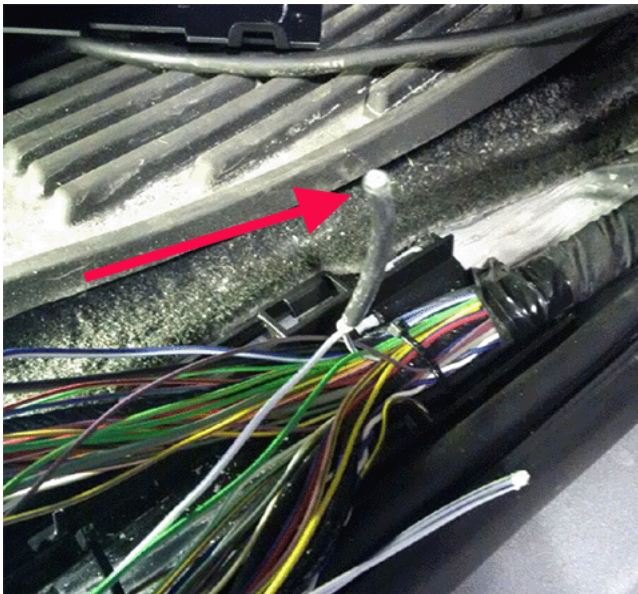
These concerns could be caused by high resistance/open in the Communication Enable circuit 5986. The BCM activates this circuit when the ignition key is in ACC, ON, and START positions (There will be voltage present in the OFF position only for a short time until the BCM goes to sleep). The communication enable circuit wakes up the module for serial data bus communication. Circuit 5986 will have approximately 12 volts and should light a test light, but is not designed to handle heavier electrical loads like a headlight bulb. Shown below are two known areas where circuit 5986 has been found to be open or have high resistance:

1. Under the driver's sill plate
2. Splice J365 located under the passenger front sill plate

Monitor the voltage on the communication enable circuit 5986 at any of the modules affected, example EBCM, PSCM, and/or SCM. If low voltage or no voltage is present when the concern occurs, inspect for high resistance under the driver's or passenger's sill plate area. Repair any opens or high resistance in the circuit.
