# Service Bulletin

Bulletin No.: 19-NA-270

**Subject:** Phone Ringer Volume Turned Down or Too Quiet

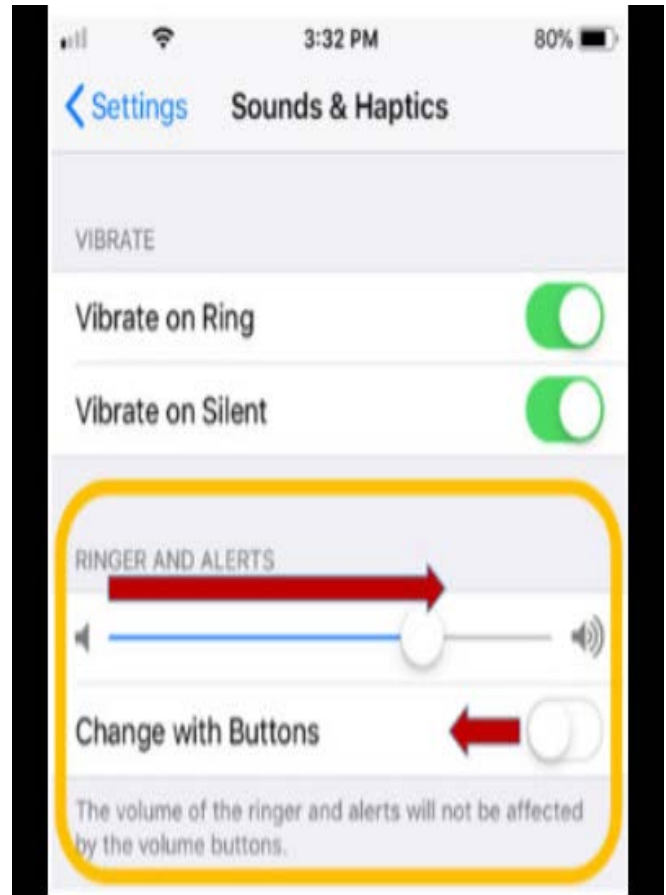
5441750

| <b>Condition</b> | <p>Some customers may comment that their Apple iPhone phone ringer volume is too low. This may stem from one of two conditions:</p> <ol style="list-style-type: none"><li>1. A customer may comment their phone ringer is being turned down, has changed to mute, or that they are missing incoming calls after exiting a vehicle that it was previously Bluetooth connected to.</li><li>2. A customer may comment of an intermittent low ringer volume in-vehicle in which the phone's ringer may be louder than the ring tone coming from the vehicle speakers.</li></ol> |
| <b>Cause</b> | The cause of the condition may be incorrect phone settings, or by phone behavior when connected to a radio that does not allow remote audio volume control. |

1. On the customer's Apple iPhone, enter phone *Settings*.
2. Select *Sounds & Haptics*.
3. Disable *Change with Buttons*.
4. Turn the *Ringer and Alerts* volume back up to the desired level.
