#18-NA-161: Steering Jerks Or Kicks Back / Reduced Power Steering Assist / Engine Stall / No Start / Service Stabilitrak / IPC / Radio / HVAC Goes Blank Various DTCs - (Sep 23, 2020)

Subject: Steering Jerks Or Kicks Back / Reduced Power Steering Assist / Engine Stall / No Start / Service Stabilitrak / IPC / Radio / HVAC Goes Blank Various DTCs

This bulletin replaces PIT5405C. Please discard PIT5405C.

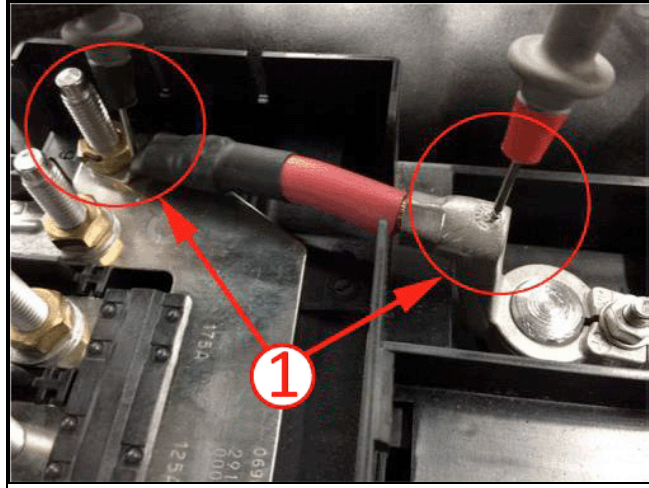
1. Perform a loaded voltage drop test on the short positive battery cable (1).

⇒ Refer to "Measuring Voltage Drop" in SI. If the voltage drop is above 100 mV, replace the affected cable(s).

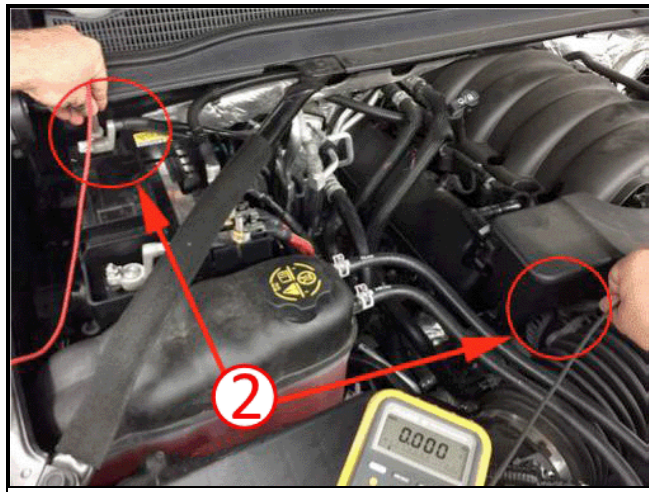
2. Perform a loaded voltage drop test on the negative battery cable (2).

⇒ Refer to "Measuring Voltage Drop" in SI. If the voltage drop is above 200 mV, replace the affected cable.

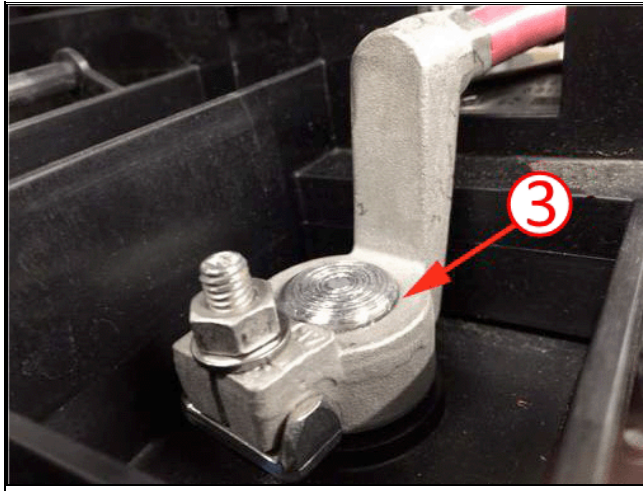
⇒ It is imperative that both the positive and negative battery top posts protrude above the battery cable clamps 1-2 mm (0.040 - 0.080 in) to be properly installed, as shown (3).

3. Check both the positive and negative battery cable clamp nuts and make sure they are properly tightened to 7 Nm (62 lb in).
4. After the positive and negative battery cables are fully installed and tightened to 7 Nm (62 lb in), grasp each battery cable near the battery post and make sure they are secure and that they do not spin on the post. If they spin, replace the battery cable.

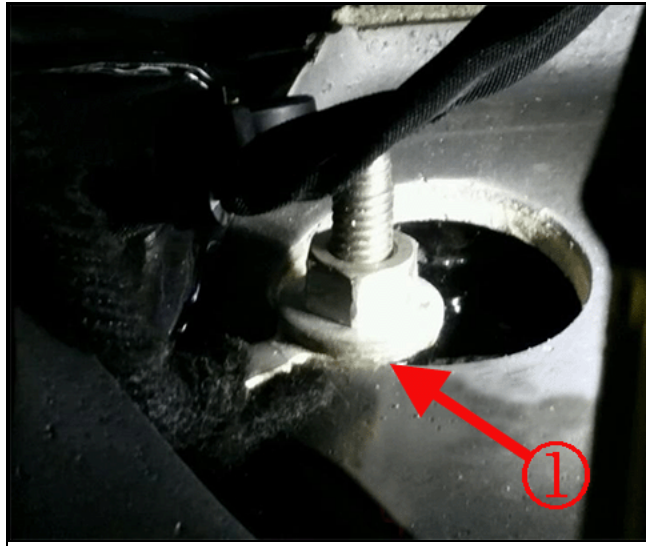
Inspect G218 (applies LD Trucks and SUVs built prior to June 2015):

- Check for the nut being loose or cross threaded (1), repair and tighten as necessary.

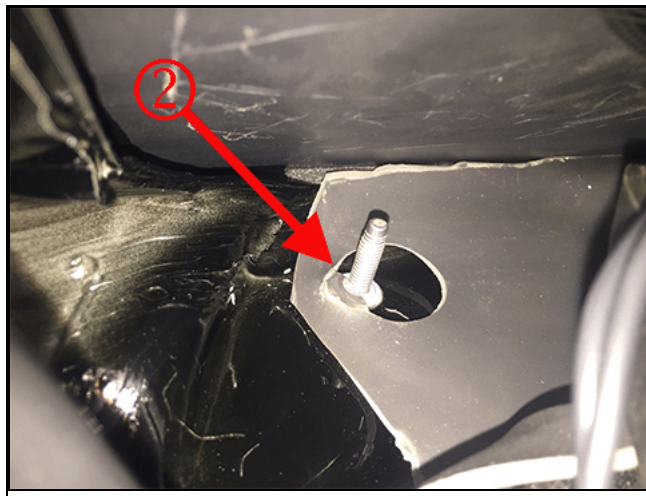
- Check for the front of dash insulator mat (2) being trapped between the ground eyelet and the body/stud as shown.
⇒ If the dash insulator mat is trapped, cut the mat away from the ground stud so it will no longer interfere. Reinstall the ground eyelet, the nut, and retighten.

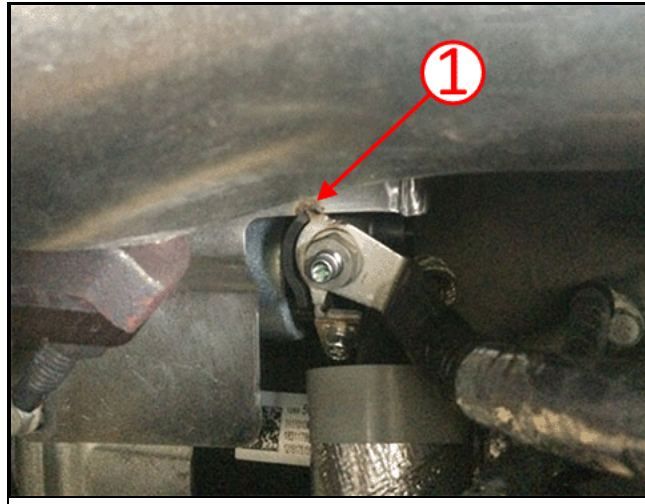
Inspect the starter solenoid B+ battery cable for possible contact at the starter heat shield (1) or a loose shield resting on terminal.

⇒ If the battery cable is shorting out on the starter heat shield, replace the B+ battery cable and starter heat shield.

⇒ After installing the new starter heat shield and B+ battery cable, ensure there is adequate clearance and each fastener is torqued properly so it will no longer short out.
