## #PIP5806A: Intermittent Extended Crank No Start And A Possible DTC P0341 Set - (Jun 18, 2021)

**Subject: Intermittent Extended Crank No Start And A Possible DTC P0341 Set**

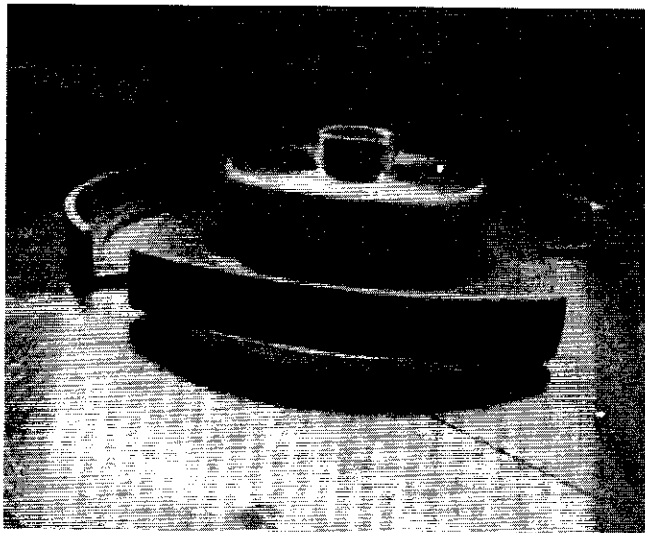
This is a bent trigger wheel.

If you find the cam sensor trigger wheel bent, replace it.
