Service Bulletin

Bulletin No.: 19-NA-257

Subject: Pickup Box Out of Alignment

Brand:	Model:	Model Year:		VIN:		Engine:	Transmission:
		from	to	from	to		
Chevrolet	Silverado 1500 (New Model)	2019	2019			All	All
	Silverado 1500	2020	2021				
GMC	Sierra 1500 (New Model)	2019	2019				
	Sierra 1500	2020	2021

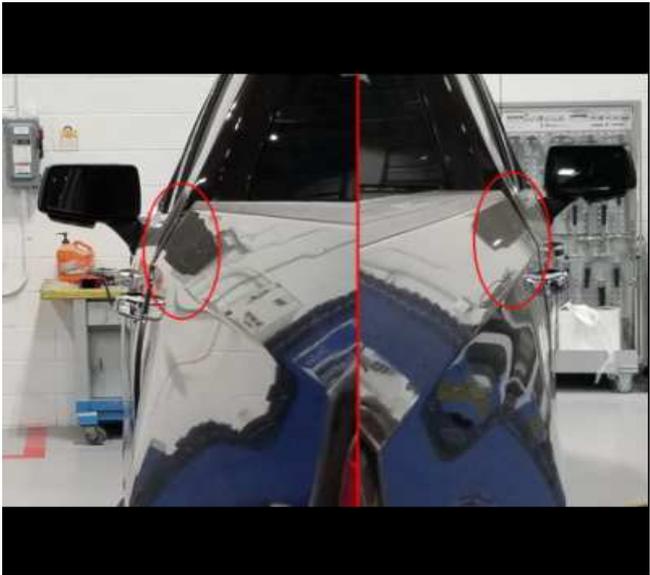
<p style="text-align: right;">5442974</p> <p>The pickup box appears to be out of alignment from side to side of the truck. The condition is more noticeable from rear of truck, down the side.</p>
Cause	The cause of the condition may be the pickup box was misaligned from the assembly plant.
Correction	Adjust the pickup box to within tolerance, following the steps in the Service Procedure below.
