Service Bulletin

Bulletin No.: 20-NA-166

Subject: Information on Malfunction Indicator Lamp (MIL) Illuminated - DTCs P050D and/or P0300 Setting on A Cold Start and/or Engine Runs Rough when Warm with No Codes

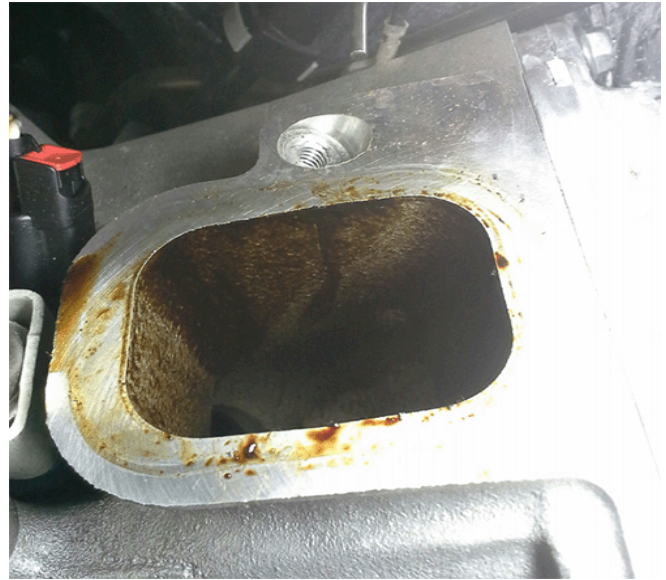
4806659

If the head casting line is the concern, the intake port will be wet with a coolant oil mix.

The location of where the coolant is running down in the port will also look washed down.

If this is found, the cylinder head will need to be replaced.
