#21-NA-155: Information on Check Trailer Wiring Message and/or Service Trailer Brake Displayed on Driver Information Center (DIC) - DTC C1114 Set - (Sep 21, 2021)

Subject: Information on Check Trailer Wiring Message and/or Service Trailer Brake Displayed on Driver Information Center (DIC) - DTC C1114 Set

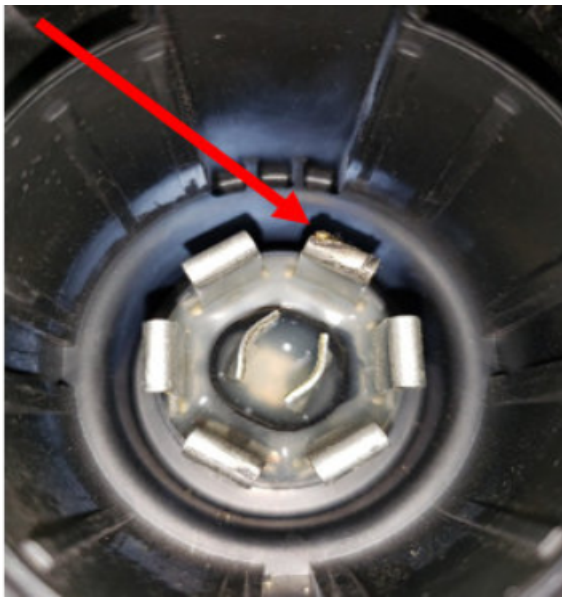
1. Short on trailer side damaged the terminal – Trailer side connector is loose/worn – **Non-Warranty Issue.**

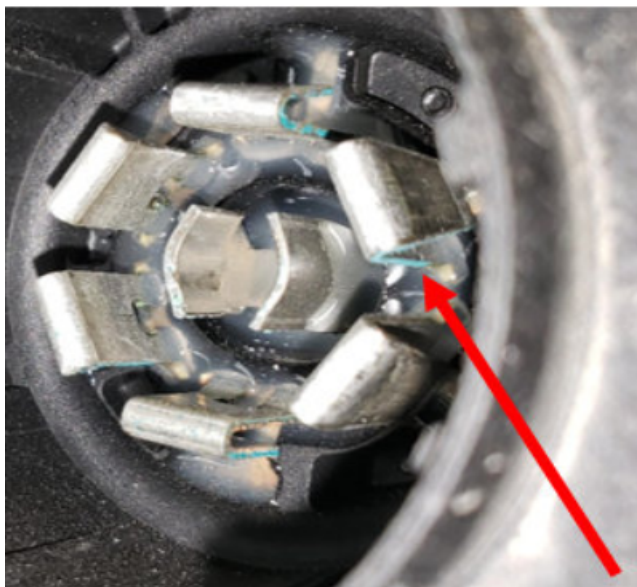
- The blue/green is expected, and this small amount of corrosion does not impact function of connector – **Non-Warranty Issue.**

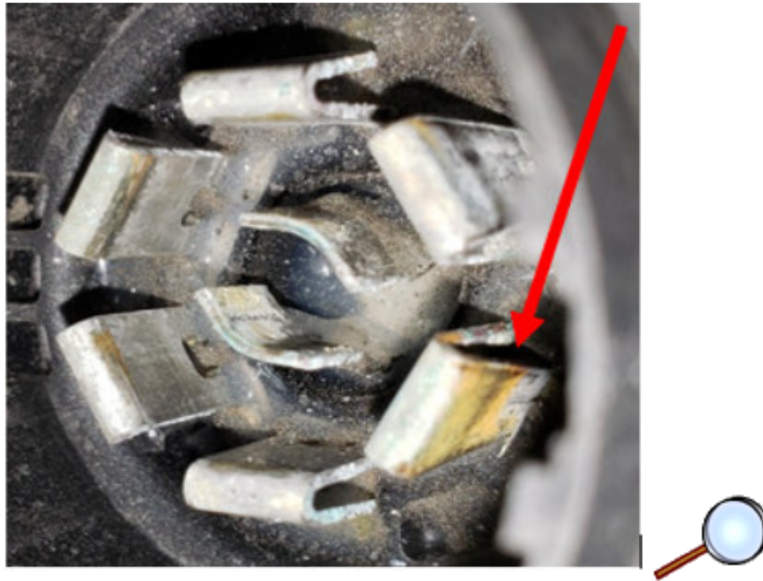
- Trailer side connector is damaged/deformed causing removal of protective plating. This is the result of the trailer side connector is moving or bouncing when connected (excessively worn connector) – **Non-Warranty Issue.**

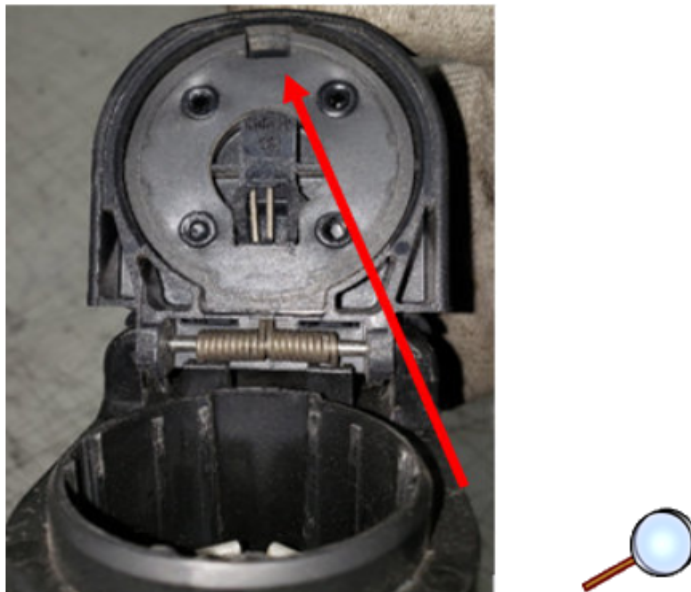
- Trailer side harness retention tab has been broken off cover which is the result of customer pulling away from trailer without releasing the trailer harness – **Non-Warranty Issue.**

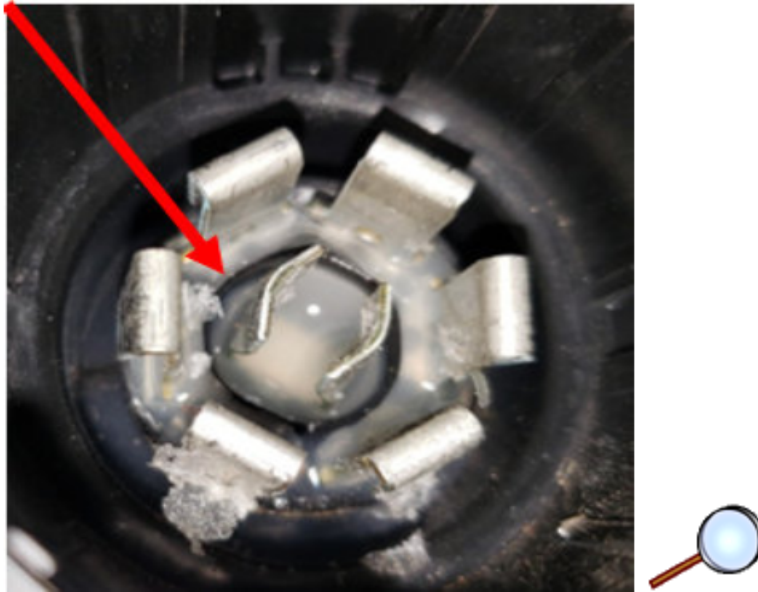
1. Sealant from part on terminals, would cause intermittent connection issues connecting to trailer – **Subject to terms of warranty.**

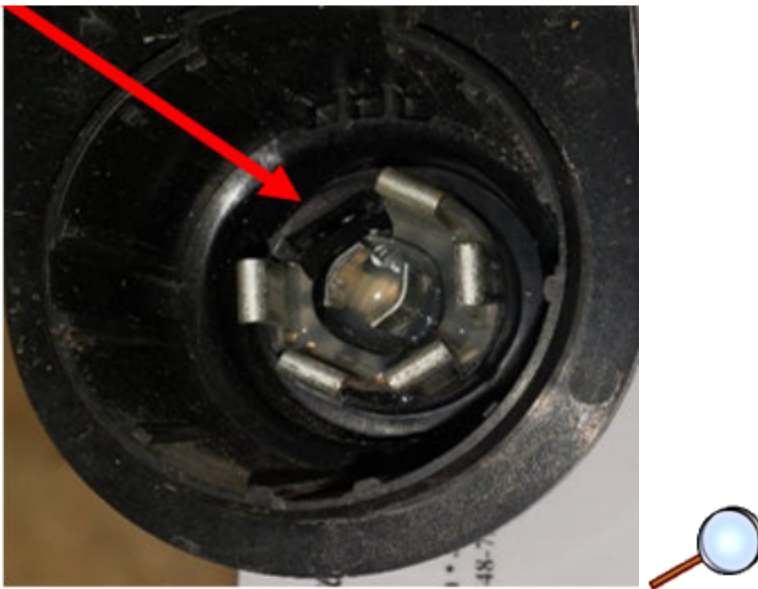
2. Terminal is pushed out – **Subject to terms of warranty.**
