#21-NA-222: Various Vehicle Handling Concerns Suspension Noise or Damaged Suspension Components Due to Vehicle Modifications - (Oct 13, 2021)

**Subject: Information on Various Vehicle Handling Concerns Suspension Noise
 or Damaged Suspension Components Due to Vehicle Modifications**

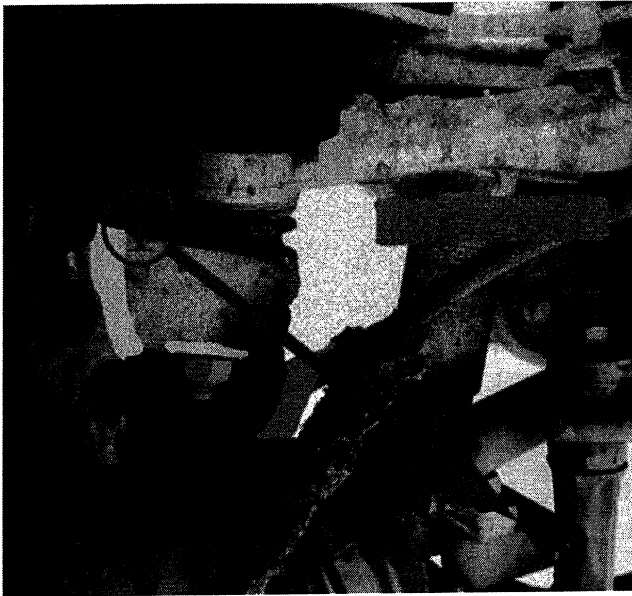
1. Aftermarket lift kit block

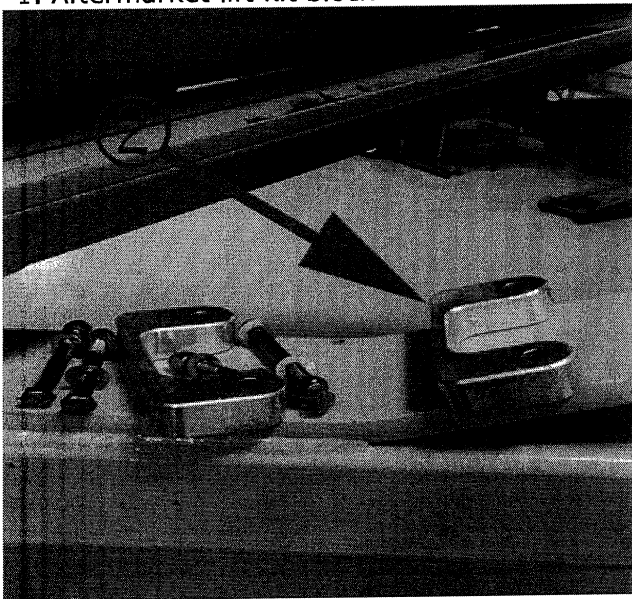
2. Aftermarket lift kit blocks removed from a truck

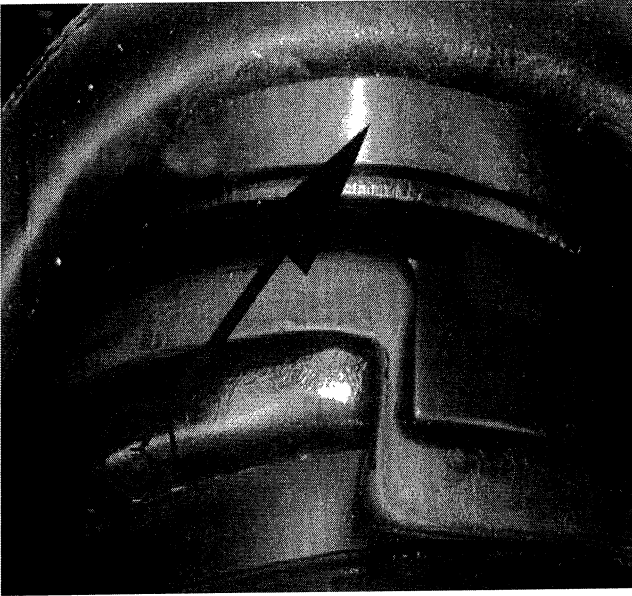
3. Aftermarket coil spring spacer

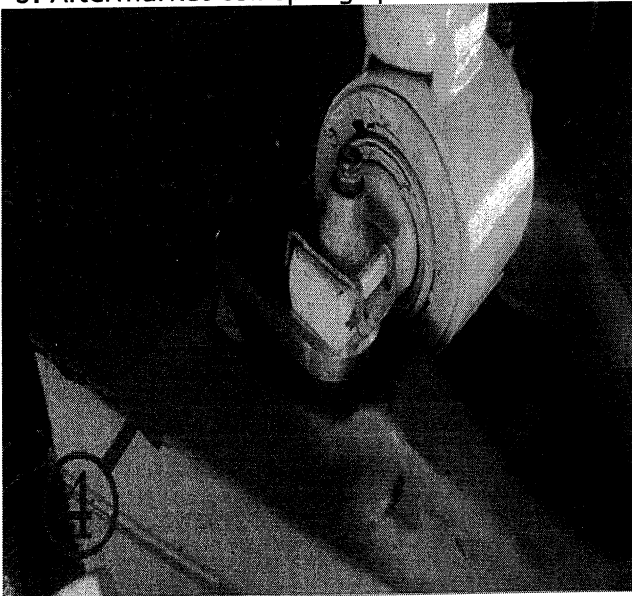
4. Aftermarket lift kit blocks installed

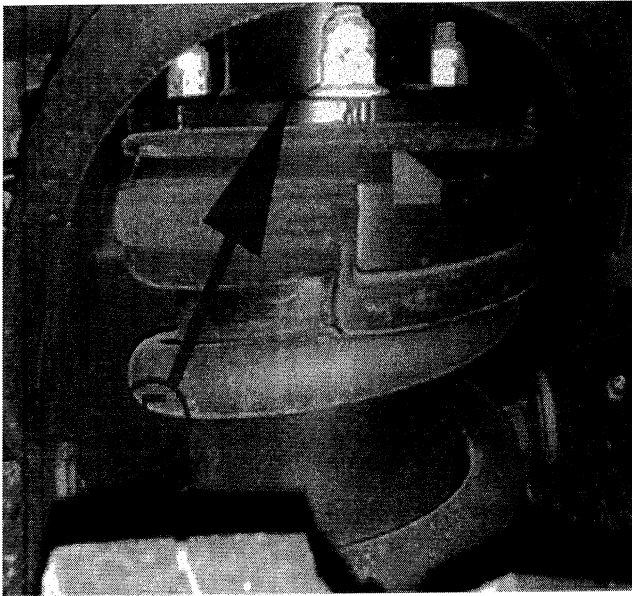
5. Aftermarket coil spring spacer

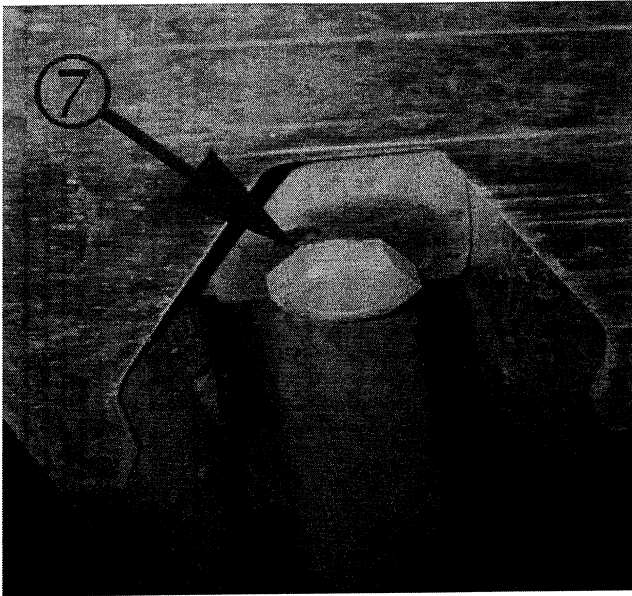
Inspect for improperly adjusted torsion bars (shown below #7) resulting in improper Z-height adjustments. For this example, the Z-height for this truck would be above the specifications but there is not an actual lift kit installed.

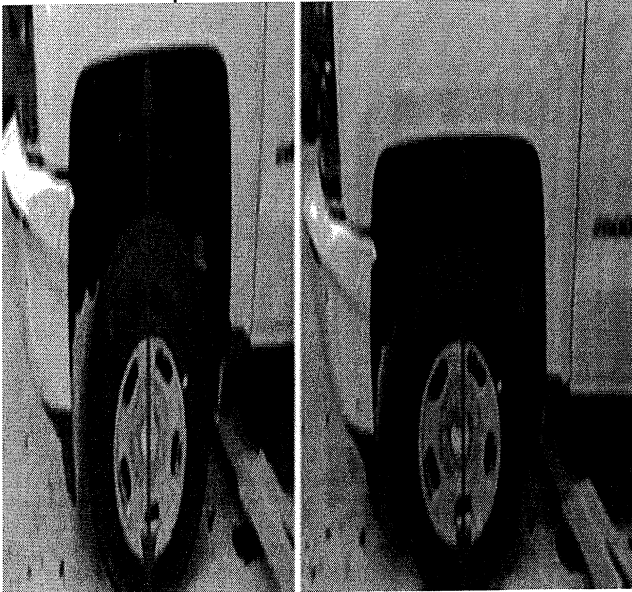
Below is an example of lift provided by improperly adjusting the z-height. In this example, the front suspension has been raised about 3 inches.

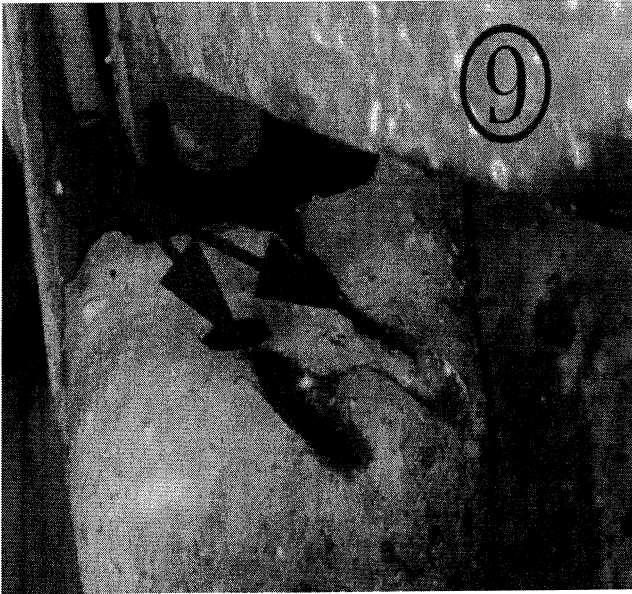
If the torsion bars have been improperly adjusted as shown above, also inspect for contact between the upper control arm (shown below #9) and the frame (shown below #10). If contact is found inspect the upper ball joint for looseness, as it may have been damaged by the modification.

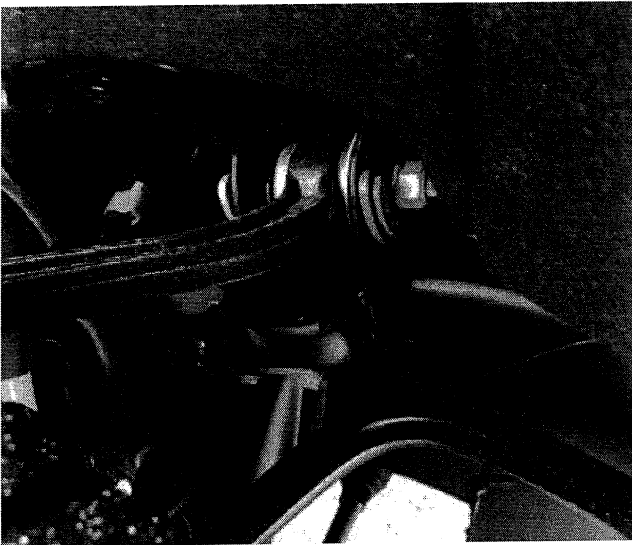
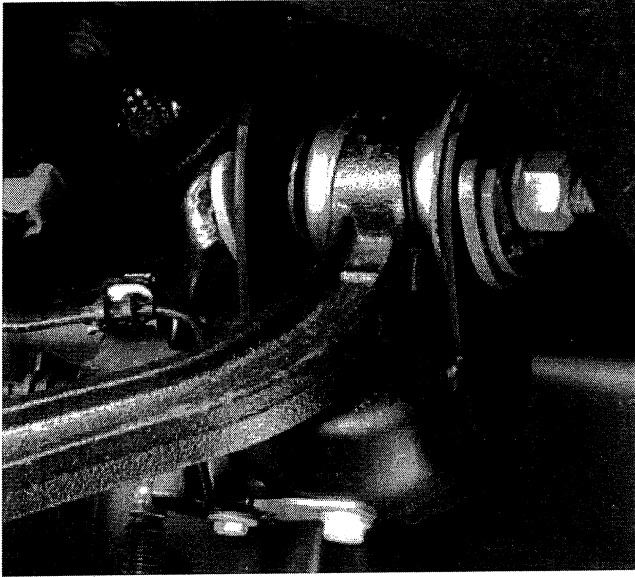
Below is an example of a vehicle sitting at factory ride height (A) with 25 mm gap between upper control arm and bump stop, and a vehicle that has had the torsion bar adjusted (B) has a 5 to 10 mm gap between upper control arm and bump stop.

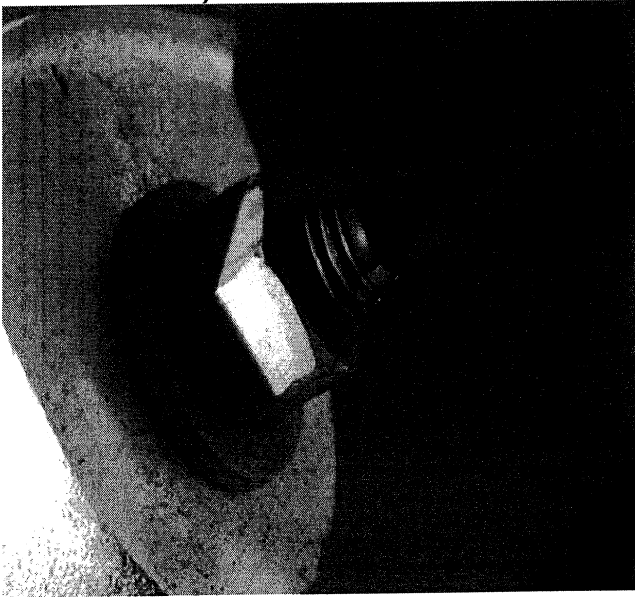
When determining if a vehicle has been modified additional clues can be found by inspecting for quality control marks (shown below #8) from the factory that are not aligned (especially on new trucks):

Note: The green quality control marks do not line up indicating this vehicle has been tampered with.

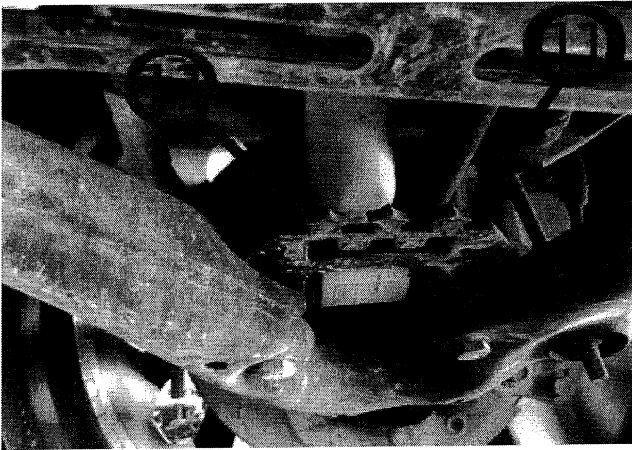
11. Aftermarket Lift Kit Block installed

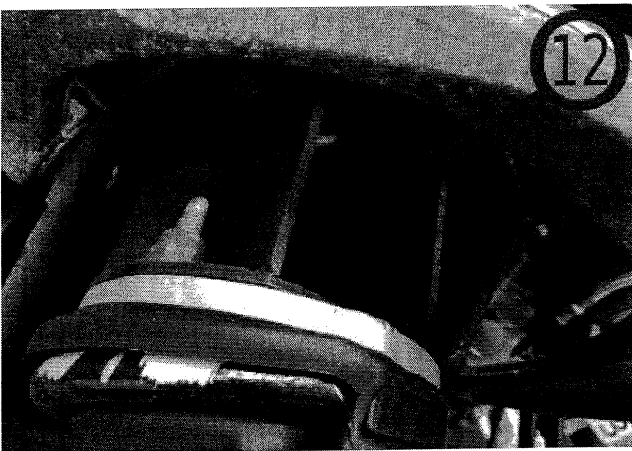
12. Aftermarket Coil Spring Spacer installed
