Service Bulletin

Bulletin No.: 21-NA-149

Subject: Engine Wire Harness Chafing / IPC Gauges Sweep / IPC Warning Message / SES/Check Engine/MIL / No Start / No Crank / Runs Rough / Stalls / Reduced Engine Power / Various DTCs

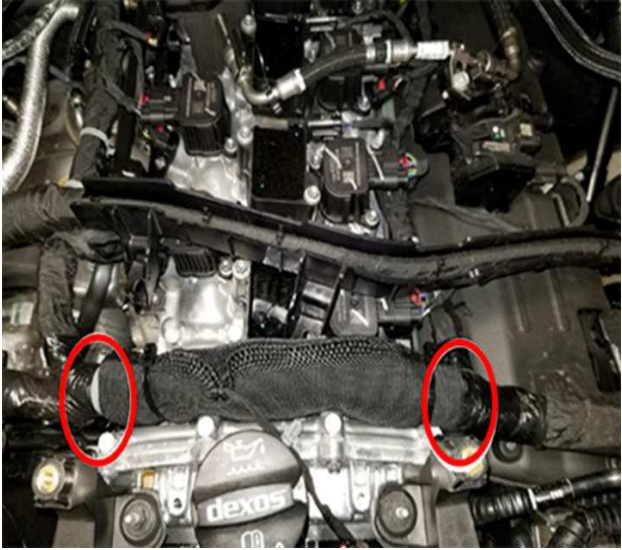
<p style="text-align: right;">5394681</p> <p>Example of engine wiring harness damage at Camshaft Carrier Cover shown below.</p>

<p>Cause 1</p>	<p>This Cause pertains to vehicles equipped with engine 2.7L, L3B only.</p> <p>These concerns may be caused by engine harness contact with under hood components.</p> <p>Caution: This Document Only Applies To VINs NOT Covered by Customer Satisfaction Program N192219370 Please Verify In VIS Before Proceeding</p> <p>Shown below are areas that should be inspected for this concern.</p> <p>Inspect the engine harness as it crosses over top of the Camshaft Carrier Cover.</p> <p>Harness damage can occur at any point across the Camshaft Carrier Cover.</p> <p>Typical inspection locations shown below.</p>

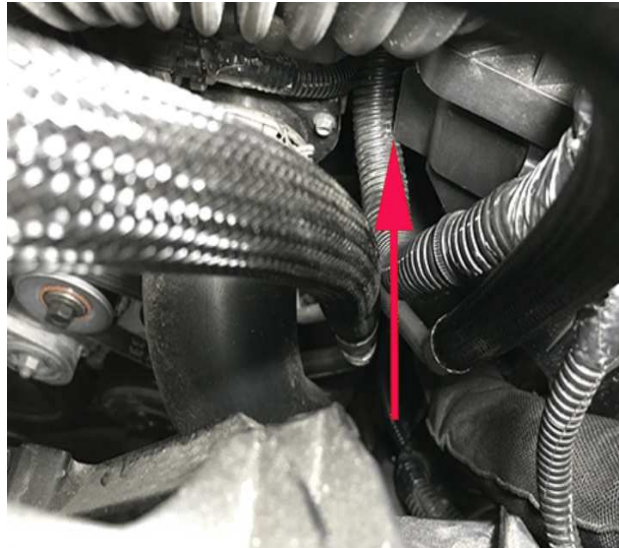
5394683

Inspect the engine harness at the Lower Air Cleaner Housing as shown below.

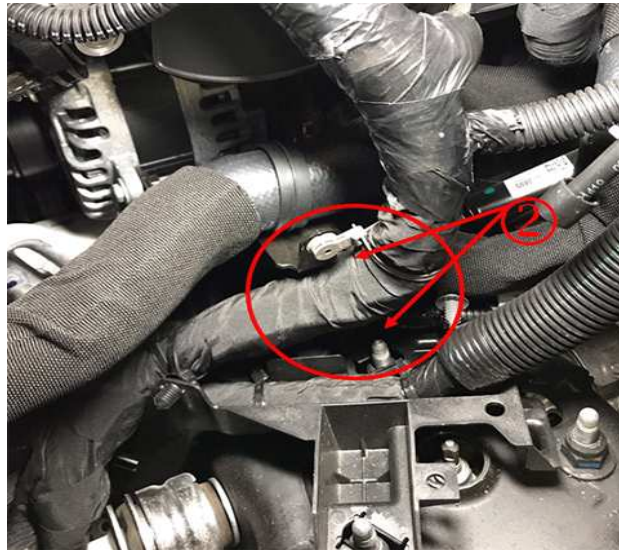
5324752

Example of engine harness damage, Lower Air Cleaner Housing removed shown below. Inspect the engine harness at the Generator Bracket and Left Front Coil Spring stud as shown below.

Note: Under normal driving conditions, the engine will rock back and forth in its mounts.

This may result in harness contact with this bracket that may not be present during engine off inspections.

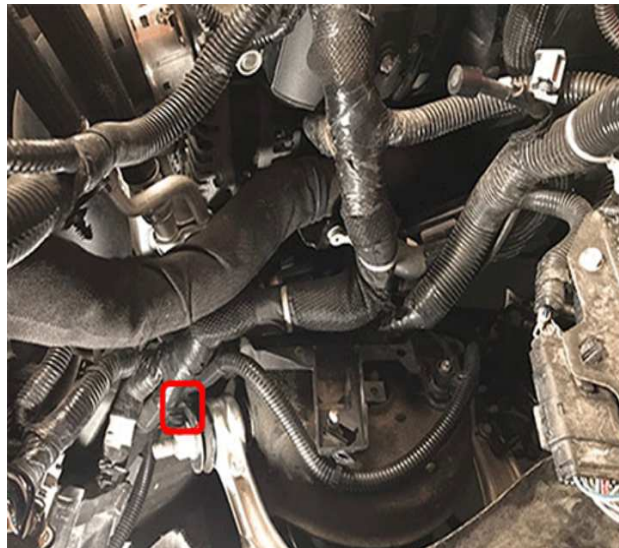
5394677

Inspect the engine harness at the Left Front Upper Control Arm Bushing as shown below.

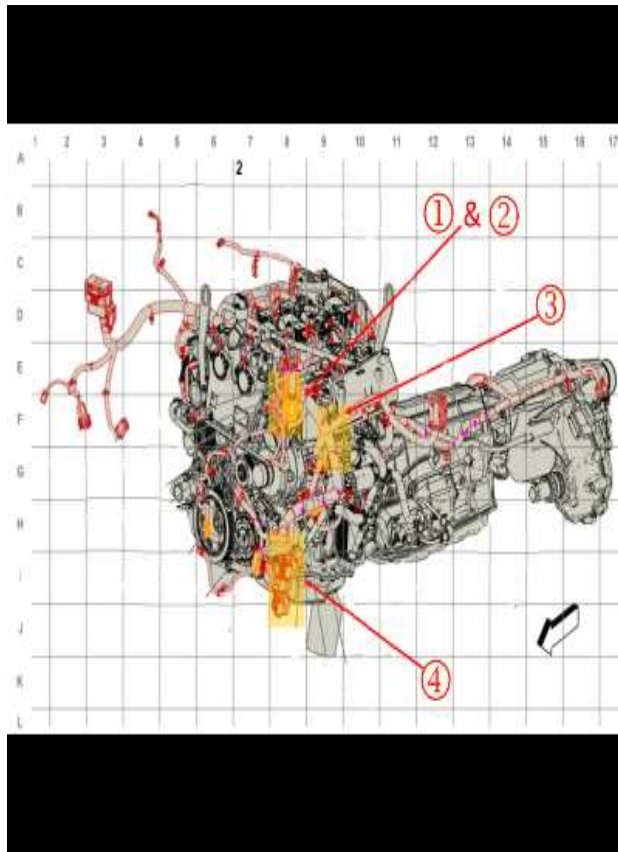
5911724

These concerns could be caused by engine wiring harness chafe on underhood components at various locations:

- Front corner of the left hand cylinder head (1)
- Drive belt idler pulley bracket (2)
- Oil Dipstick bracket (3)
- ECM/TCM bracket (4)

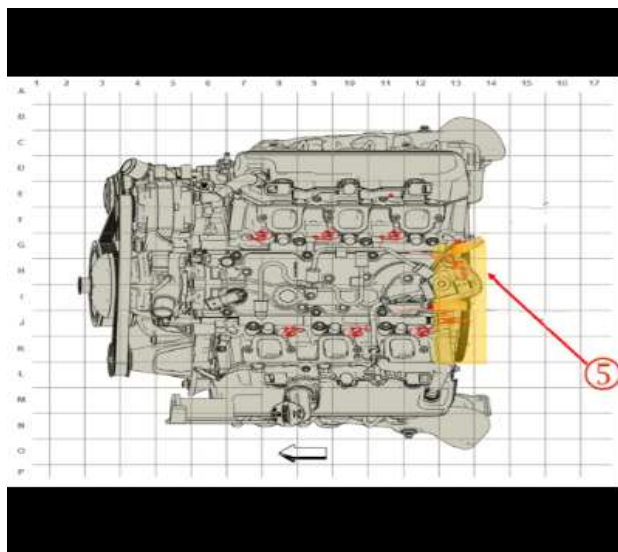
5911725

- Fuel Rail (5)

<p>This harness chaffing could cause shorting of any number of circuits to ground. Due to the number of circuits in the harness, there is a wide variety of different symptoms that could occur depending on which circuit(s) are damaged.</p>
<p>Cause 3</p>	<p>This Cause pertains to vehicles equipped with engine 3.0L, LM2 only. <u>For any of the DTC's listed above inspect the following areas</u></p> <ol style="list-style-type: none"> 1. The engine harness pinched/shorted/chaffed at grid coordinates G-8, as shown below. This location is approximately 18 inches from the ECM connectors (1) and on top of the generator (2), as shown below. Due to the number of circuits in the harness, there is a wide variety of different symptoms that could occur, depending on which circuit(s) are damaged. 2. The engine harness shorted/chaffed at grid coordinates C-9, as shown below. The engine harness could be shorted out on the PVC hose clamp at the crankcase pressure regulator, as shown below (6). This is located approximately 4 inches from the crankcase sensor connector pigtail harness breakout. <p><u>For DTC's: P0201, P0202, P0203, P0204, P0205, P0206, and/or P0216 inspect the following 3 areas:</u></p> <ol style="list-style-type: none"> 1. Inspect for poor terminal tension at connector X160, shown below as callout 25. While inspecting X160 make sure the terminal locking feature (4) is not missing. 2. Inspect the fuel injector connectors to make sure they are fully connected/seated. 3. Inspect the fuel injector wiring harness near the X160 connector (3) for being pinched/shorted/chaffed, as shown below (5). <p><u>For DTC's: P2382,P2383,P11CC,P11D5,P1488,P14D9, and/or P23AF inspect the following area:</u></p> <p>Note:</p> <ol style="list-style-type: none"> 1. Inspect the exhaust pressure differential sensor harness at the connector. The circuits may appear good, and test within a proper reading. 2. Gently pull on the individual wires. This will sometimes cause 1 or 2 wires to break at the connector. 3. After installing the new connector, we advise adding extra tape to limit the movement/vibration of the harness at the connector.

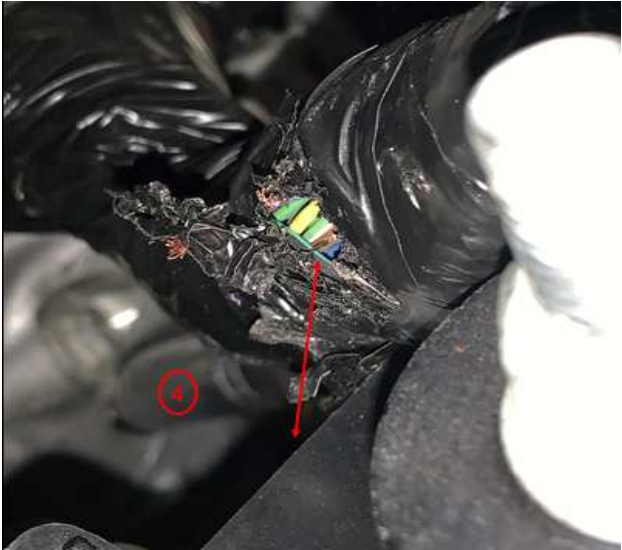
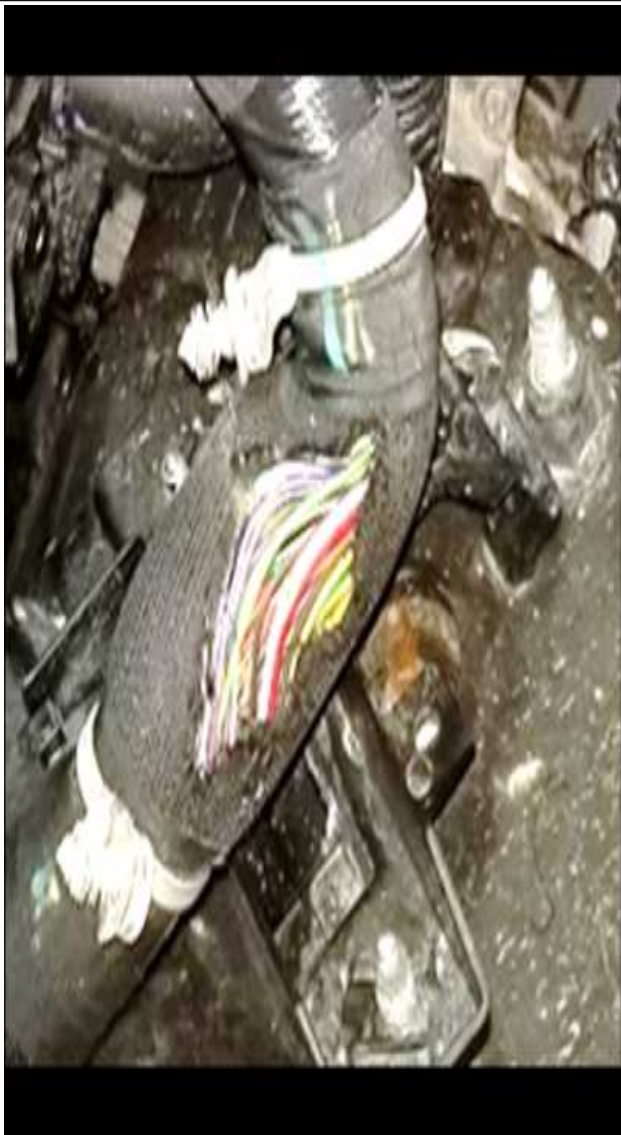
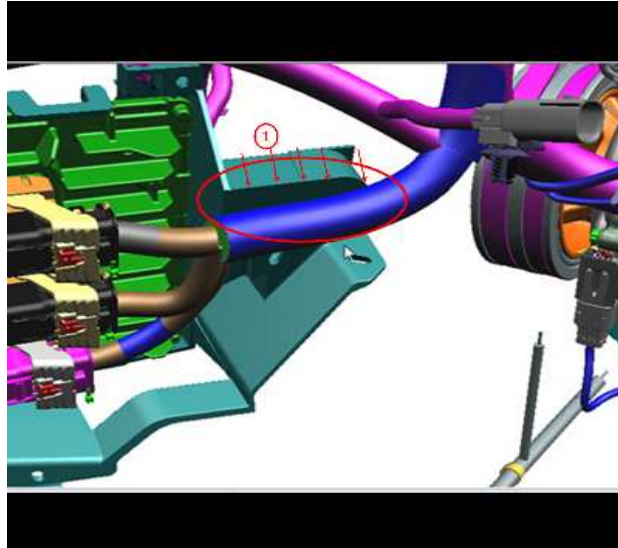
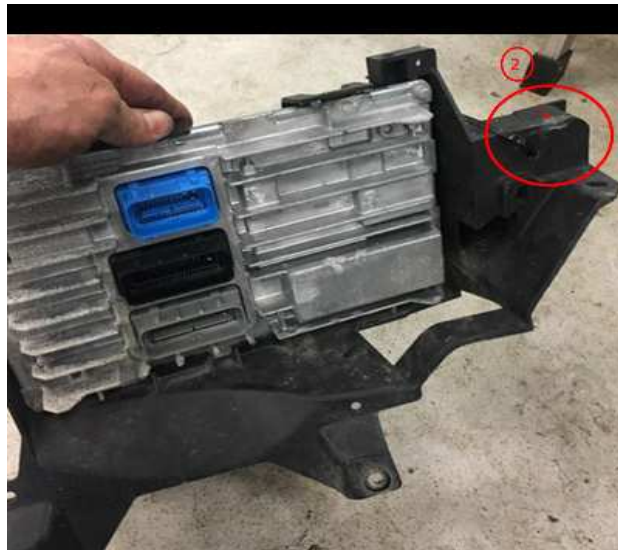
Examples of extreme wire chaffing.

The cause of the condition may be an engine wire harness clip was removed during production due to ergonomic issues (hand clearance and branch stiffness). This led to an uncontrolled branch that came into contact with a sharp edge (1) & (2) on the ECM/TCM bracket, driver side upper control arm, and/or shock tower and caused chaffing during engine vibration and roll.

Utilizing Engine Harness sleeves, anti-abrasion tape, and zip-ties to secure the harness away from one or more of the chaffing points. Follow the Service Procedure steps below.

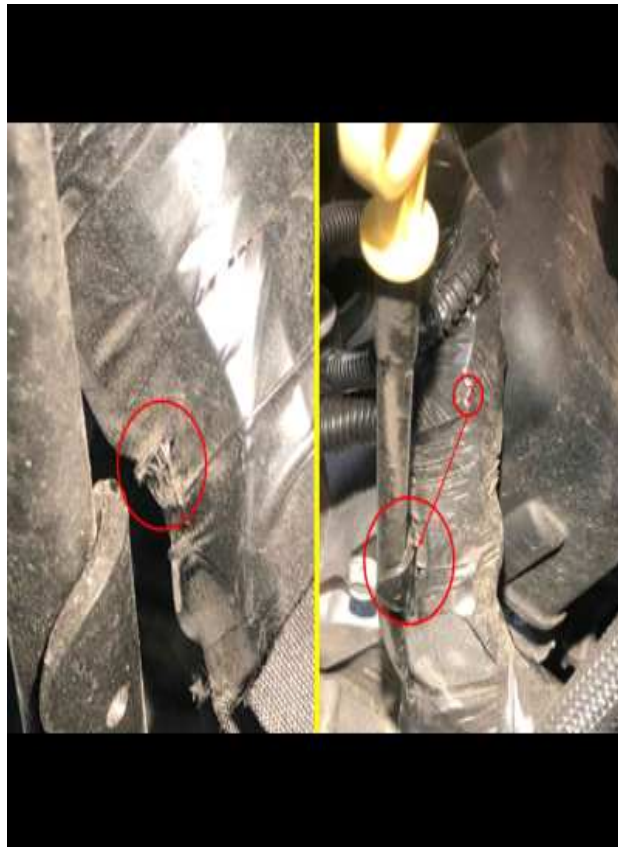
5911722

This Correction pertains to vehicles equipped with engine 4.3L, LV3 only.
Note: The first graphic below is a before, and after (2), repair example of harness chaffing at the Oil Dipstick bracket.

To correct this concern, repair the damaged wiring following the SI wire-to-wire repair procedures. Once repaired, protect and reposition the engine wiring harness to prevent future harness damage.

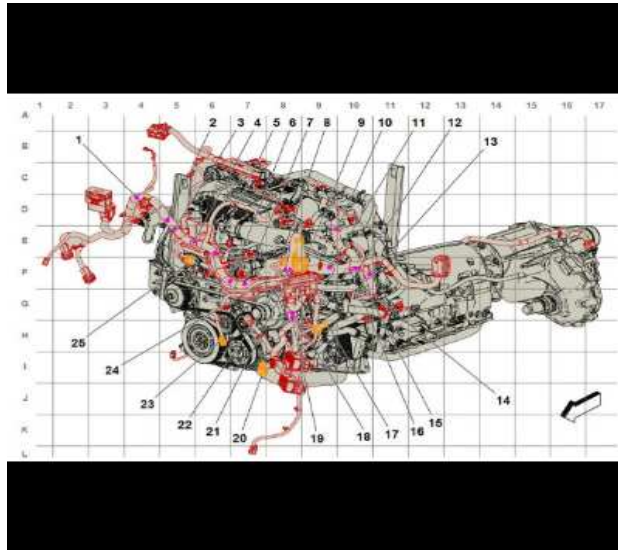
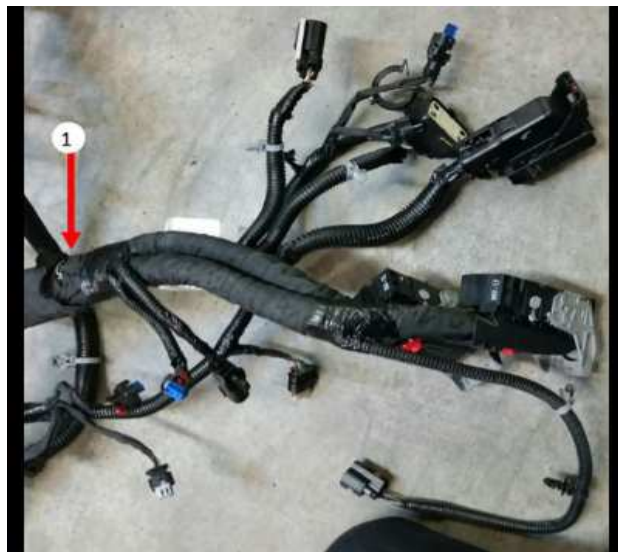
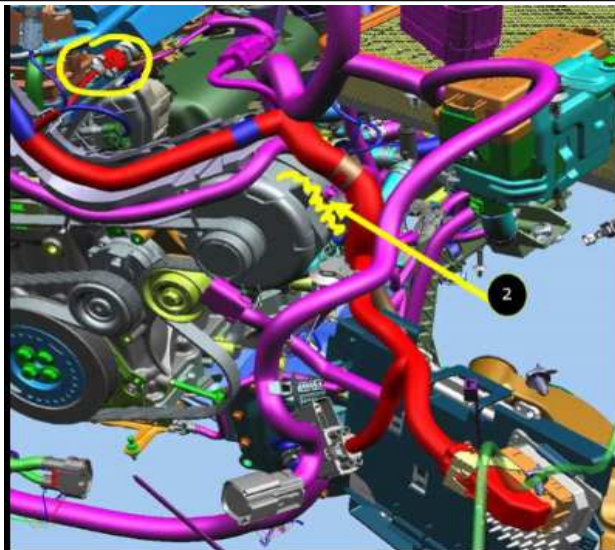
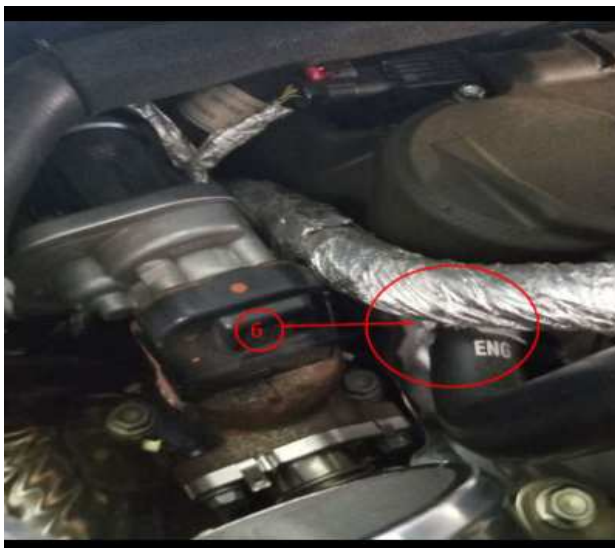
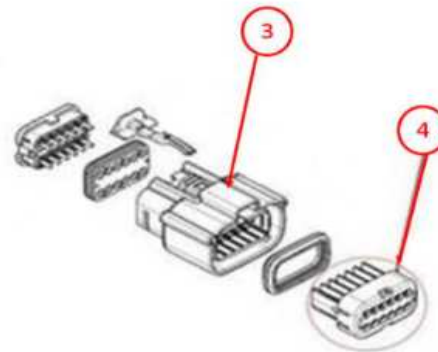
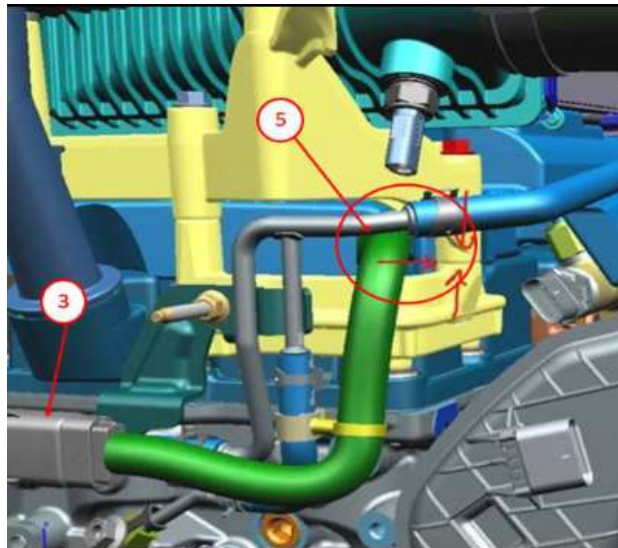
In many cases, the ECM has been unnecessarily replaced for these concerns. Please thoroughly inspect the areas shown above and follow published SI diagnostics before any parts are replaced. If any concerns are found, then follow SI Wiring and Connector repair instructions to correct the concern.

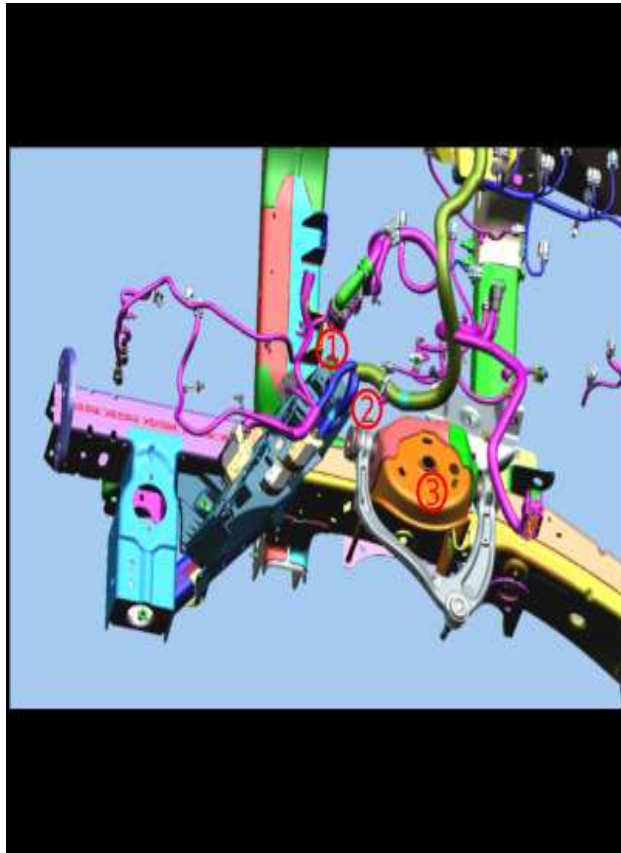
5868341

3. Locate the three contact points where the wire harness is chaffing, the ECM/TCM black bracket (1), the upper control arm (2), and the shock tower bolt (3).

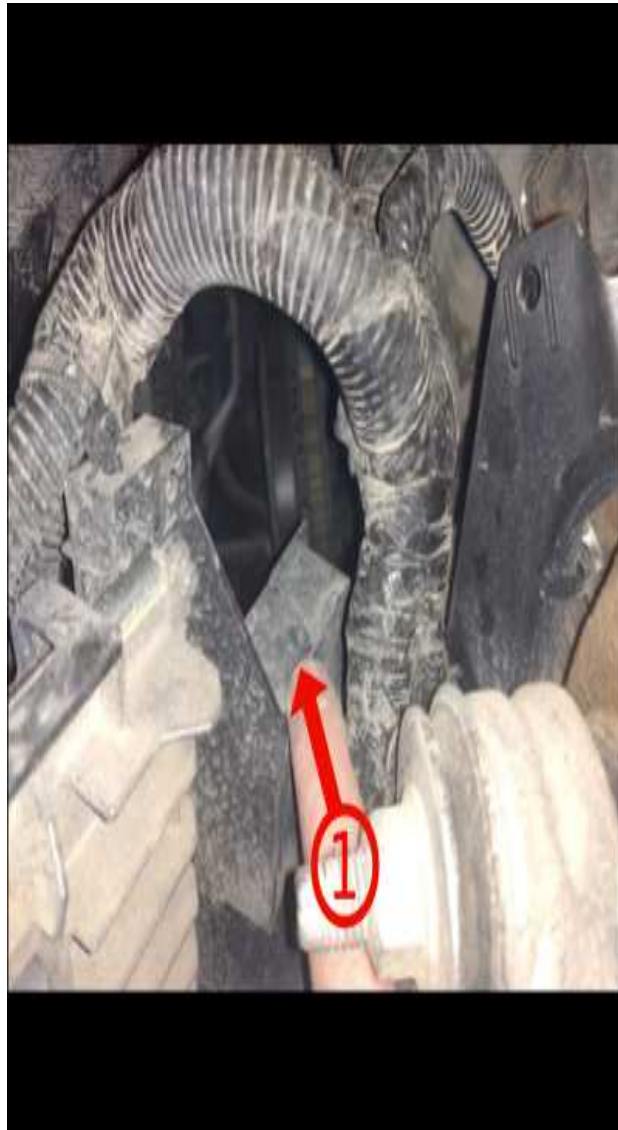
5868349

4. At the ECM/TCM bracket, locate the wire harness laying against the ledge (1).

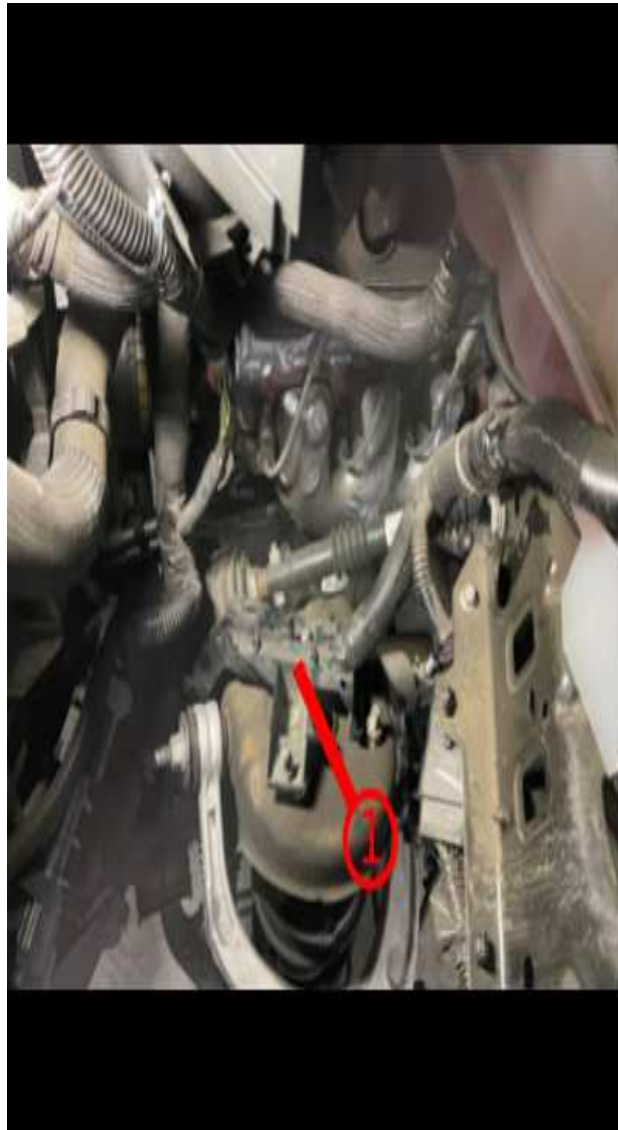
5868359

9. At the shock tower point there is a wire harness canal (1).
