Bulletin No.: 00-06-01-001

Service Bulletin

Subject: Engine Noise (Check/Replace Crankshaft Position Sensor)

**Models: 1999 Chevrolet and GMC C/K Models (Silverado and Sierra)
with 4.8 L or 5.3 L V8 Engine (VINs V, T — RPOs LR4, LM7)
Built within the following VIN breakpoints:**

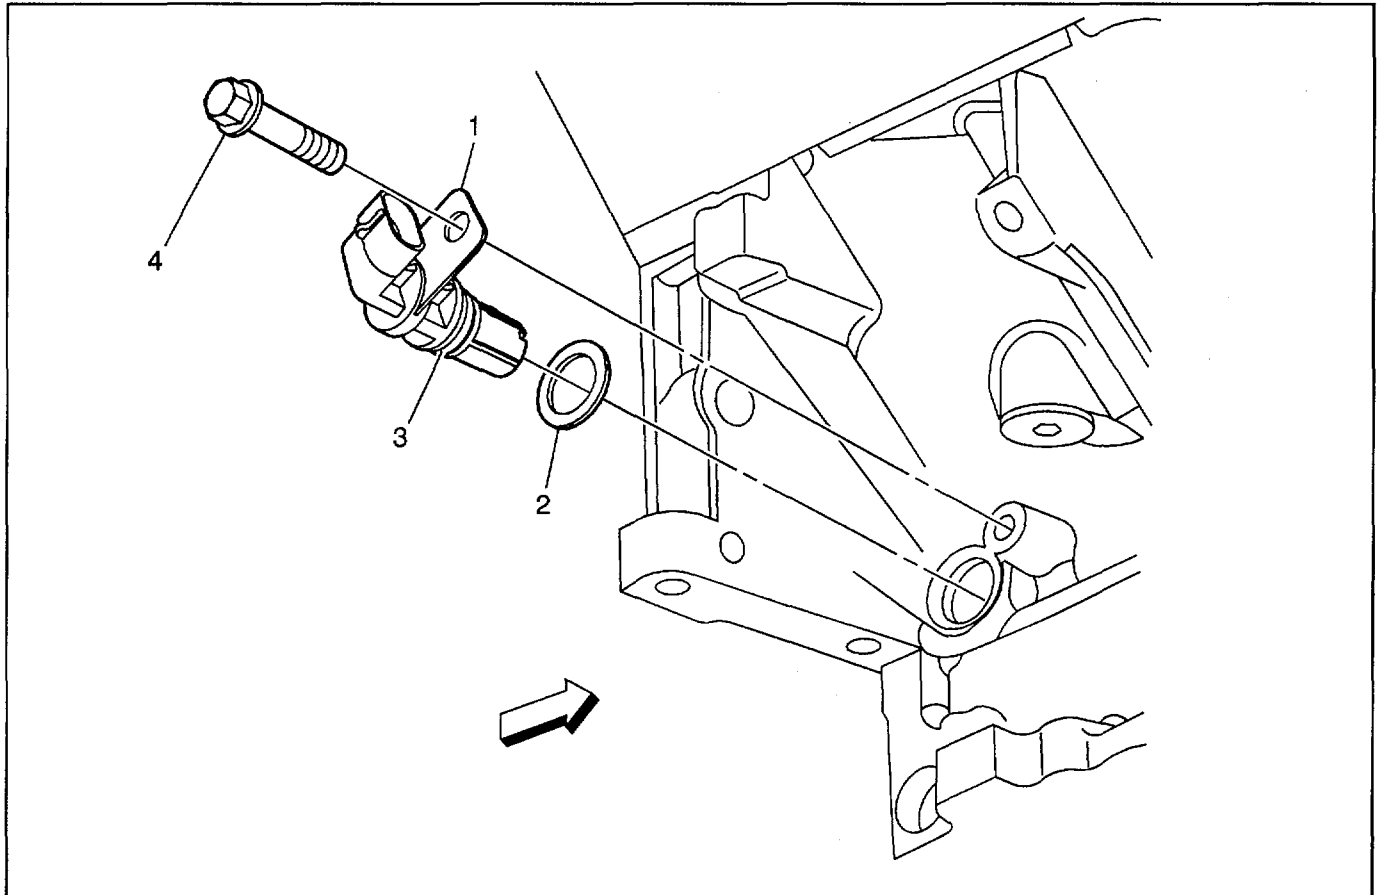
Crankshaft Position Sensor with Shim Washer

Some customers may comment on a whirling sound from the lower rear side of the engine. This occurs as the engine warms up, between 1500 and 2000 engine RPM. The sound may not be present on a cold engine.

The crankshaft position sensor may be making contact with the reluctor ring.

1. Remove the crankshaft position sensor (1), and check for witness marks caused by contact with the reluctor ring. Reference the Service Manual procedure as needed.
2. If no witness marks are evident on the crankshaft position sensor (1):

Important: Do not place an additional shim washer (2) on the crankshaft position sensor (1), if one was not previously installed.

- 2.1. Reinstall the original crankshaft position sensor (1) with any O-rings and shims that may have been previously installed.

Tighten the mounting bolt (4) to 25 N·m (18 lb ft).

3. If witness marks are evident on the crankshaft position sensor (1):

- If a shim washer and/or O-ring had been previously installed:
call Technical Assistance for additional instructions.
- If a shim washer and/or O-ring is not present:
 - 3.1. Place a shim washer (2) P/N 12565102 on a new crankshaft position sensor.
 - 3.2. Install the new crankshaft position sensor (1) with the mounting bolt (4).

Tighten the mounting bolt to 25 N·m (18 lb ft).

- 3.3. Perform the Crank Angle Sensing Error (CASE) re-learn procedure.
- 3.4. With the engine at operating temperature, verify the correction of the noise condition.
