Document ID# 893793
2002 Chevrolet Tahoe - 2WD

Audible Spark Knock (Detonation), MIL Illuminated, DTC P0332 Set (Replace Rear Bank Knock Sensor and RTV Area Around Sensor) #02-06-04-023A - (Jun 14, 2002)

1999-2002 Chevrolet Silverado, Suburban, Tahoe

with 4.8L, 5.3L or 6.0L Engine (VINs V, T, Z, N, U -- RPOs LR4, LM7, L59, LQ9, LQ4)

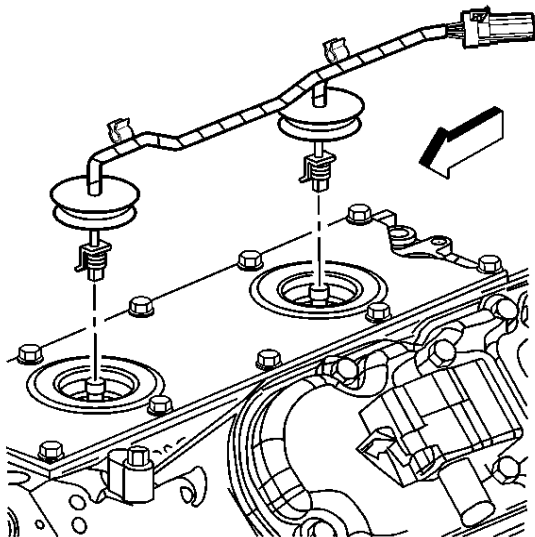
This condition may be the result of corrosion of the rear bank knock sensor due to water intrusion into the sensor cavity. This condition is more apparent on vehicles in which customers frequently wash the engine compartment.

1. Remove the intake manifold. Refer to the Intake Manifold Replacement procedure in the Engine Controls sub-section of the appropriate Service Manual.
