Document ID# 893793

**2002 Chevrolet Chevy K Silverado - 4WD  
2GCEK19T221230343**

# **Audible Spark Knock (Detonation), MIL Illuminated, DTC P0332 Set (Replace Rear Bank Knock Sensor and RTV Area Around Sensor) #02-06-04-023A - (Jun 14, 2002)**

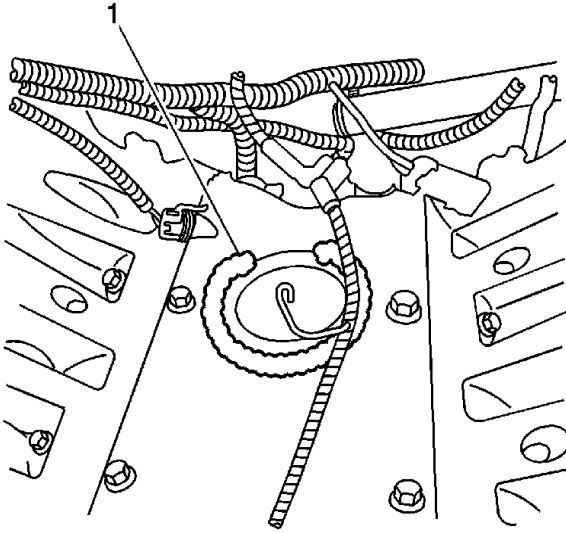
This condition may be the result of corrosion of the rear bank knock sensor due to water intrusion into the sensor cavity. This condition is more apparent on vehicles in which customers frequently wash the engine compartment.

6. Apply a bead of RTV silicone sealant approximately 9 mm (3/8 in) wide and 6 mm (1/4 in) high along the outside edge of the ridge on the engine block valley cover around the rear bank knock sensor. DO NOT form a complete circle. Leave the rear section open as shown.
7. From the underside of the intake manifold, completely remove the rear intake manifold seal (foam material).
8. Install the intake manifold. Refer to the Intake Manifold Replacement procedure in the Engine Controls sub-section of the appropriate Service Manual.
