#PIT5374: Headlight Performance (BCM Calibration and Bulbs) - (Feb 27, 2015)

Subject: Headlight Performance (BCM Calibration and Bulbs)

Models: 2015 GMC Sierra

2014 GMC Sierra 1500

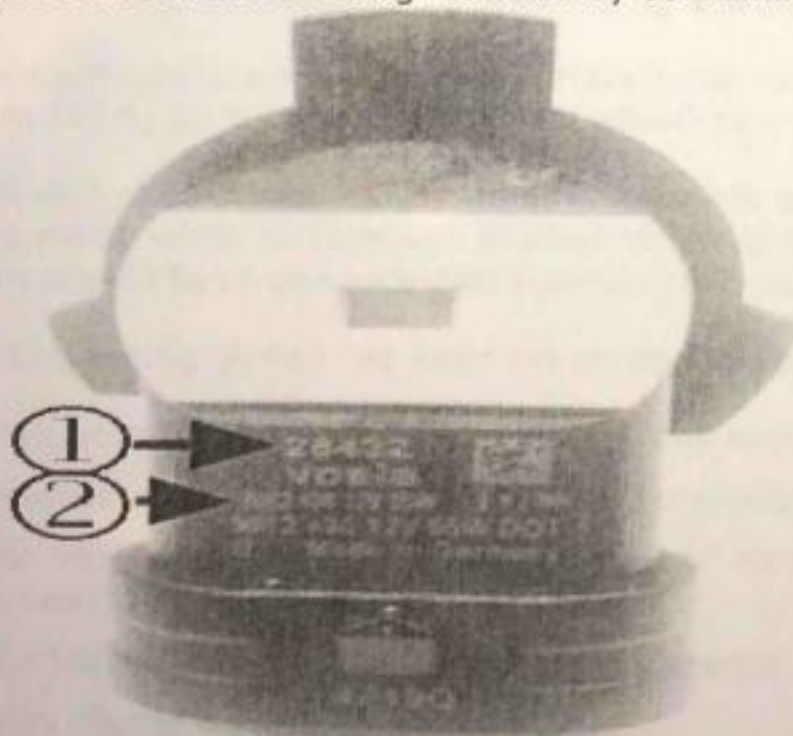
2. Replace both headlight bulbs with updated bulb part number 23342527. **IMPORTANT:** Verify the correct bulb is being installed by confirming the following markings on the bulb:

1. 28432

2. HIR2+30

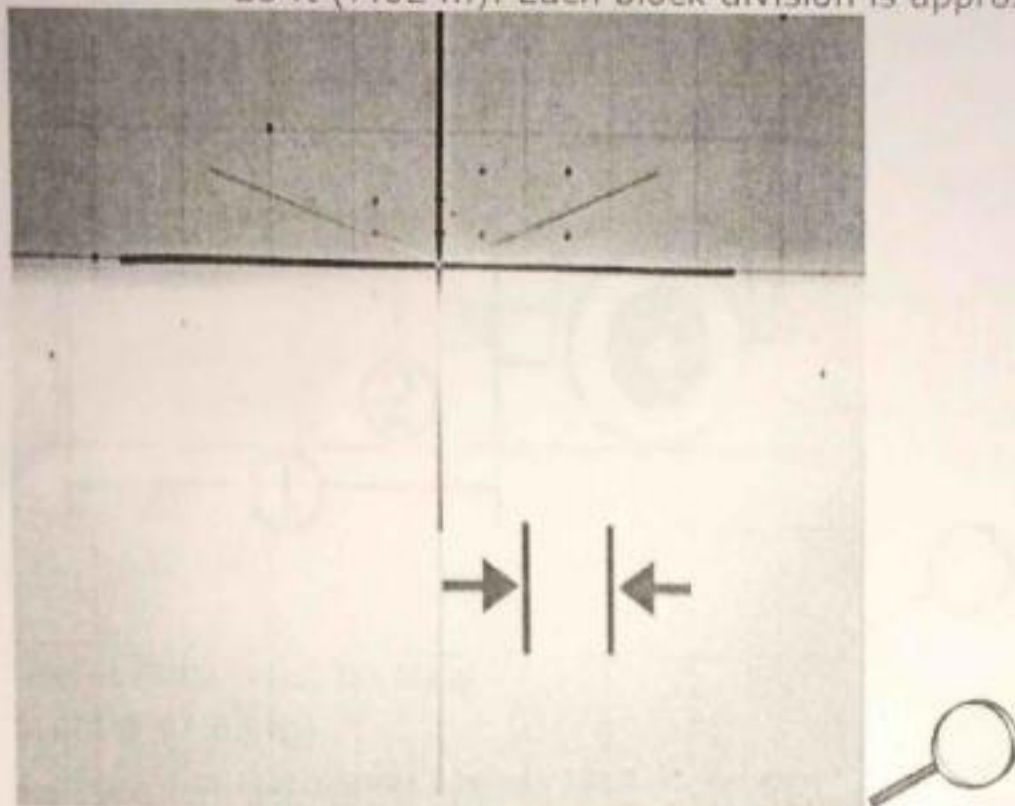
Important: When installing the new headlight bulbs, do not touch the glass and pay close attention that the bulbs are fully seated into the headlight housing. If the bulb is not properly installed it can lead to an incorrect light pattern. A beam pattern photo with a properly installed bulb is shown below. This photo is of a GMC Sierra Low beam pattern (1 Lamp with opposite lamp blocked) on wall/aiming screen at 25 ft (7.62 m). Each block division is approximately 10.5" (26.67cm)

3. After bulb replacement, perform Headlamp Aiming procedure (see below)

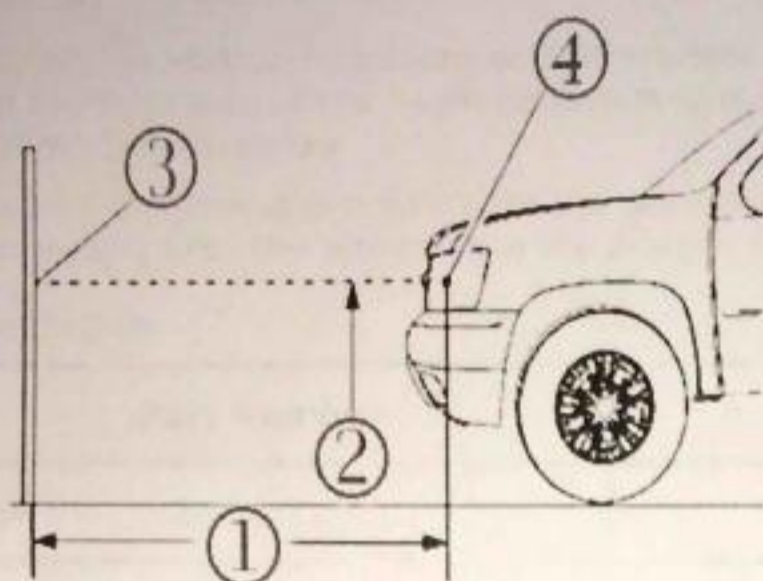
7. Measure from the floor to either headlamp reference mark.
8. At the screen, measure from the floor and place the horizontal tape at the measured height. This establishes the Horizontal Aiming Line.

Note: Floor must be level.

1. 25 ft (7.62 m)
 2. Height of Horizontal Aiming Line on screen
 3. Aiming Screen or Wall
 4. Reference mark (small circle) on headlamp lens
9. Turn the headlamps ON.
 10. Block the light from projecting onto the screen from the passenger side headlamp. This will allow the cutoff ("top" of the beam pattern) in the beam pattern from the driver's side to be more pronounced for easier aim verification.
- Important:** DO NOT cover the headlamp, this may cause excessive heat buildup.
11. On this vehicle you will be verifying the vertical aim of the cutoff (top of the beam pattern) on the right side of the "step" in the beam pattern
 12. If the vertical location of the cutoff projected onto the screen or wall differs from the figure below, then an adjustment to the beam pattern location is necessary.

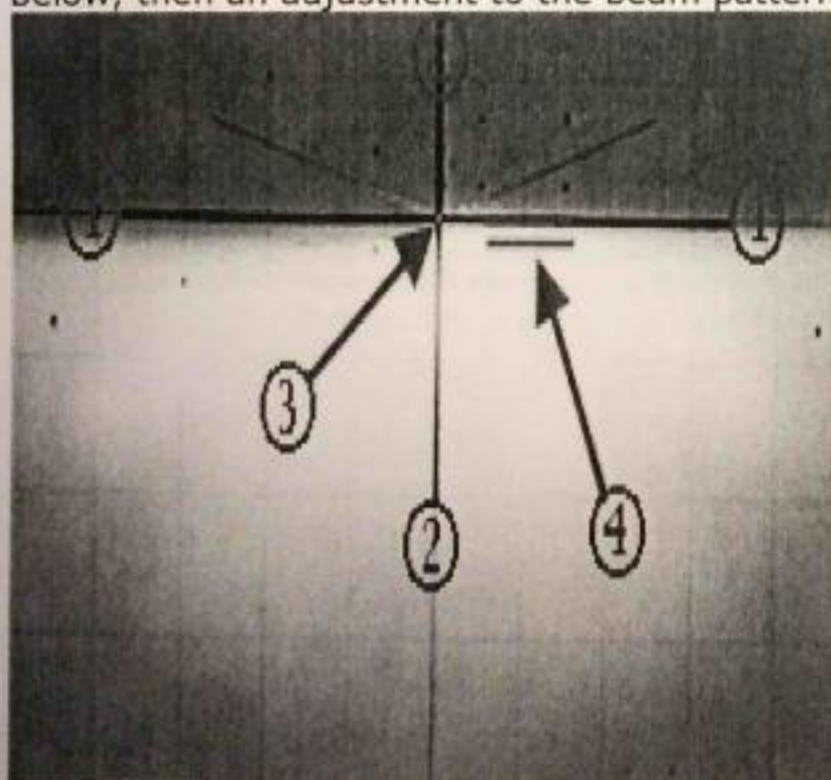
Note: GMC Sierra Low beam pattern (1 Lamp) on wall/aiming screen at 25 ft (7.62 m)

1. Horizontal Aiming Line
 2. Reference line only, Not needed for proper aiming
 3. Step in beam pattern
 4. Top of beam pattern (cutoff line) positioned at the horizontal aiming line +0 / -0.75" (-19mm)
13. Adjust the vertical headlamp aim adjustment screw until the cutoff (top of the beam pattern) on the right side of the beam pattern step is set between the Horizontal Aim Line and 0.75 (19mm) inches below
 14. Repeat the aiming procedure for the passenger's side headlamp while blocking the light from projecting onto the screen from the driver's side headlamp.
