2015 Chevrolet Suburban - 4WD | Escalade, Escalade ESV, Suburban, Tahoe, Yukon, Yukon XL Service Manual 7527571 |

## #PIT5429: Rough Harsh Ride - (Jun 1, 2015)

**Subject: Rough Harsh Ride**

**Models: 2015 Cadillac Escalade Models**

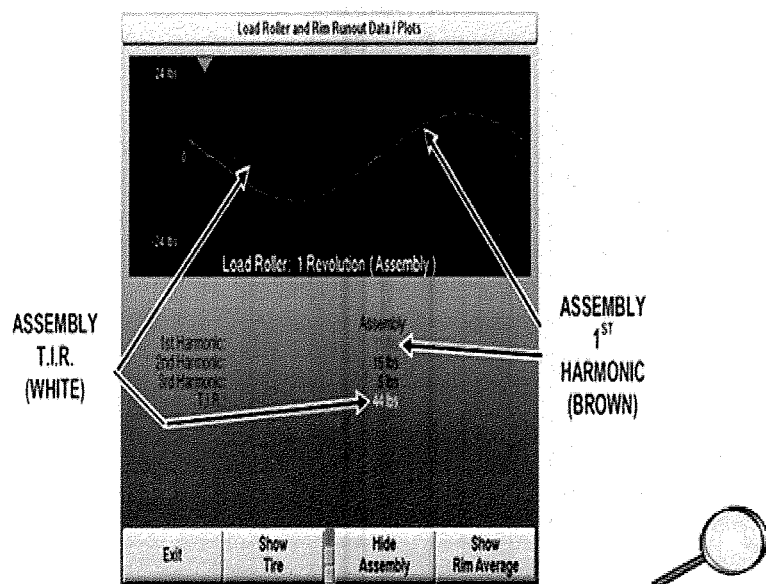
The GSP9700 checks tire low-speed RFV only, in the radial plane only

The GSP9700 is set to display T1 RFV. Higher order RFV, T2 & T3 can be displayed in the Assembly Data Plots Screen, as shown above. Depending on the level of GSP9700, the screen may be under 'Data' or 'Runout Plots,' then "Rim and Load Roller Runout Plots."

When checking tires on the GSP9700, if (radial) T2 is high or close to the (radial) T1 value, the tire should be replaced. As an example, if a tire and wheel assembly is measuring T1 at 10 lbs RFV, the tire would be considered good; however, if in displaying the higher orders, it is found that the tire and wheel assembly also has T2 at say 9 lbs RFV, the tire needs to be replaced. Refer to the latest version of PI1354 for latest procedures.
