**Subject:** Roof Beacon (TRW) Switch Wiring Location/Access

**Models/Years Affected:** 2014-15 Chevrolet Silverado 1500 LD  
2014-15 GMC Sierra 1500 LD

**Affected:** 2015 Chevrolet Silverado 2500/3500 HD  
2015 GMC Sierra 2500/3500 HD  
With option TRW

**Origination Date:** February 6, 2015

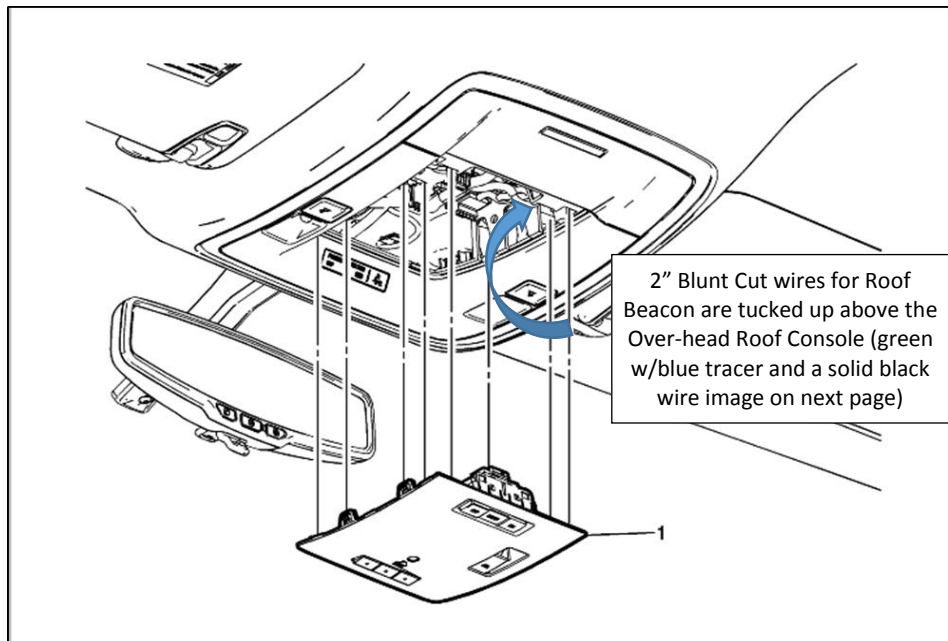
#### Roof Console Removal

Customer and Upfitters may have made several inquiries in search of the location and access methods for the blunt cut wiring for the Roof Beacon provision option (TRW).  
NOTE: Blunt cut wires are only ~ 2 inches in length.

To access the blunt cut wires for the roof beacon, remove center section of the Roof Console as follows...

1. Use a flat bladed plastic trim tool in order to release the retainer clips securing the trim plate to the roof console assembly.
2. Disconnect electrical connections where/when required.

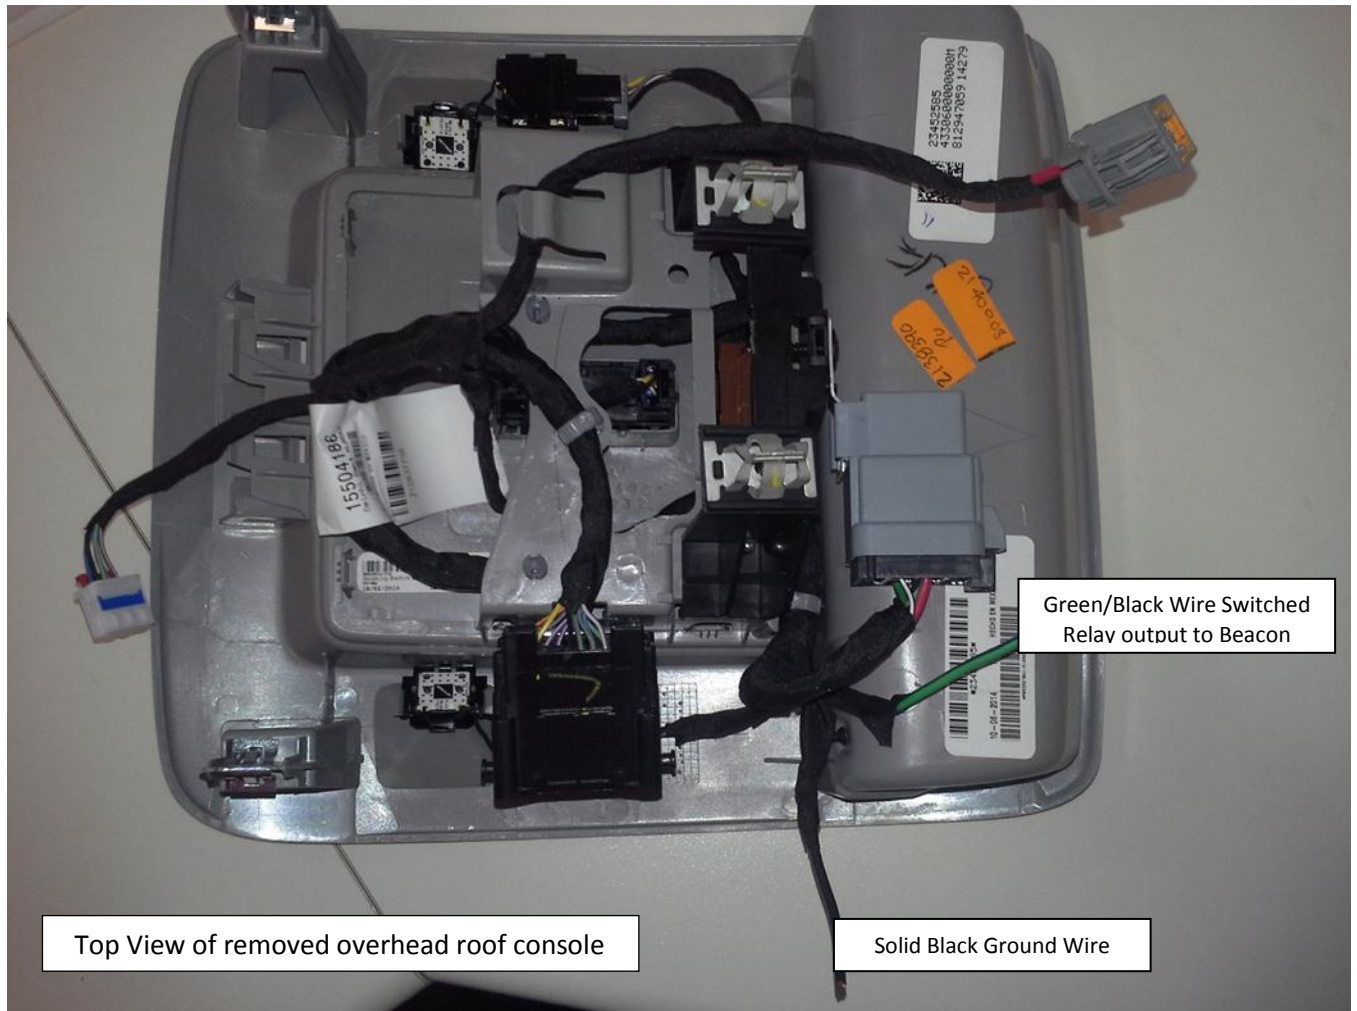
**Removed Roof Console**

Top View of removed overhead roof console

Solid Black Ground Wire

Green/Black Wire Switched Relay output to Beacon
