## #PIT5501E: Steering Feels Loose / Excessive Lash / Fluid Leak At Lash Adjuster - (Mar 7, 2017)

**Subject: Steering Feels Loose / Excessive Lash / Fluid Leak At Lash Adjuster**

Brand:	Model:	Model Year:		VIN:		Engine:	Transmission:
		from	to	from	to		
Chevrolet	Silverado 2500/3500	2016-2017		All	All	All	All
GMC	Sierra 2500/3500	2016-2017		All	All	All	All

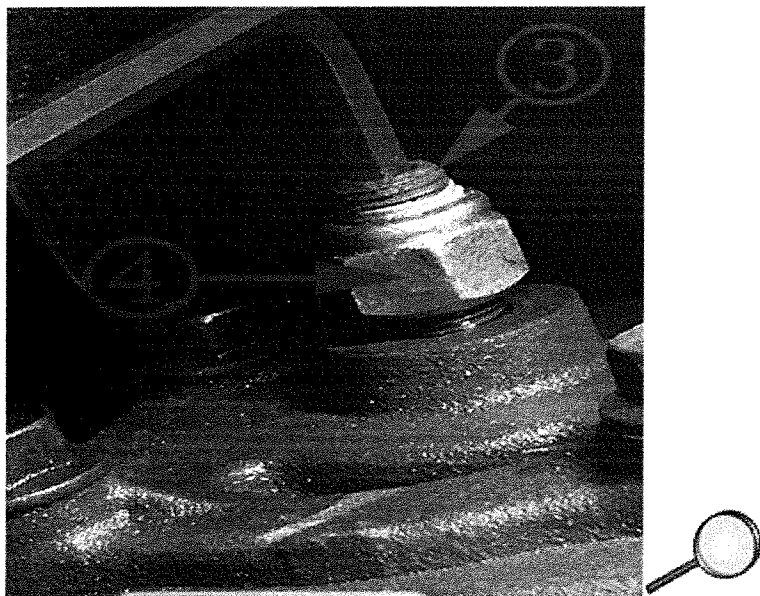
These concerns could be caused by the pitman shaft adjuster stud (3) unthreading up/out of the cover plate, which can cause excessive lash in the steering gear. This issue is NOT caused by the lock nut (4) turning on the adjuster stud (3), shown below.

- The adjuster stud nut (4) will not be seated up against the cover plate, shown below.
- The adjuster stud (3) can easily be turned in or out by hand using an Allen wrench.

If it is found that the pitman shaft adjuster stud (3) has unthreaded up/out AND there is NO reason to believe someone has previously turned the adjuster stud nut (4) on the adjuster stud (3), continue to the recommendations section to apply thread locker on the adjuster stud threads.

If any lash/play is found, OR there IS reason to believe someone has turned the adjuster stud nut (4) on the adjuster stud (3), follow the SI procedure titled "Steering Gear Pitman Shaft Over-Center Preload Adjustment - Off Vehicle (Heavy Duty)".
