#PIT5542: Front Seat Lateral Movement and/or Unable To Install Front Seat Lateral Retainer When Performing PI1376 Or PI1183 - (Jan 25, 2017)

Subject: Front Seat Lateral Movement and/or Unable To Install Front Seat Lateral Retainer When Performing PI1376 Or PI1183

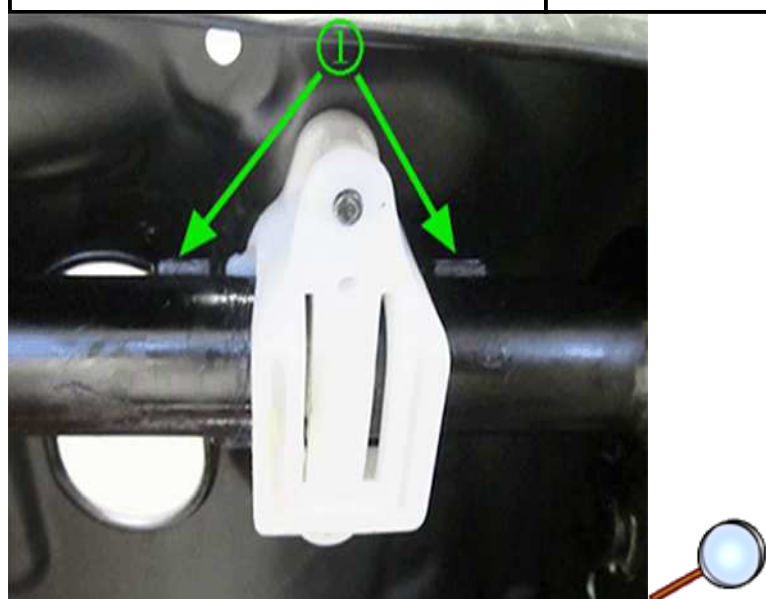
Involved Region or Country	North America and N.A. Export Regions
Additional RPO/s:	N/A
Condition	Some customers may comment of excessive lateral driver or passenger seat movement and/or a clunk/click/pop type feeling or noise. This condition occurs when the seat is occupied and the vehicle is being driven on roads with curves, or during low speed turning maneuvers.
Cause	<p>This concern could be caused by movement between the seat pan front pivot points and the seat frame pivot bar.</p> <p>For 2014 and 2015 Model years, a front seat lateral retainer was developed to correct lateral seat movement, as outlined in PI1376 and PI1183. If the seat frame base was previously replaced for any reason, the new seat frame would have the 2016/2017 updates, which incorporates the welded brackets as described below (1).</p> <p>For 2016 and 2017 model years, an updated seat frame design that incorporates welded brackets (1) to the seat frame pivot bar on each side of the white guide block. This helps to reduce the excessive lateral seat movement.</p> <p>Regardless of the model year, in some cases, even with the updated seat frame design, there still could be excessive clearance between the welded brackets (1) and the white guide block. This will cause excessive lateral seat movement.</p>

If excessive lateral seat movement is found between the welded brackets (1) and the white guide block, the front seat lateral retainer (GM PN 13405675) can be installed to correct this condition.
