# #01-08-42-001K: Exterior Lamp Condensation and Replacement Guidelines - (Feb 8, 2016)

**Subject: Exterior Lamp Condensation and Replacement Guidelines**

**Models: 2017 and Prior GM Passenger Cars and Trucks**

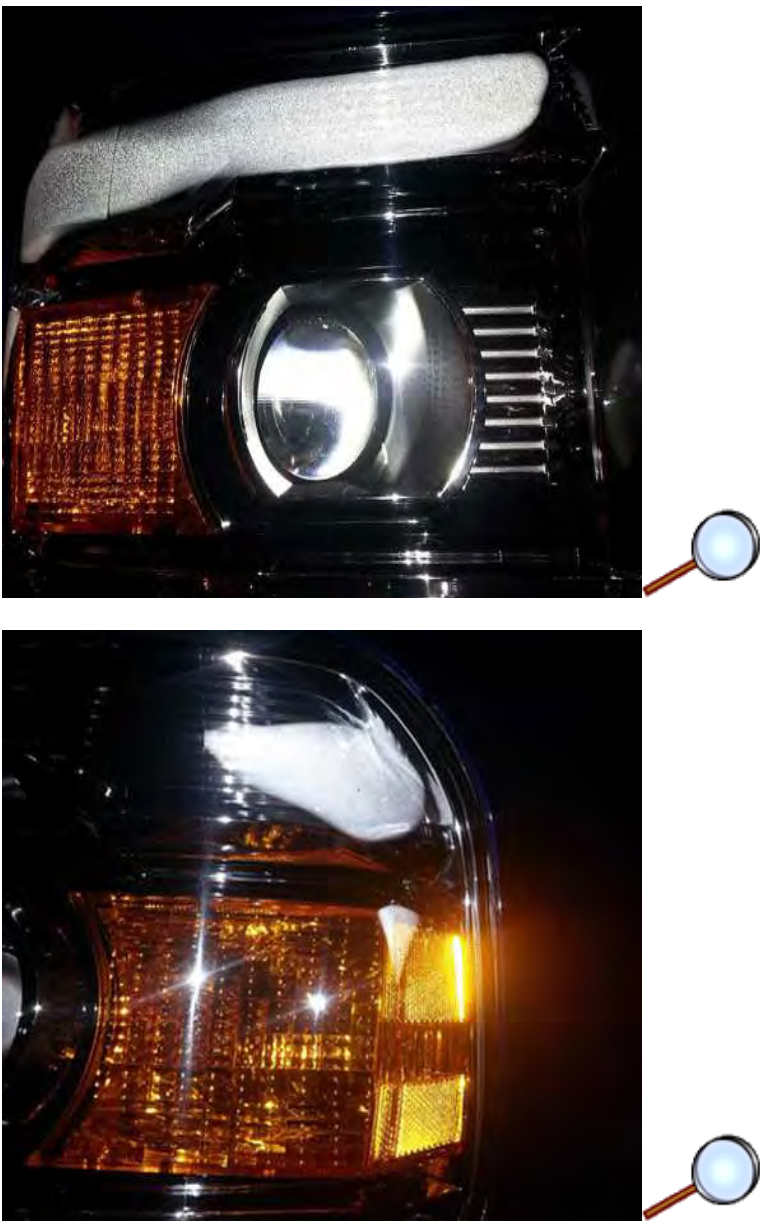
### 2014 Sierra Headlamp, Full and Partial Examples

### A Fine Mist or White Fog on the Inside Surface of the Lamp Lens Occurring After a Period of High Humidity

- May be located primarily in the lens corners (near the vents) and SHOULD NOT cover more than half the lens surface.
- The condition should clear of moisture when the vehicle is parked in a dry environment, or when the vehicle is driven with the lights ON.
- A comparison of the equivalent lamp on the opposing side of the vehicle indicates a SIMILAR performance.

If the above conditions are noted, the customer should be advised that replacement of a lamp assembly may not correct this condition.

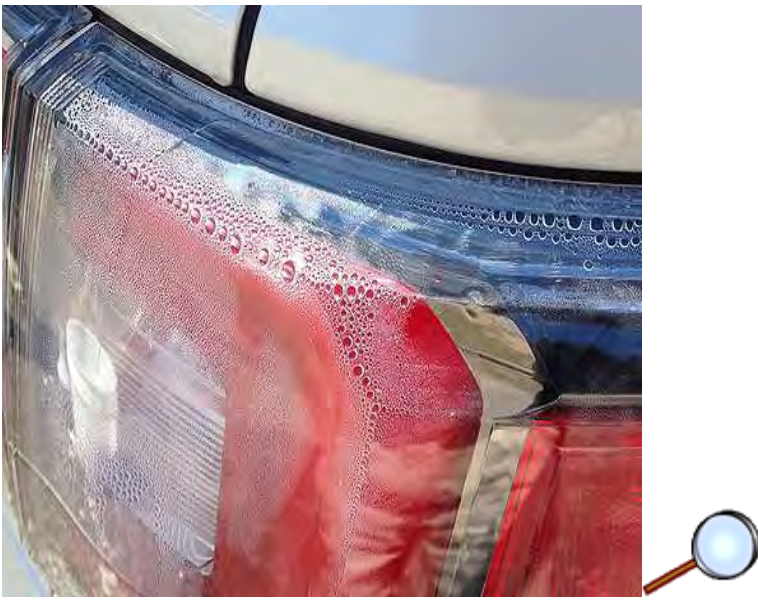
### 2014 Acadia Tail Lamp Example

**Numerous & Various Size Drops of Water Collecting on the Inside Surface of the Lamp Lens After the Vehicle Has Been Exposed to Rain or a Car Washing Environment**

- A condition that covers more than half the surface of the lamp lens.
- An accumulation of water in the bottom of the lamp assembly.
- A condition that WON'T clear when the vehicle is parked in a dry environment, or when the vehicle is driven with the lights ON.
- A comparison of the equivalent lamp on the opposing side of the vehicle indicates a different performance.

**If a lamp is found to be exhibiting a leak, review the most recent version of Service Bulletin 02-08-42-001 for information regarding impact damage and modification inspection.**

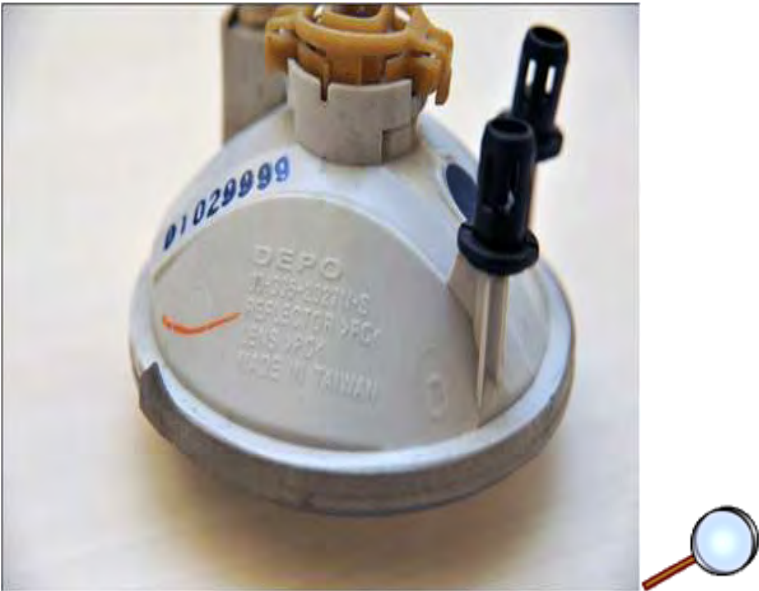
This fog lamp was returned for retaining moisture. As you can see it is marked with the Depo brand (it is also called out on the front lens).
