#PIT5501F: Steering Feels Loose / Excessive Lash / Fluid Leak At Lash Adjuster - (Jun 8, 2017)

Subject: Steering Feels Loose / Excessive Lash / Fluid Leak At Lash Adjuster

| Brand: | Model: | Model Year: | | VIN: | | Engine: | Transmission: |
|---|---|---|---|---|---|---|---|
| Chevrolet | Silverado 2500/3500 | 2016 | | All | All | All | All |
| GMC | Sierra 2500/3500 | 2016 | | All | All | All | All |

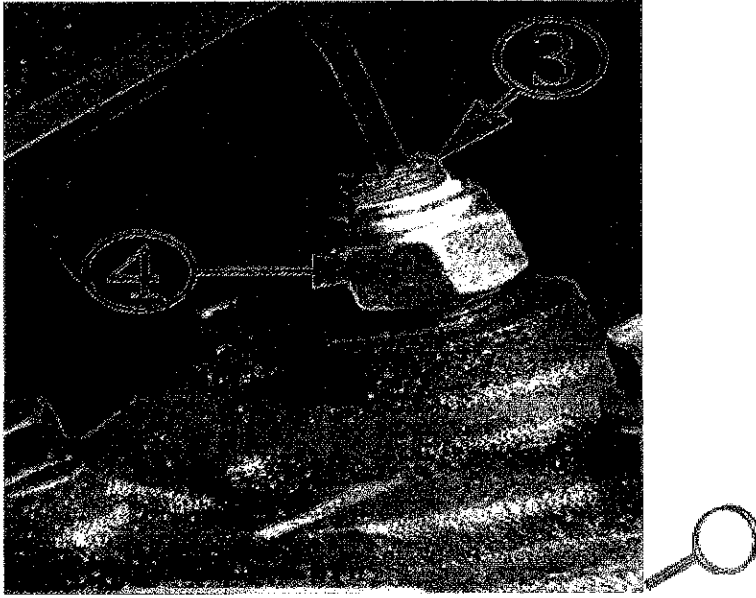
These concerns could be caused by the pitman shaft adjuster stud (3) unthreading up/out of the cover plate, which can cause excessive lash in the steering gear. This issue is NOT caused by the lock nut (4) turning on the adjuster stud (3), shown below.

- The adjuster stud nut (4) will not be seated up against the cover plate, shown below.
- The adjuster stud (3) can easily be turned in or out by hand using an Allen wrench.
