#PIT5405B: Reduced Power Steering Assist Engine Stall IPC / Radio / HVAC Goes Blank Various DTCs - (Aug 17, 2016)

Models: 2015-2016 Cadillac Escalade Models
 2014 Chevrolet Silverado 1500
 2015-2016 Chevrolet Silverado, Suburban, Tahoe
 2014 GMC Sierra 1500
 2015-2016 GMC Sierra, Yukon Models

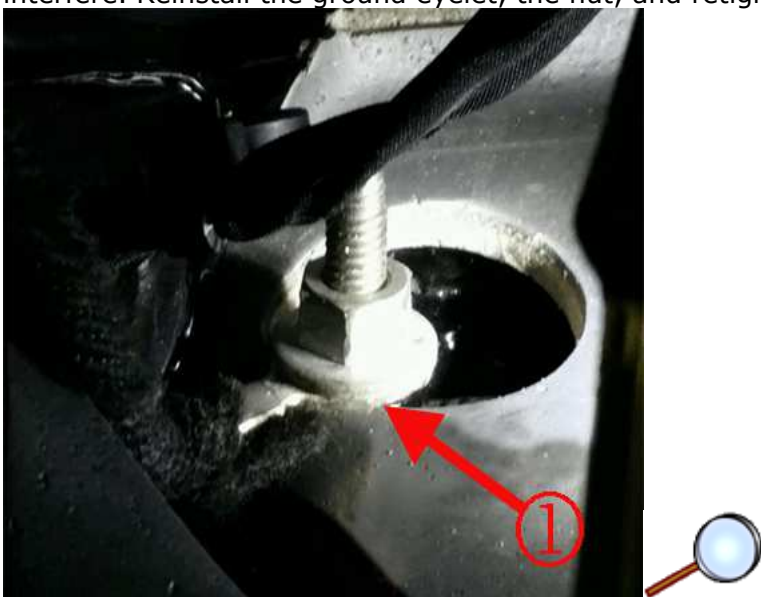
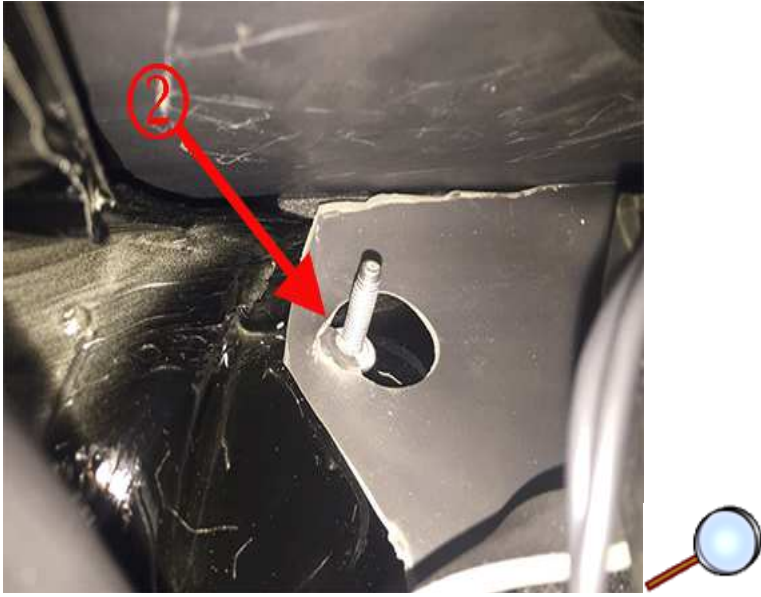
1. A poor BCM ground at G218.
2. A shorted B+ Battery cable (3) at the Starter Solenoid caused by:
 - A loose starter shield contacting the starter battery cable terminal ring
 - A starter cable ring terminal that has been mis-installed and/or rotated when installed on the starter solenoid.
3. Battery cables with high resistance and/or loose connections at the:
 - Battery fuse block
 - Positive or negative battery cables
4. A discharged or faulty battery.
5. A loose connection at the main power and ground 2-way connector (X183 or X133 depending on model) for the power steering rack.

1. Inspect G218 for a loose connection or the front of dash insulator mat (2) for being trapped between the ground eyelet and the body/stud as shown below (1). If the dash insulator mat is trapped, cut the mat away from the ground stud so it will no longer interfere. Reinstall the ground eyelet, the nut, and retighten
