#17-NA-302: Dust Buildup Around Filler Cap Area - (Sep 27, 2017)

Subject: Dust Buildup Around Filler Cap Area

Brand:	Model:	Model Year:		VIN:		Engine:	Transmission:
		from	to	from	to		
Chevrolet	Silverado	2017	2018				
GMC	Sierra

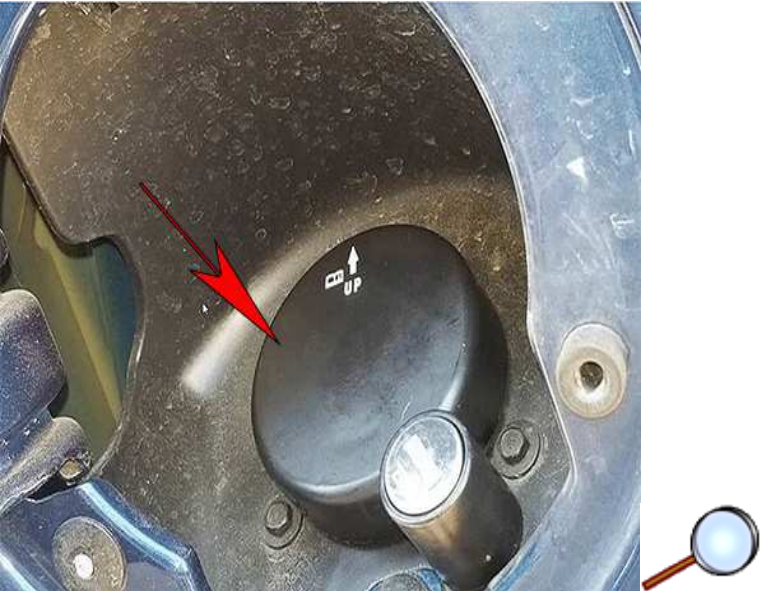
Involved Region or Country	North America and NA Export vehicles
Condition	Some customers may comment on excess amount dirt that can build up around the filler neck.
Cause	This condition may be caused when trucks are operated in high amount of dirt or dust which can migrate to the filler cap area.
Correction	<div>

</div> <p>Notify the customer that GM had made available a locking gas cap for drivers that operate in these dirty or dusty environments. This will protect the fill area from dirt intrusion and protect the fuel system.</p>
