#18-NA-135: Water Leaks in Bed Area on Trucks Equipped with High Desert Package - (Apr 26, 2018)

Subject: Water Leaks in Bed Area on Trucks Equipped with High Desert Package

Brand:	Model:	Model Year:		Date Breakpoint:		Engine:	Transmission:
		from	to	from	to		
Chevrolet	Silverado	2017	2018	SOP	Built Prior to March, 1, 2018	All	All

Involved Region or Country	North America, N.A. Export Regions
Additional Options (RPOs)	Equipped with High Desert Package — RPO (ZYD).
Condition

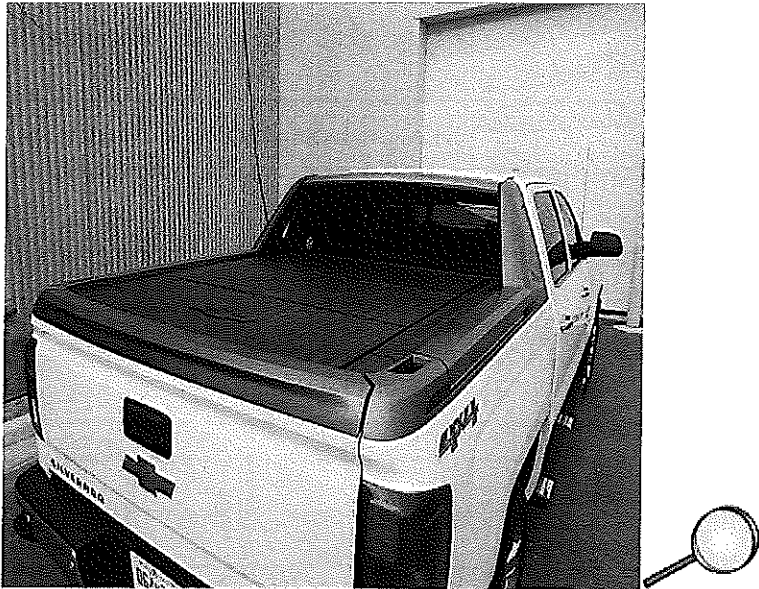
<p>Some customers may comment on finding water leaks in the bed area of their vehicle, which has the High Desert option package.</p>
Cause	© 2018 General Motors. All rights reserved.

The cause of the condition may be that the design intent of the High Desert Package is NOT to provide a completely water tight cargo area. The package is designed to have a water management system, but some water may still migrate into the bed area.
Correction	A design improvement has been made to all of the service parts listed in the part table below. Follow the Service Procedure below for part replacement and additional steps that can reduce, but not eliminate, water getting into the bed area.
