#10-06-01-008G: Engine Oil Consumption on Aluminum Block/Iron Block Engines with Active Fuel Management (AFM) (Install AFM Oil Deflector and Clean Carbon from Cylinder and/or Install Updated Valve Cover) - (Jan 3, 2013)

Models: 2007-2011 Cadillac Escalade Models

2007-2011 Chevrolet Avalanche, Silverado 1500, Suburban, Tahoe

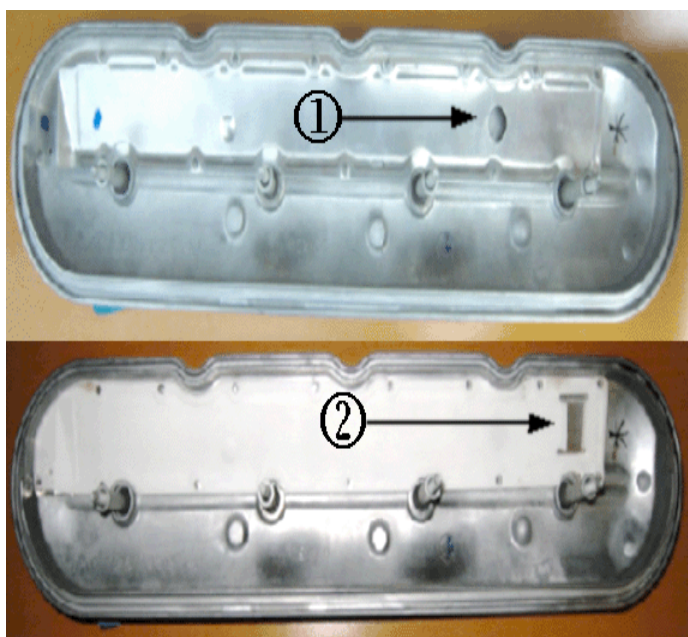
- 1) Old Design
- 2) New Design

PCV pullover or an overactive lifter can cause oil to be pulled through the PCV system even at low vehicle mileage. A correctly functioning PCV system will only leave a film of oil in the intake manifold. Inspect the intake manifold to see if there is any oil puddling in the bottom. If there is you will need to replace the left valve cover. Two new left rocker arm covers have been released for trucks and vans. Technicians should replace the left rocker arm cover with GM P/N 12570427 for 2007-2008 or GM P/N 12642655 for 2009-2011. Refer to the Parts Information below for the Camaro. This rocker arm cover has a relocated PCV drain hole that prevents oil from entering the intake manifold. Refer to Valve Rocker Arm Cover Replacement - Left Side in SI.

Note: These rocker covers are for specific years. The PCV orifice is different for each. The correct

cover must be used or an SES light may set.
