## #PIP5504A: Diagnosing Fishbite Chuggle Misfire Feeling Or Shudder Vibration, With A Light Tip In - (Jan 17, 2018)

**Subject: Diagnosing Fishbite Chuggle Misfire Feeling Or Shudder Vibration, With A Light Tip In**

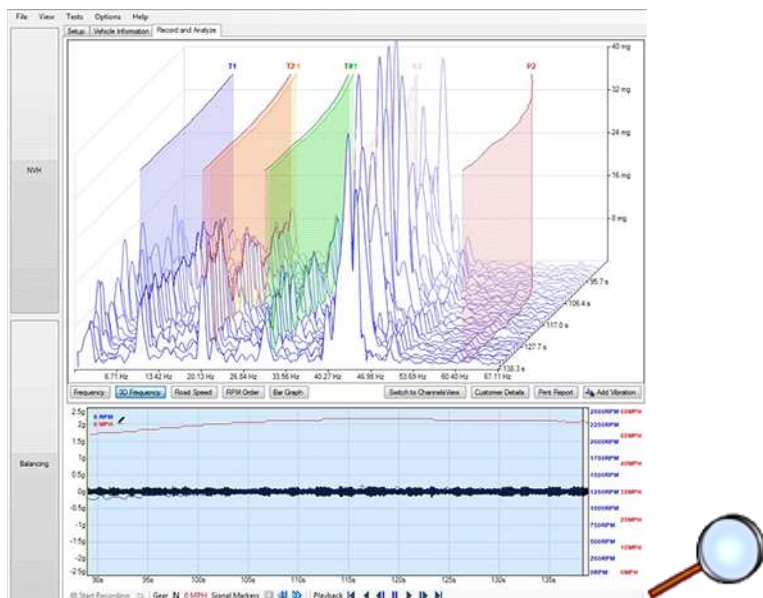
To confirm TCC Shudder, the vibration concern must be present in normal operation (Mode A), but not present with the torque converter clutch disabled (Mode B) or with the torque converter clutch locked (Mode C).

If TCC Shudder is present, a vibration peak will appear at approximately 43Hz +/-3Hz as shown in the picture above. If the vibration frequency follows engine, tire, or driveshaft speed, then it is NOT TCC Shudder. TCC Shudder vibration frequency should stay constant per gear while vehicle and engine speeds change.

5.3 Flush cooler lines, replace converter, drain, and refill ATF.
