# UI Bulletin #110j

**Subject:** Upfitter Auxiliary  
Switches (RPO 9L7)

**Models Affected:** Chevrolet Silverado  
GMC Sierra

**Model Years:** 2014 and Beyond

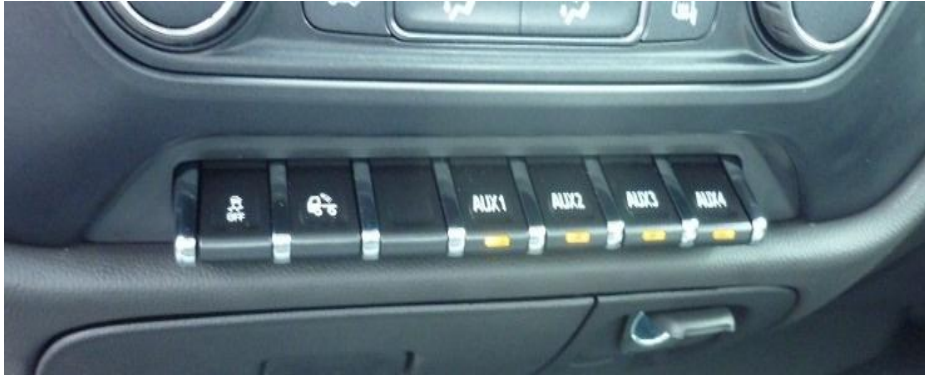
**Figure 1**  
(4 switch configuration shown)

For the 2014/15 Full-size trucks (1500 fleet/work 2500/3500HD), built with the regular production option (RPO) 9L7 (auxiliary switch bank), this switch bank replaces the standard switch bank located just below the Climate Controls (refer to figure 1) and is intended specifically for adding controlled features/functions from inside the cab.

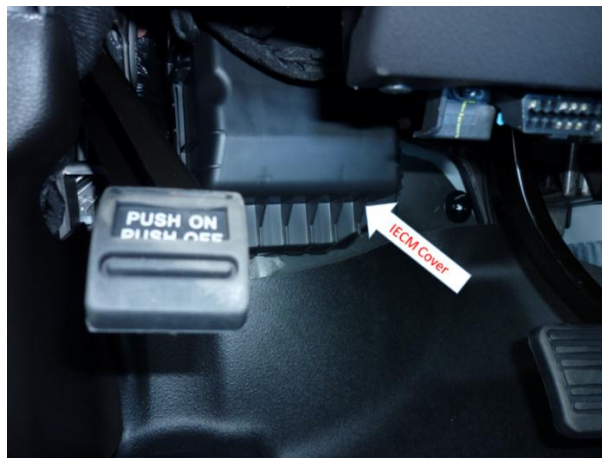
**Figure 2**

The outputs from the switches are located inside the cab into the LH IP Junction Block (IECM (X61A)). Refer to Figure 2

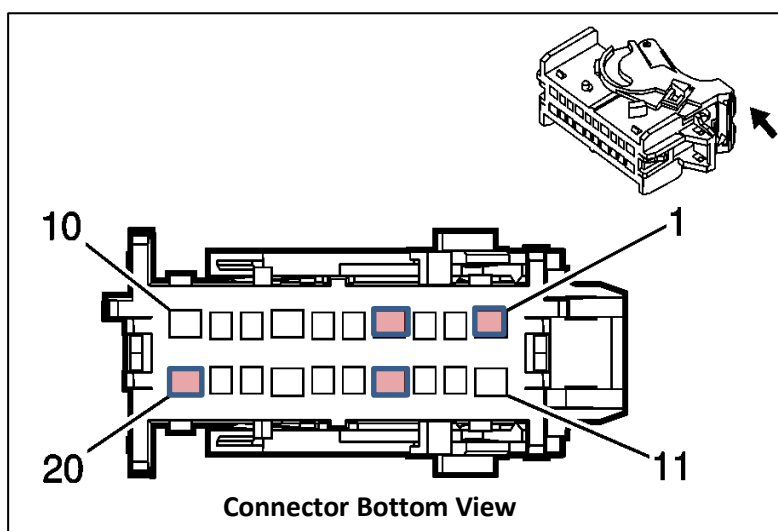
**Figure 4**

Pin #1, 4, 14 and 20 are used for Upfitter added/configured circuits

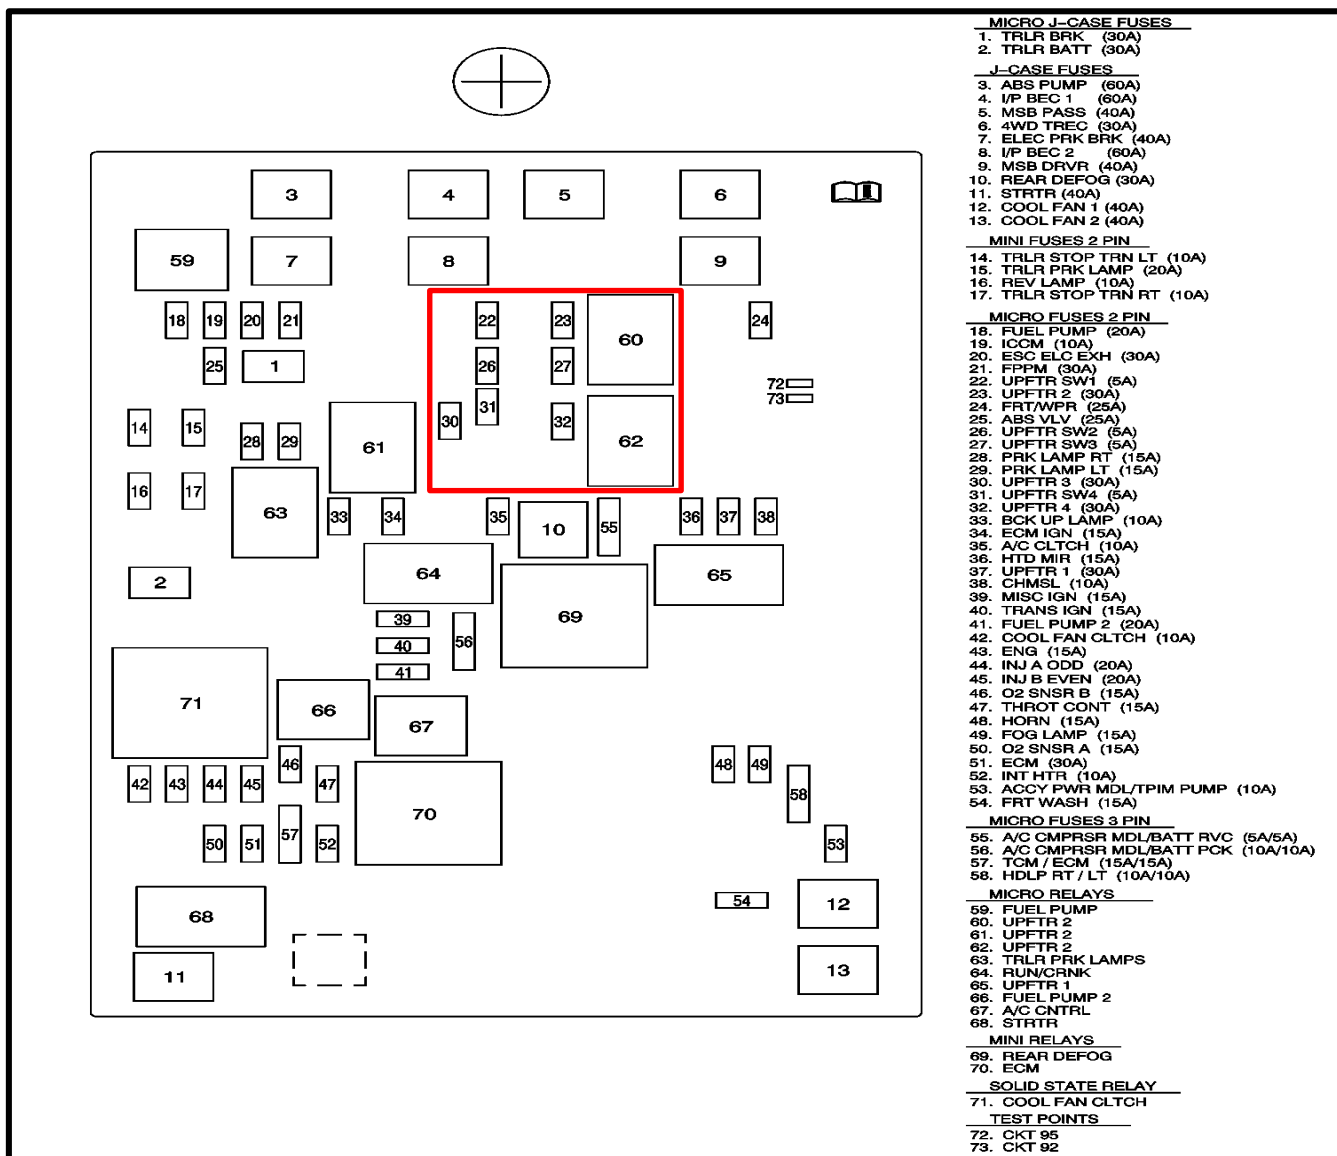
**Figure 5**

NOTE: The red squared area in Figure 5 reflects the fuses involved in the possible fuse reconfiguration used for the powering of the AUX switches.

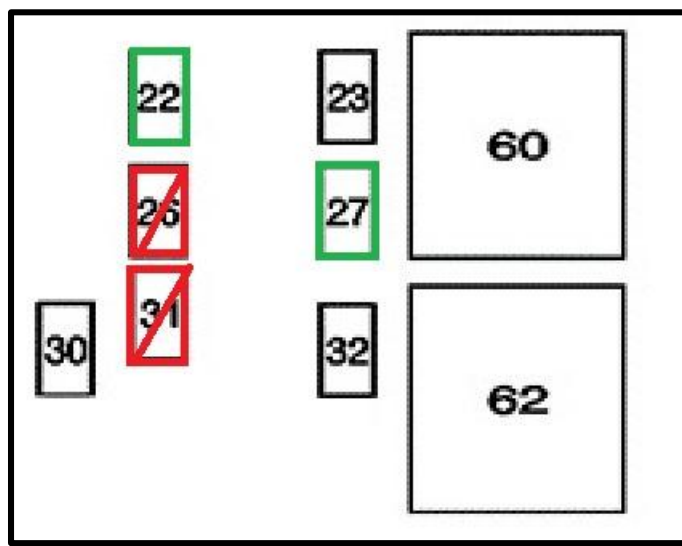
Figure 6 shows the fuses configured for all switches (1, 2, 3 & 4) for battery powered. This is the default fuse location from vehicle manufacturing (note fuse locations 26 & 31 are unpopulated).

Never populate both fuse locations for either pairing of AUX switches. This is to mean do NOT install fuses in both locations of 22 and 26 or in both locations of 27 and 31.

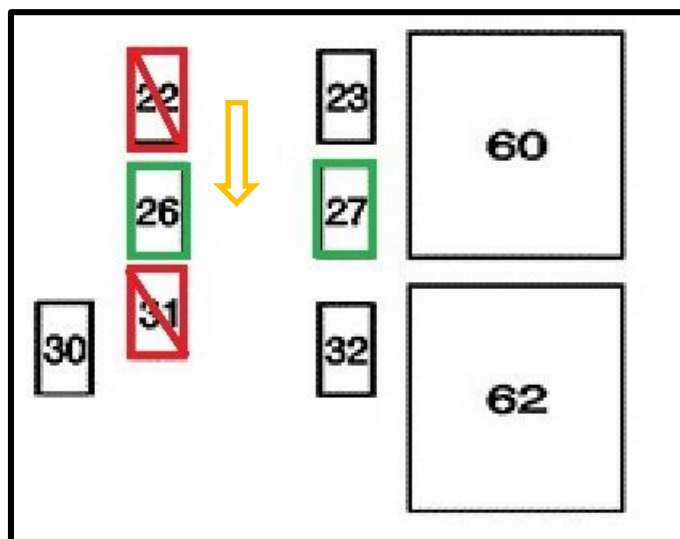
Figure 7 shows the fuses configured for switches 1 & 2 to be Ignition powered and switches 3 & 4 being battery powered. This configuration is accomplished by **MOVING** the fuse from location 22 **TO** location 26 (leaving locations 22 & 31 unpopulated)

Never populate both fuse locations for either pairing of AUX switches. This is to mean do NOT install fuses in both locations of 22 and 26 or in both locations of 27 and 31.

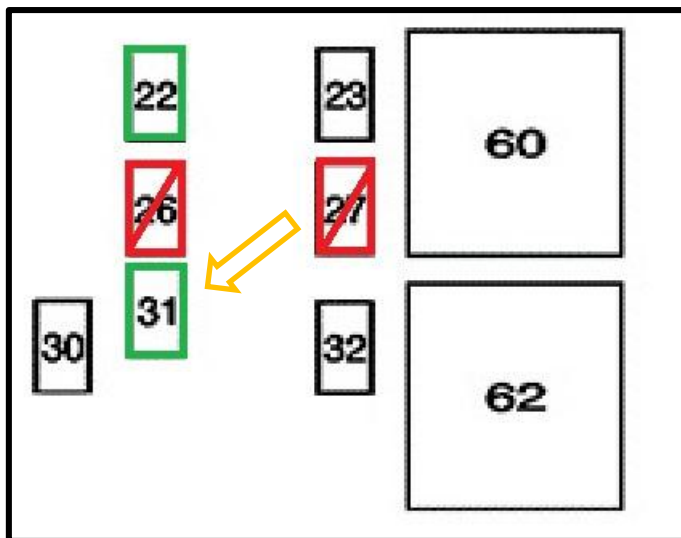
**Figure 8**

Figure 8 shows the fuses configured for switches 1 & 2 to be Battery powered and switches 3 & 4 being Ignition powered. This configuration is accomplished by **MOVING** the fuse from location 27 **TO** location 31 (leaving locations 26 & 27 unpopulated)

Never populate both fuse locations for either pairing of AUX switches. This is to mean do NOT install fuses in both locations of 22 and 26 or in both locations of 27 and 31.

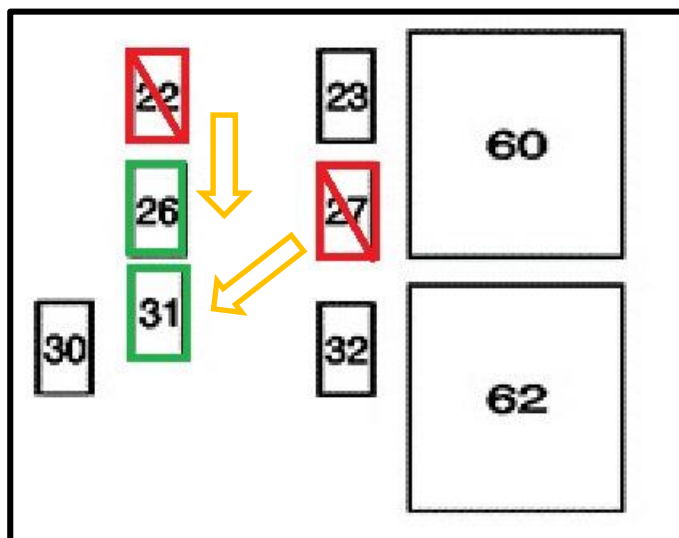
**Figure 9**

Figure 9 shows the fuses configured for all switches (1, 2, 3 & 4) to be Ignition powered. This configuration is accomplished by **MOVING** the fuse from location 22 **TO** location 26 and **MOVING** 27 **TO** 31 (leaving fuse locations 22 and 27 unpopulated)

Never populate both fuse locations for either pairing of AUX switches. This is to mean do NOT install fuses in both locations of 22 and 26 or in both locations of 27 and 31.

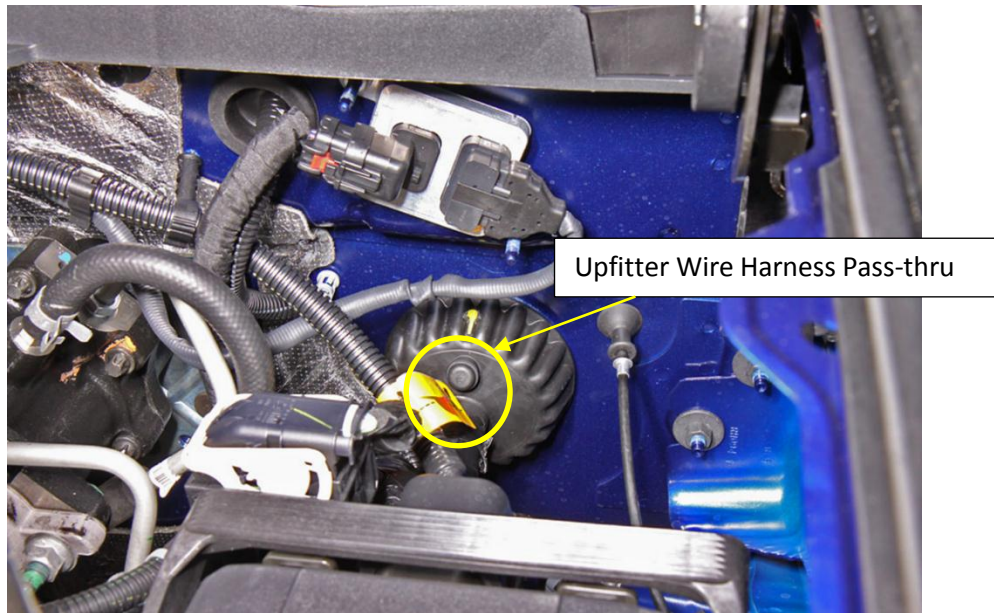
**Figure 10**

Figure 10 shows the location of the upfitter wire harness pass through
