**#PIT5579 - Tick Creak Rattle Noise - (Aug 11, 2017)****Subject:**

Tick Creak Rattle Noise

Brand:	Model:	Model Year:		VIN:		Engine:	Transmission:
		from	to	from	to		
Cadillac	Escalade	2015-2016		All	All	All	All
Chevrolet	Suburban	2015-2016		All	All	All	All
Chevrolet	Tahoe	2015-2016		All	All	All	All
GMC	Yukon	2015-2016		All	All	All	All

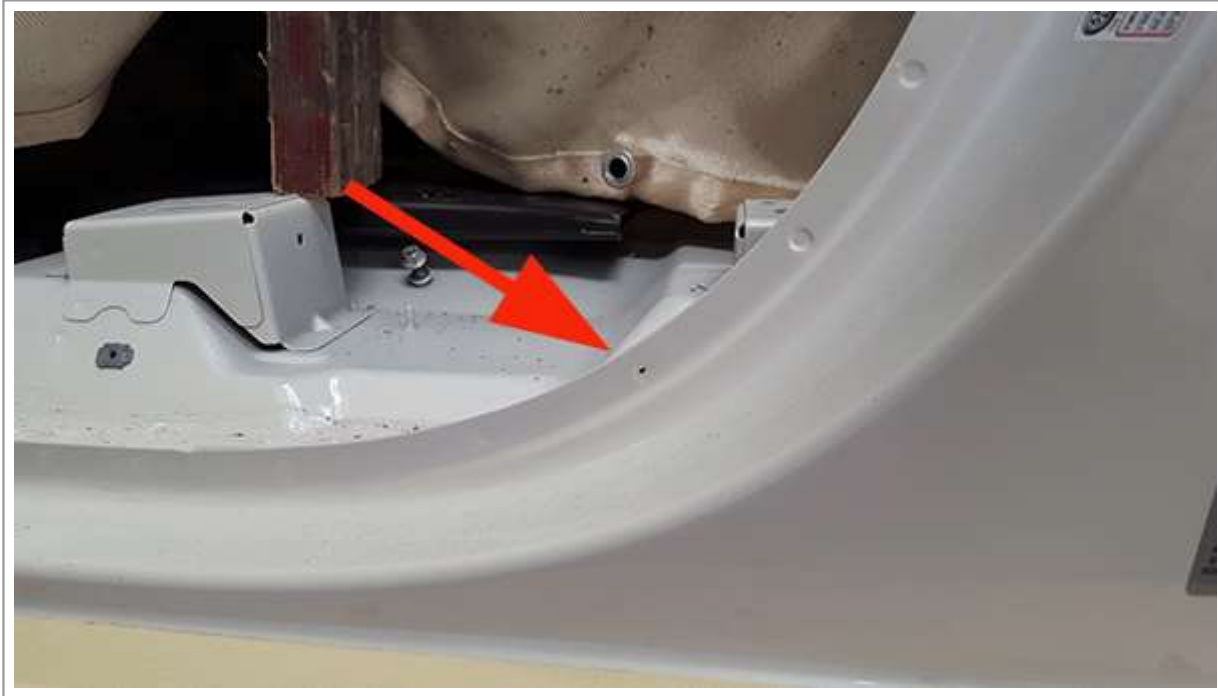
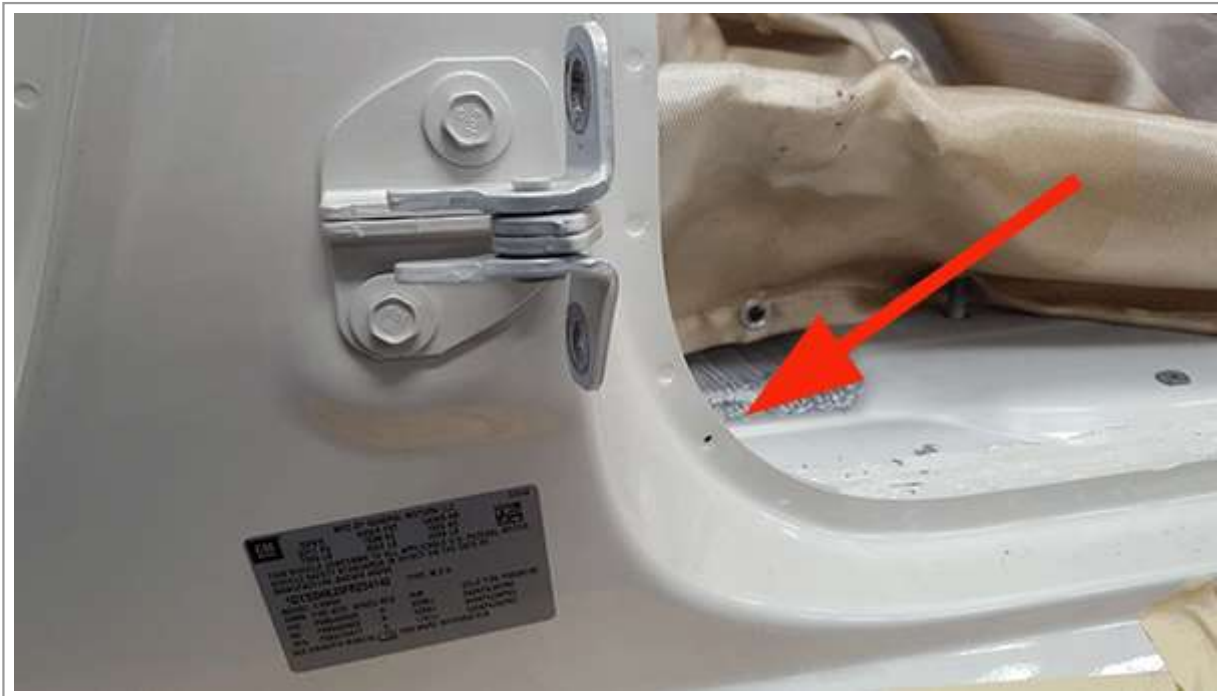
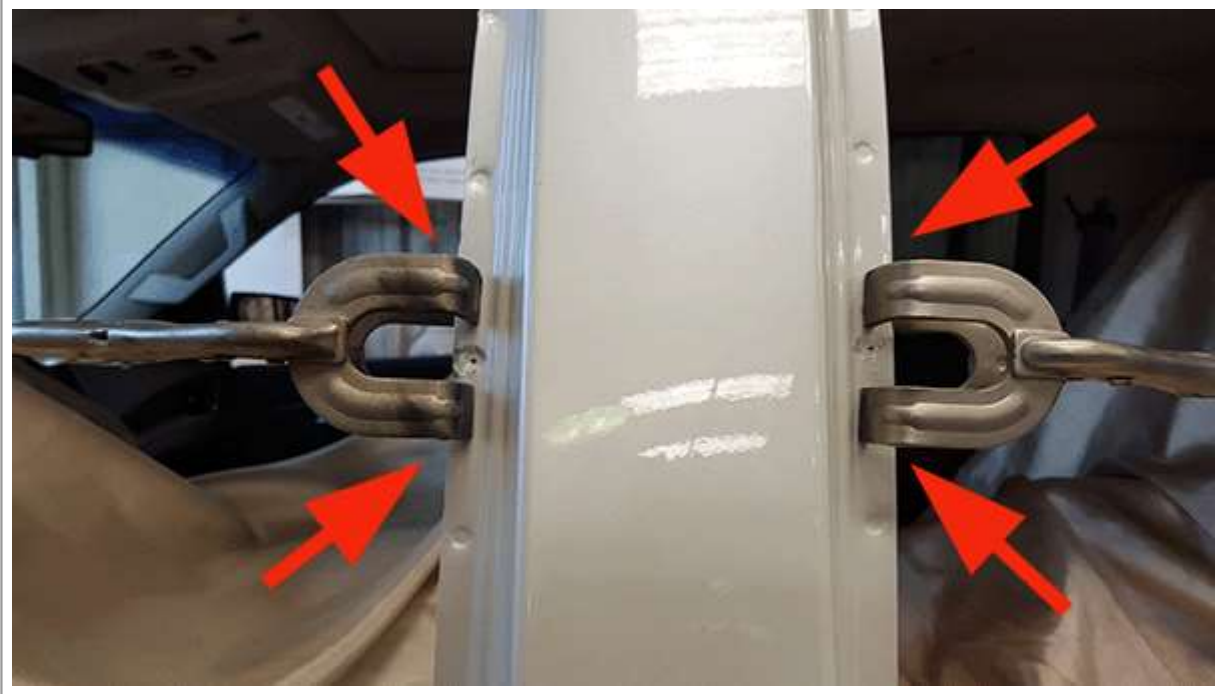
**Condition 1: Inspect for missing or incomplete welds near the base of the B pillar.**

Repair welds as necessary

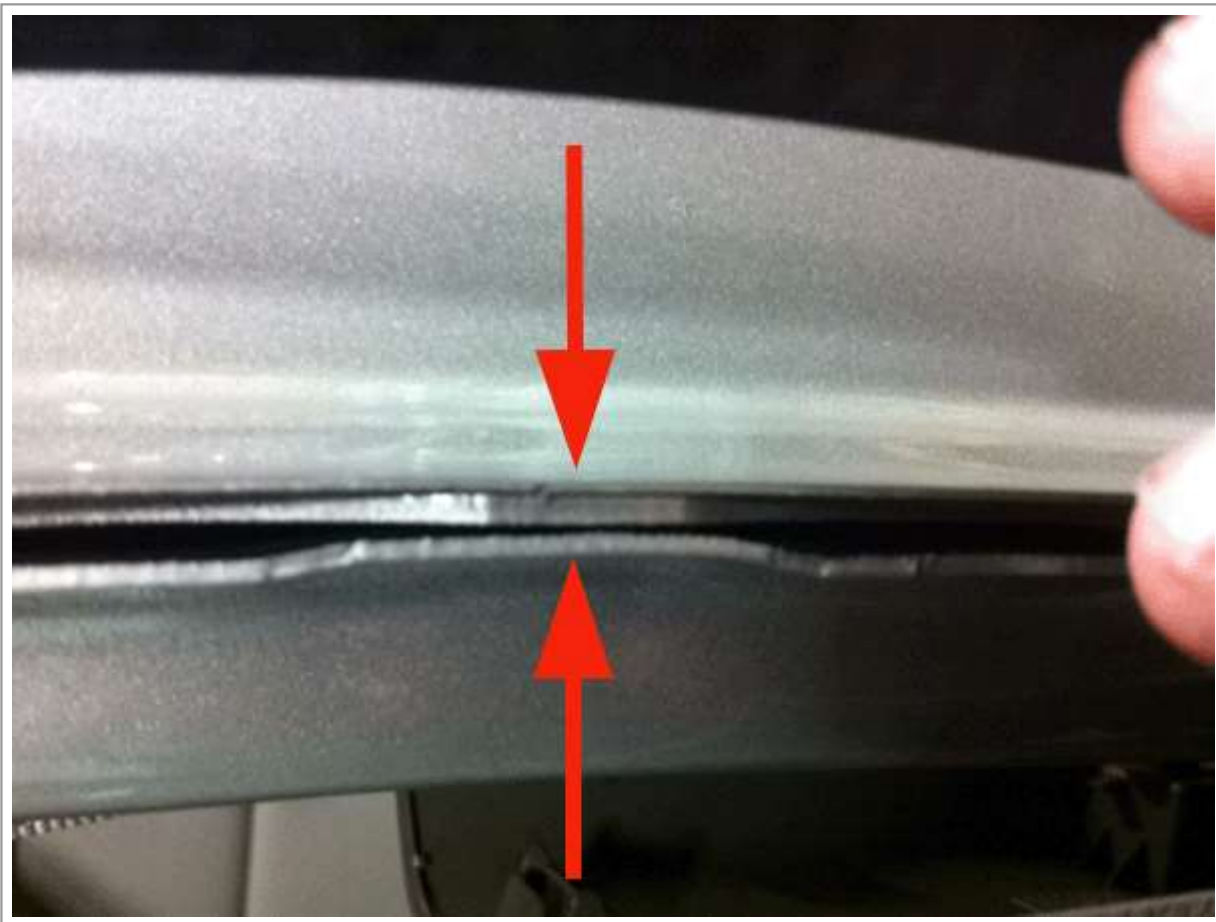
**Condition 2: Inspect B pillar in area near seat belt mounting where there are three pieces of sheet metal sandwiched together for contact between the panels.**

Using a screwdriver or other suitable tool slightly separate the sheet metal to eliminate contact between panels. Ensure that the tool is insulated so that it will not damage the finish.

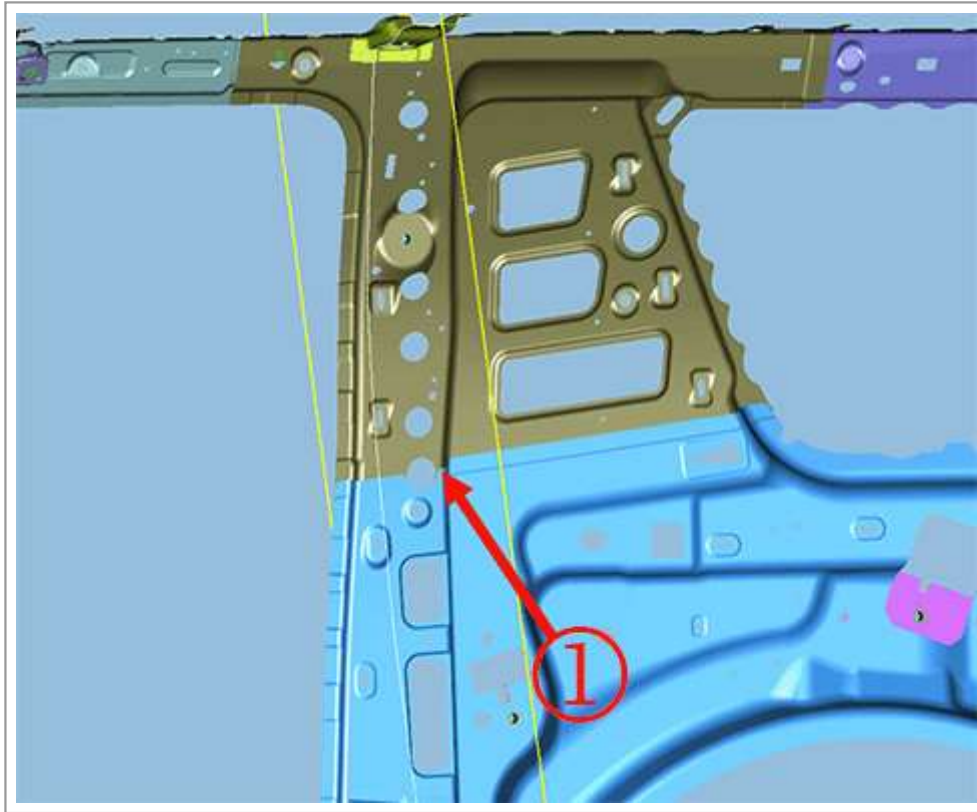
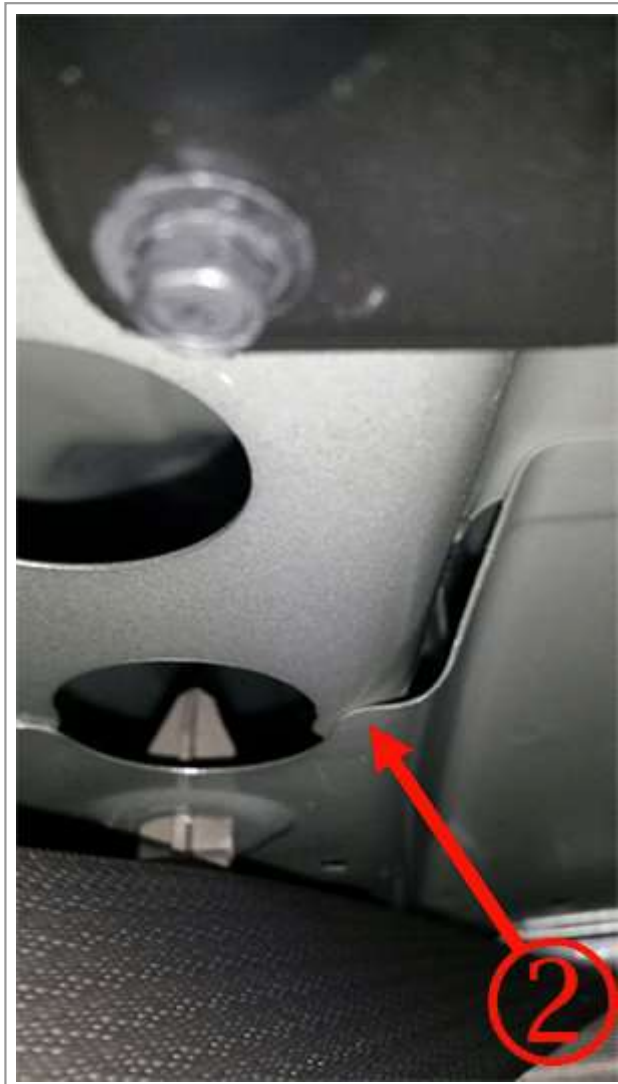
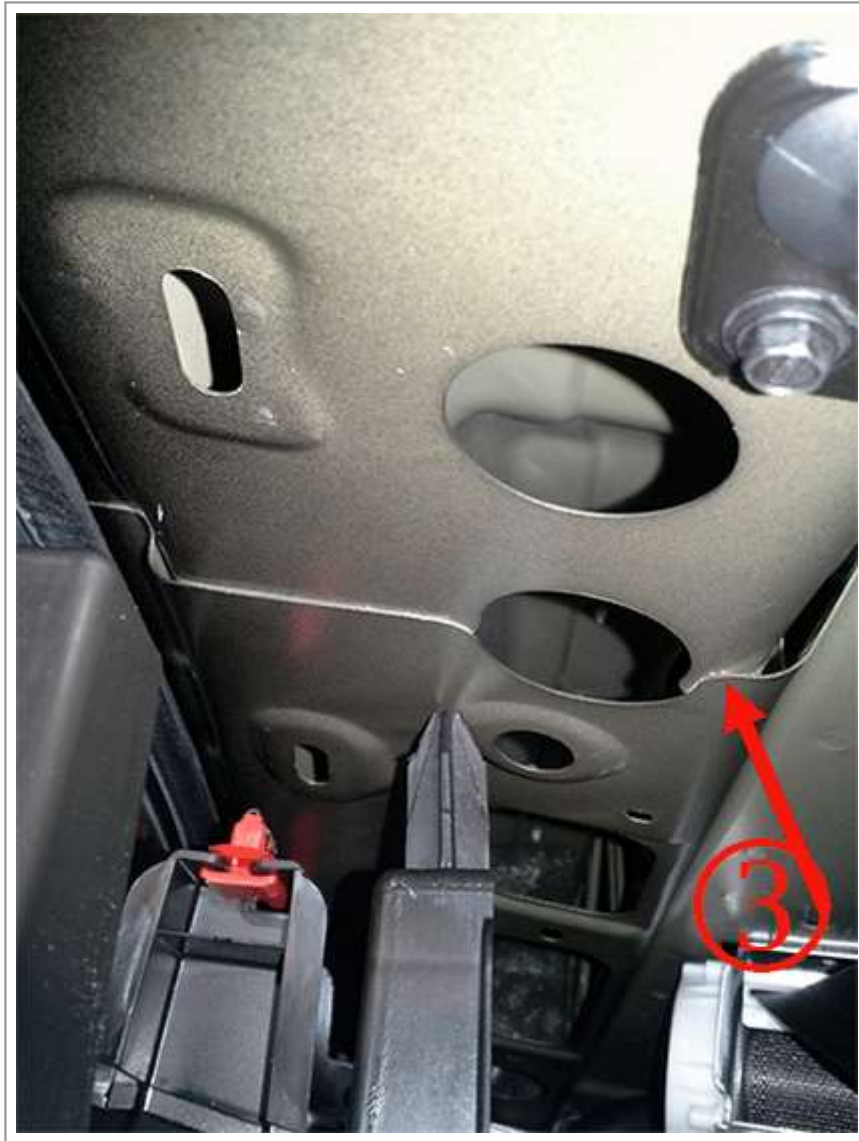
**Condition 3: Inspect C pillar for contact between sheet metal in area shown.** Provided By Par-Tech, Inc. (<http://www.partechgss.com>) ^

Using a screwdriver or other suitable tool slightly separate the sheet metal panels to eliminate contact
