2015 Chevy Truck Silverado 1500 2WD V6-4.3L

## #18-NA-161: Steering Jerks Or Kicks Back / Reduced Power Steering Assist / Engine Stall / No Start / Service Stabilitrak / IPC / Radio / HVAC Goes Blank Various DTCs - (Oct 22, 2018)

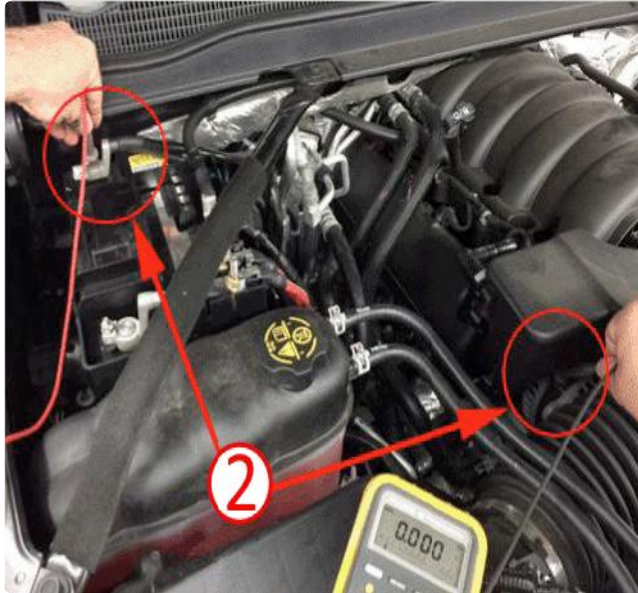
<b>Cause 2</b>	This condition may be caused by a poor BCM ground at G218.
<b>Cause 3</b>	<p>This condition may be caused by a shorted B+ Battery cable (3) at the Starter Solenoid caused by:</p> <ul style="list-style-type: none"> <li>• A loose starter shield contacting the starter battery cable terminal ring.</li> <li>• A starter cable ring terminal that has been mis-installed and/or rotated when installed on the starter solenoid.</li> </ul>
<b>Cause 4</b>	This condition may be caused by a discharged or faulty battery.
<b>Correction 1</b>	<p><b>Important:</b> The following steps must be completed in order. Grasping or attempting to rotate cables could affect readings and should be done <b>after</b> performing the voltage drop measurement.</p> <p><b>Note:</b> When checking voltage drop, the voltage drop should be performed with the fuel system disabled (or hold the accelerator WOT) and while cranking the engine. MIN/MAX on the Digital Multi Meter (DMM) should NOT be used. The voltage drop should be monitored at a STEADY crank. Inspect for any high resistance and/or loose connections at both the battery fuse block and the positive or negative battery cables.</p> <div data-bbox="613 968 1252 1556" data-label="Image"> </div> <div data-bbox="623 1562 1068 1608" data-label="Text"> <p><a href="#">Open In New Tab</a> <a href="#">Zoom/Print</a></p> </div> <ol style="list-style-type: none"> <li>1. Perform a loaded voltage drop test on the short positive battery cable (1). <ul style="list-style-type: none"> <li>◦ Refer to “Measuring Voltage Drop” in SI. If the voltage drop is above 100 mV, replace the affected cable(s).</li> <li>◦ For positive cable parts information, refer to the Parts Information section.</li> </ul> </li> </ol>

2. Perform a loaded voltage drop test on the negative battery cable (2).
  - Refer to "Measuring Voltage Drop" in SI. If the voltage drop is above 200 mV, replace the affected cable.
  - For negative cable parts information, refer to the Electronic Parts Catalog (EPC).

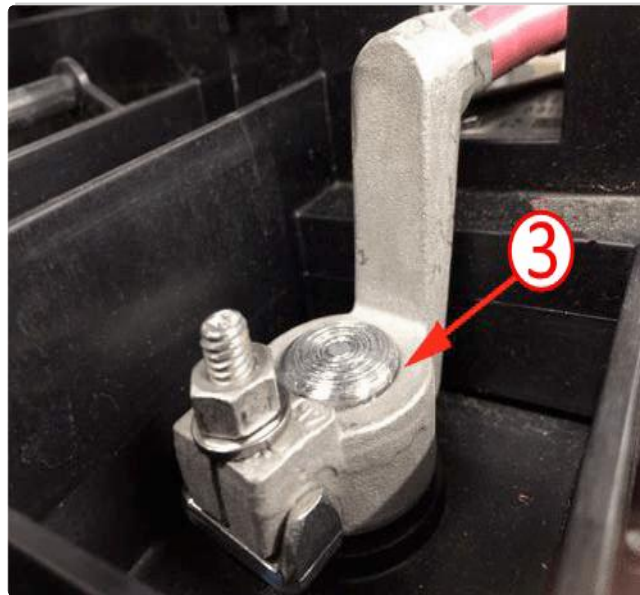
- It is imperative that both the positive and negative battery top posts protrude above the battery cable clamps 1-2 mm (0.040 - 0.080 in) to be properly installed, as shown (3).
3. Check both the positive and negative battery cable clamp nuts and make sure they are properly tightened to 7 Nm (62 lb in).
  4. After the positive and negative battery cables are fully installed and tightened to 7 Nm (62 lb in), grasp each battery cable near the battery post and make sure they are secure and that they do not spin on the post. If they spin, replace the battery cable.

- For positive cable parts information, refer to the Parts Information section.
- For negative cable parts information, refer to the Electronic Parts Catalog (EPC).

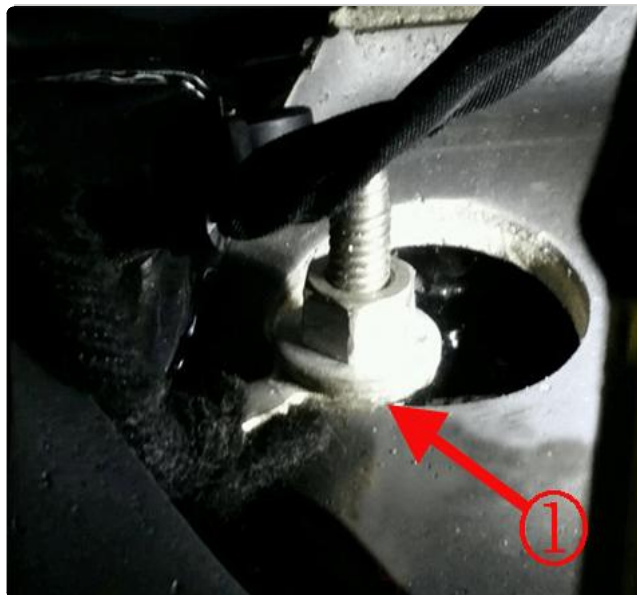
Inspect G218 (applies LD Trucks and SUVs built prior to June 2015):

- Check for the nut being loose or cross threaded (1), repair and tighten as necessary.

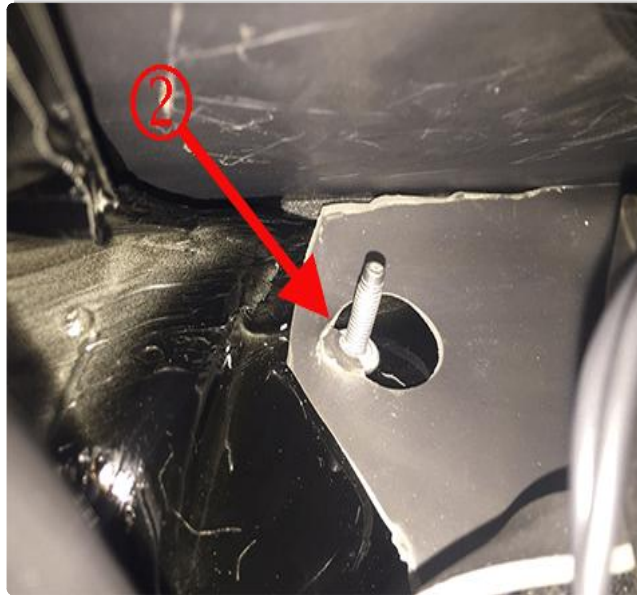
- Check for the front of dash insulator mat (2) being trapped between the ground eyelet and the body/stud as shown.
  - If the dash insulator mat is trapped, cut the mat away from the ground stud so it will no longer interfere. Reinstall the ground eyelet, the nut, and retighten.

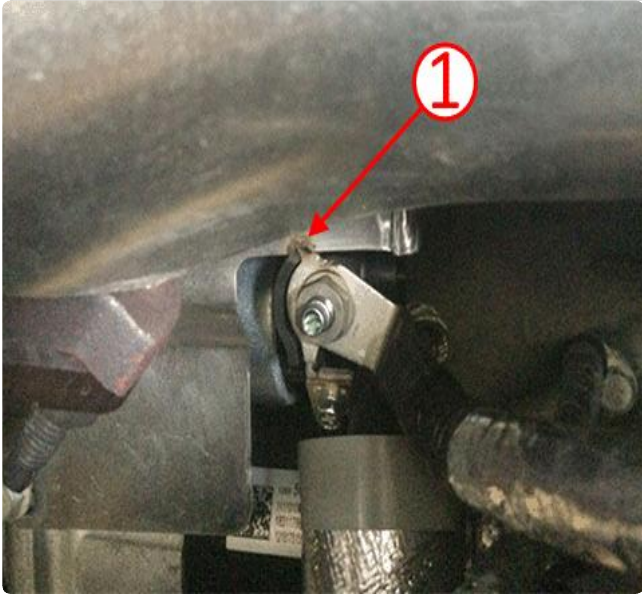
<p><b>Correction 3</b></p>	<div style="text-align: right;">

<p><a href="#">Open In New Tab</a></p> </div> <p><a href="#">Zoom/Print</a></p> <p>Inspect the starter solenoid B+ battery cable for possible contact at the starter heat shield (1) or a loose shield resting on terminal.</p> <ul style="list-style-type: none"> <li>◦ If the battery cable is shorting out on the starter heat shield, replace the B+ battery cable and starter heat shield.</li> <li>◦ After installing the new starter heat shield and B+ battery cable, ensure there is adequate clearance and each fastener is torqued properly so it will no longer short out.</li> </ul>
<p><b>Correction 4</b></p>	<p>Perform the "Battery Inspection/Test" procedure in SI, using the GR8, and replace the battery if it fails the test.</p> <ul style="list-style-type: none"> <li>◦ Technicians must attach the GR8 test print out with a Battery Replace decision, that includes the Warranty Code, to the repair order.</li> </ul>
