Headlining Trim Panel Replacement (Crew Cab without CF5)

Removal Procedure

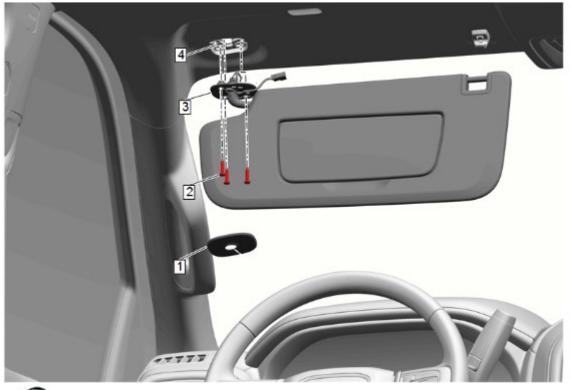
2. Sunshade (3) » Remove [2x] — Sunshade Replacement

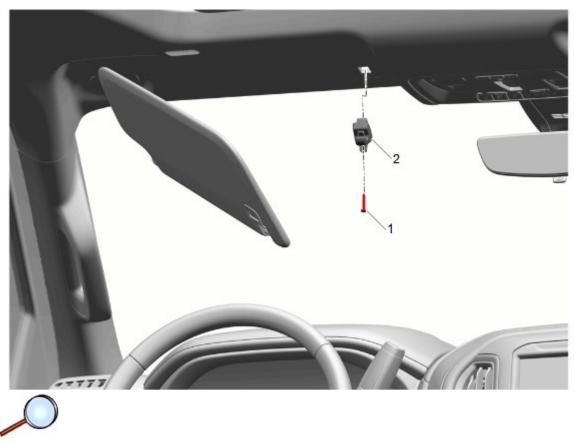
3. Sunshade Support (2) » Remove [2x] — Sunshade Support Replacement

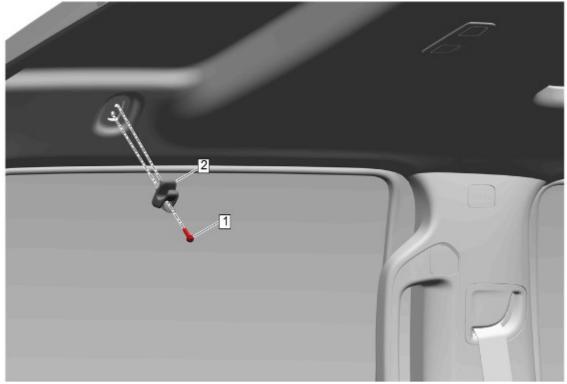
4. Coat Hook (2) » Remove [2x] — Coat Hook Replacement

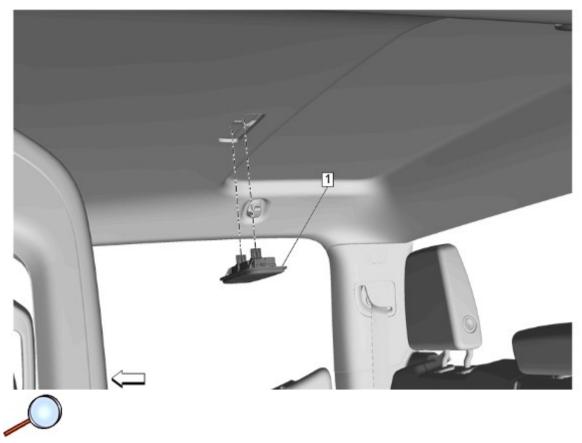
5. Rear Seat Position Center Reading and Courtesy Lamp (1) » Remove — Rear Seat Position Center Reading and Courtesy Lamp Replacement

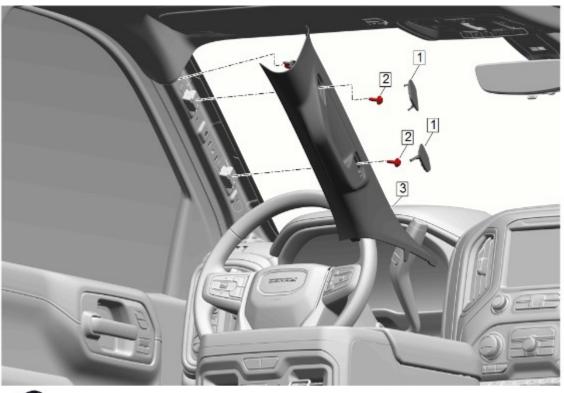
6. Windshield Garnish Molding (3) » Remove [2x] — Windshield Garnish Molding Replacement © 2020 General Motors. All rights reserved.

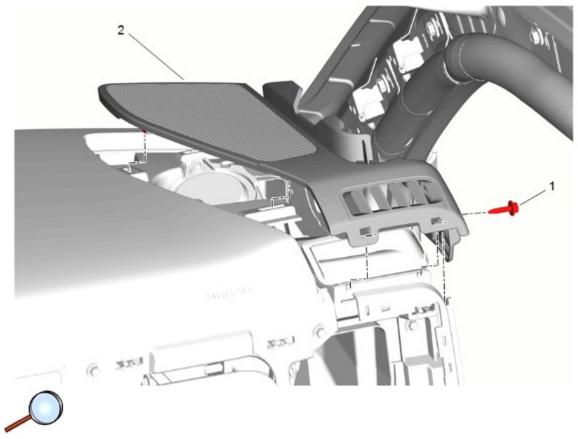
7. Radio Front Speaker Grille - Right Side (2) » Remove — Radio Front Speaker Grille Replacement - Right Side

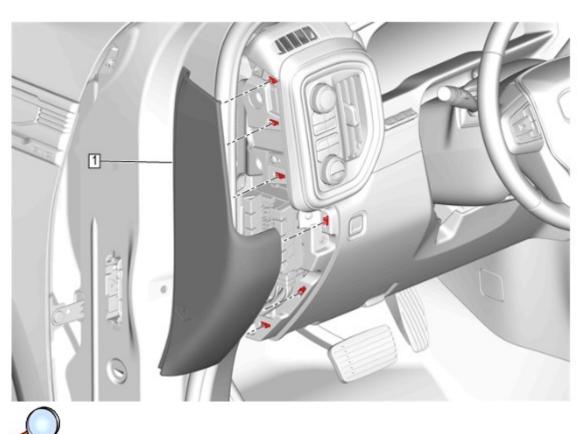
8. Remove the right side instrument panel fuse block access hole cover (1). <u>Instrument Panel Fuse Block Access Hole Cover Replacement</u>

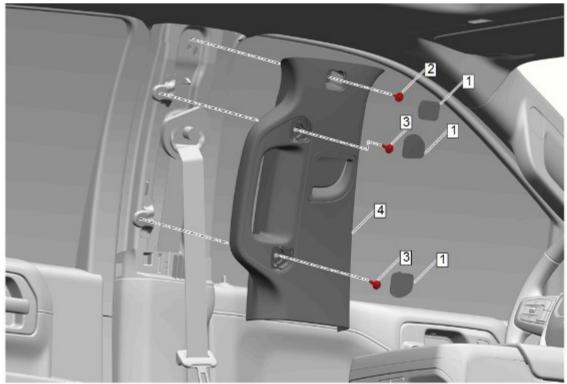
9. Center Pillar Upper Trim Panel (4) » Remove [2x] — <u>Center Pillar Upper Trim Panel Replacement</u>

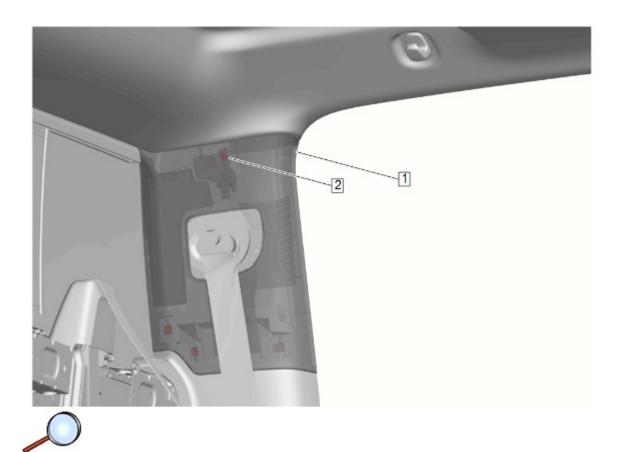
10. Body Side Rear Window Garnish Molding (2) » Remove [2x] — <u>Body Side Rear Window Garnish Molding Replacement</u>

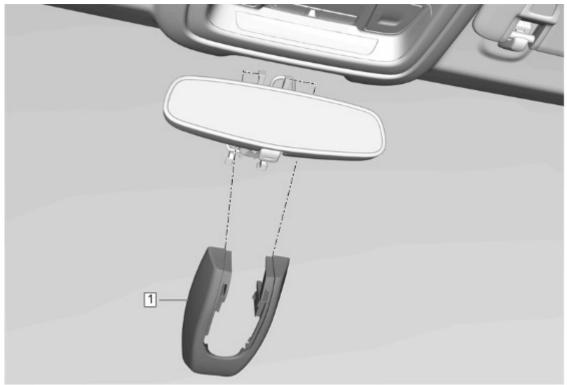
- 12. Windshield Multifunction Sensor Mount Bracket Cover (1) » Remove <u>Windshield Multifunction Sensor Mount Bracket Cover Replacement</u>
- 13. Move the driver and passenger seats fully forward and recline.

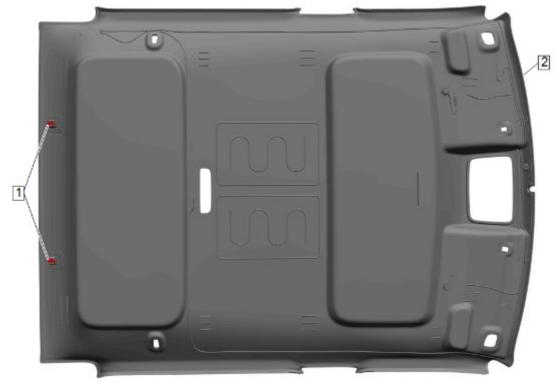
Note: Prior to removal, note the routing of the wire harness to aid in reassembly and to ensure proper installation.

- 14. Drop the headlining trim panel (2) down.
- 15. Disconnect the electrical connectors.
- 16. There are two retainers (1) at the rear underside of the headlining trim panel(2) , if necessary remove.
- 17. Windshield » Remove Windshield Replacement
- 18. With the aid of an assistant, remove the headlining trim panel (2) from the vehicle through the front windshield.
- 19. Transfer components as necessary.
- 20. If transferring or replacing the wiring harness. <u>Headliner Harness Replacement</u>

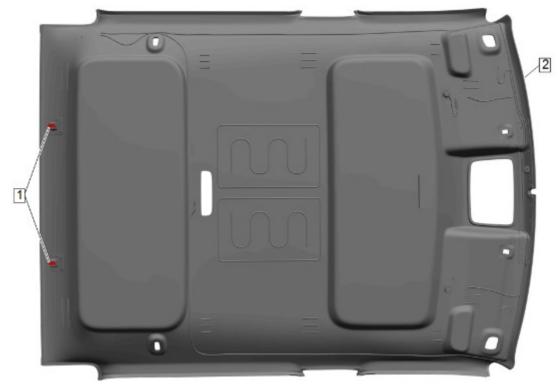
- 1. With the aid of an assistant, position the headlining trim panel (2) into the vehicle through the front windshield.
- 2. Lay the wiring harness on the new headlining trim panel (2) to confirm correct routing and ensure harness leads are proper length for mating connections prior to gluing.
- 3. Connect the electrical connectors.
- 4. Tape any unused connectors to the headlining with a high adhesive tape.
- 5. Engage the two retainers(1) at the rear underside of the headlining trim panel (2).
- 6. Windshield » Install Windshield Replacement

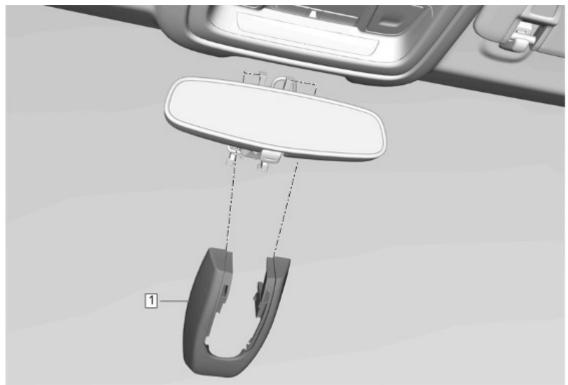
7. Windshield Multifunction Sensor Mount Bracket Cover (1) » Install — <u>Windshield Multifunction Sensor Mount Bracket Cover Replacement</u>

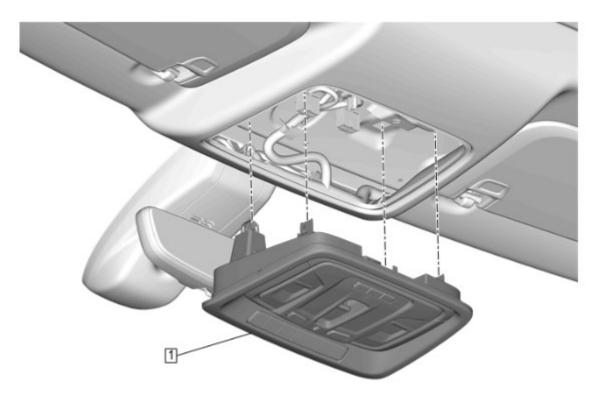
8. Roof Console (1) » Install — Roof Console Replacement © 2020 General Motors. All rights reserved.

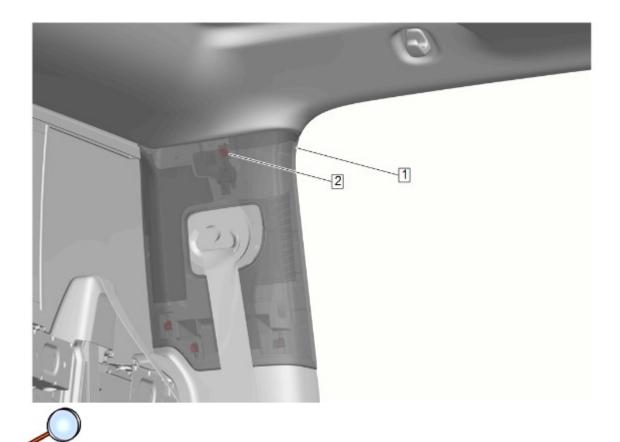
9. Body Side Rear Window Garnish Molding (2) » Install — <u>Body Side Rear Window Garnish Molding Replacement</u>

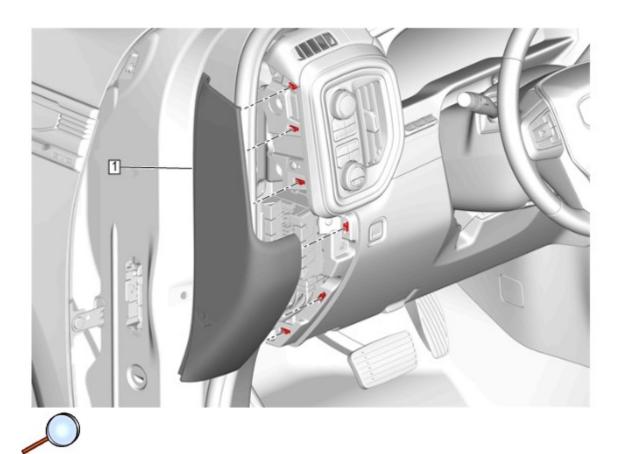
11. Install the right side instrument panel fuse block access hole cover (1). <u>Instrument Panel Fuse Block Access Hole Cover Replacement</u>

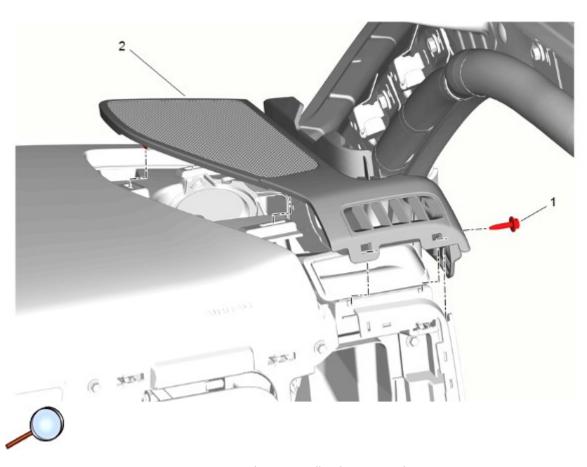
12. Radio Front Speaker Grille - Right Side (2) » Install — <u>Radio Front Speaker Grille Replacement - Right Side</u>

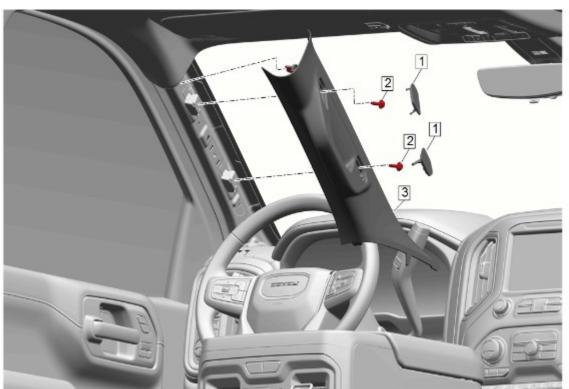
13. Windshield Garnish Molding (3) » Install $[2x] - \underline{\text{Windshield Garnish Molding Replacement}}$

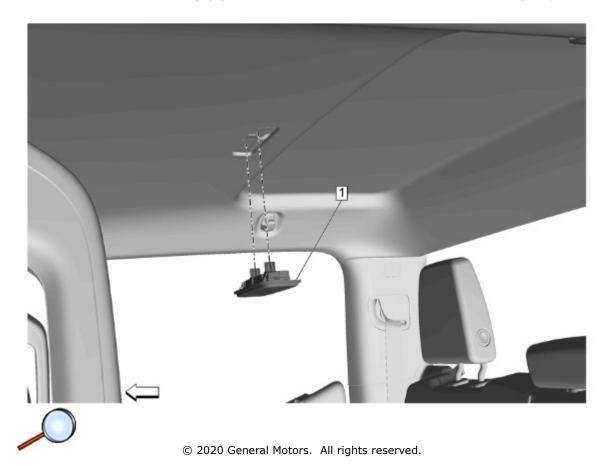
14. Rear Seat Position Center Reading and Courtesy Lamp (1) » Install — Rear Seat Position Center Reading and Courtesy Lamp Replacement

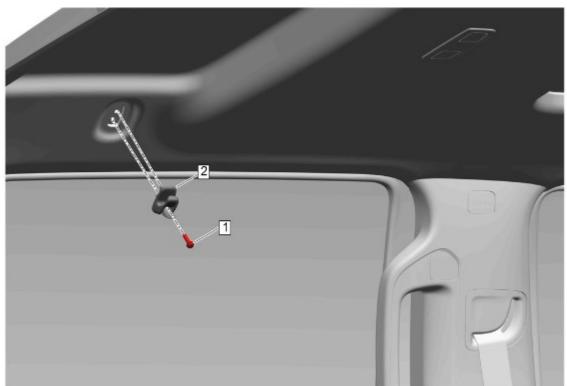
15. Coat Hook (2) » Install [2x] — Coat Hook Replacement

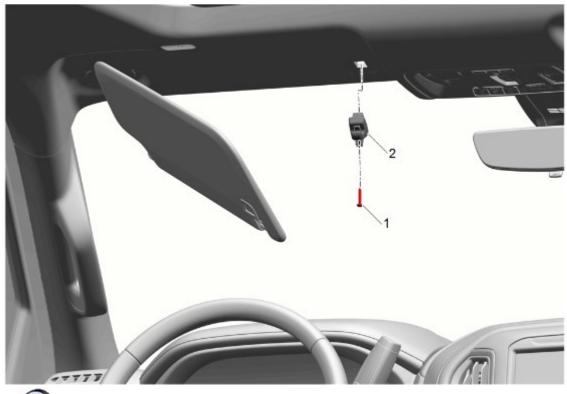
16. Sunshade Support (2) » Install [2x] — Sunshade Support Replacement

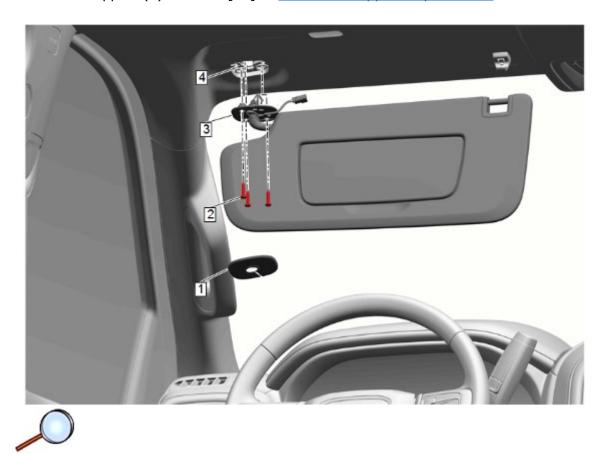
- 17. Sunshade (3) » Install [2x] <u>Sunshade Replacement</u>
- 18. Enable the SIR System. SIR Disabling and Enabling
