## Instrument Panel Lower Center Trim Panel Replacement - Left Side

### Removal Procedure

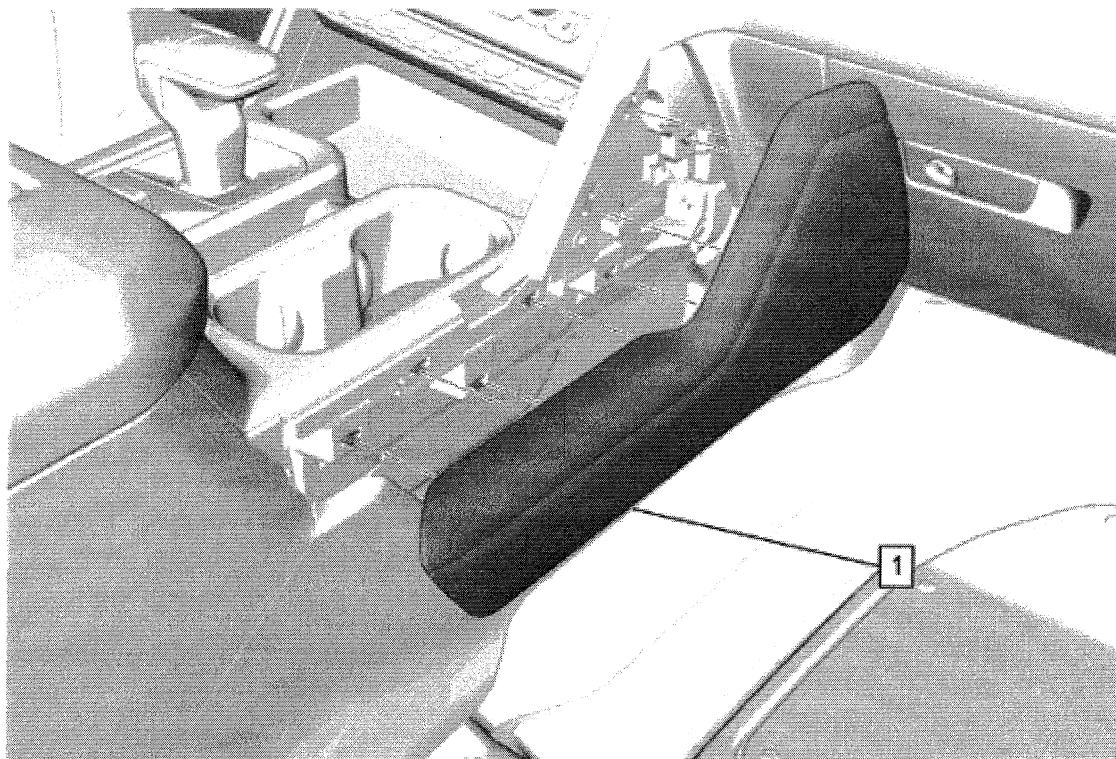
1. Using a flat-bladed plastic trim tool, release the retaining clips.
2. Front Floor Console Lower Applique - Right Side (1) » Remove

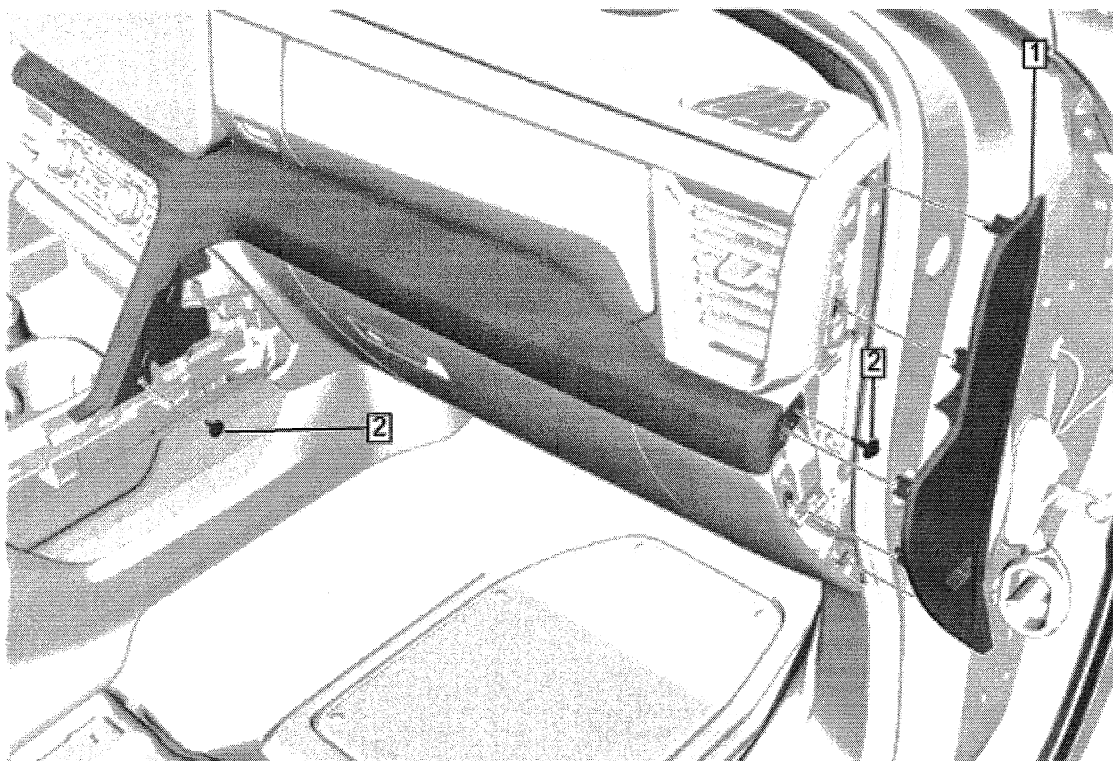
3. Using a flat-bladed plastic trim tool, release the retaining clips.
4. Instrument Panel Fuse Block Access Hole Cover (1) » Remove
5. Instrument Panel Trim Pad Bolt (2) » Remove [2x]

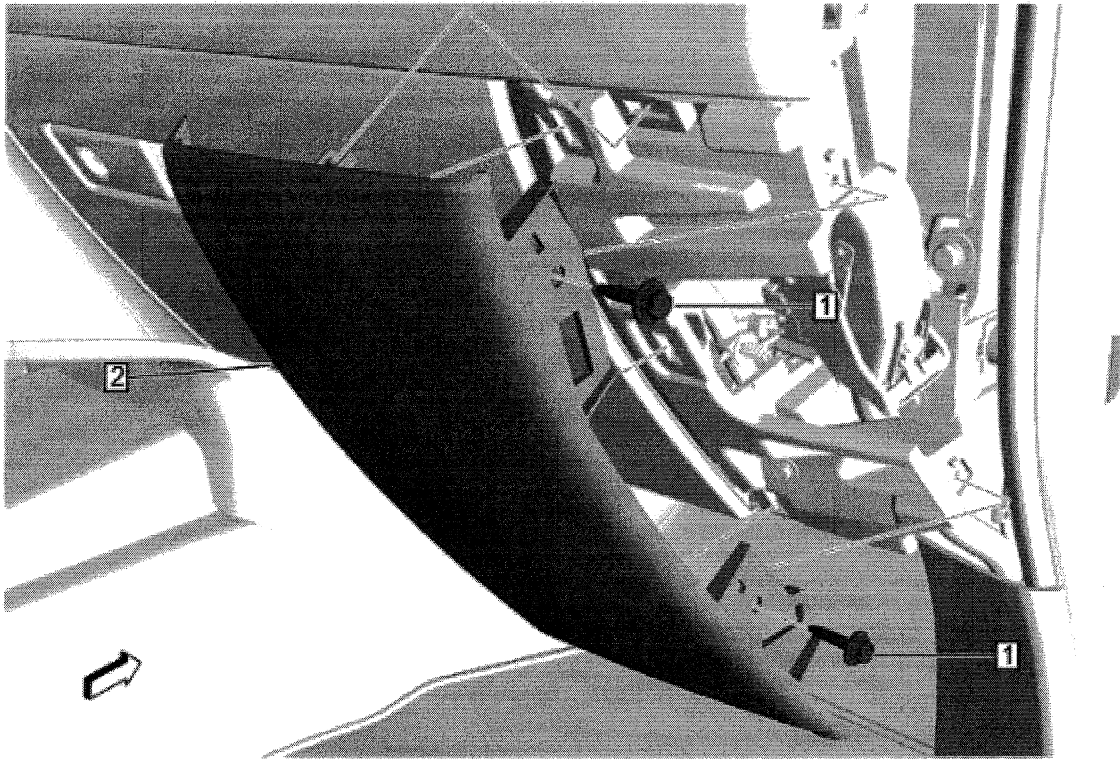
6. Instrument Panel Lower Trim Panel Outer Filler Bolt (1) » Remove [2x]

**Note:** Use a plastic trim tool if necessary.

7. Instrument Panel Lower Trim Panel Outer Filler (2) » Remove

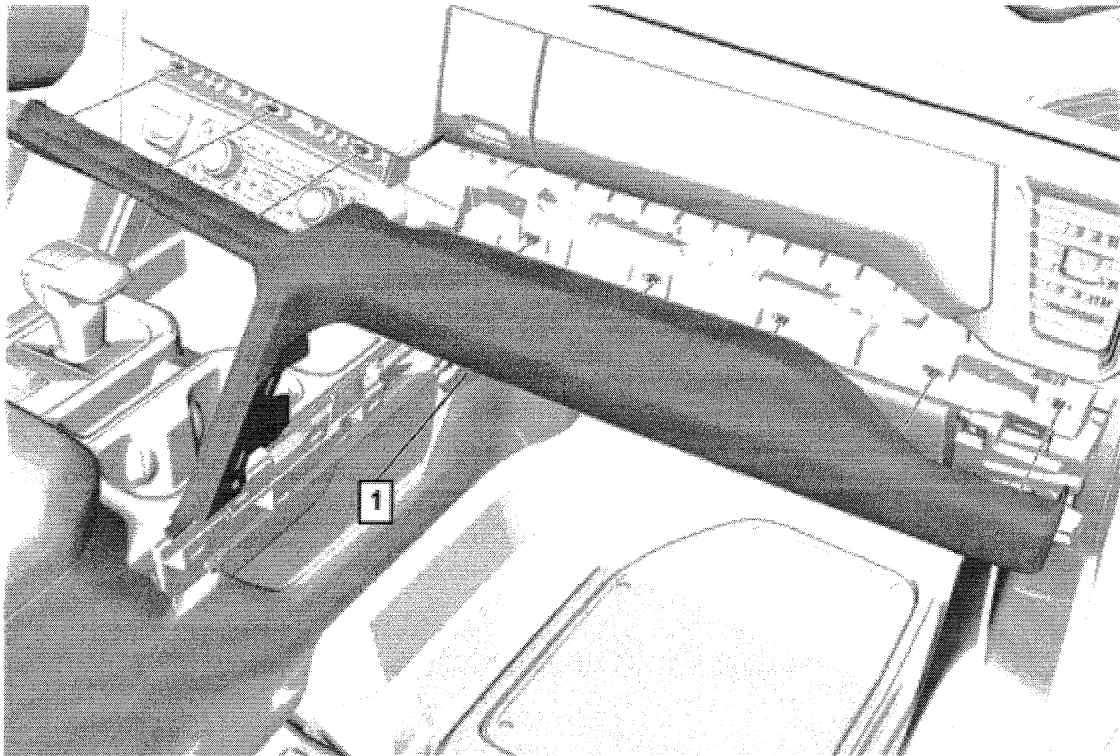
8. Using a flat-bladed plastic trim tool, release the retaining clips.
9. Instrument Panel Trim Pad - Right Side (1) » Remove

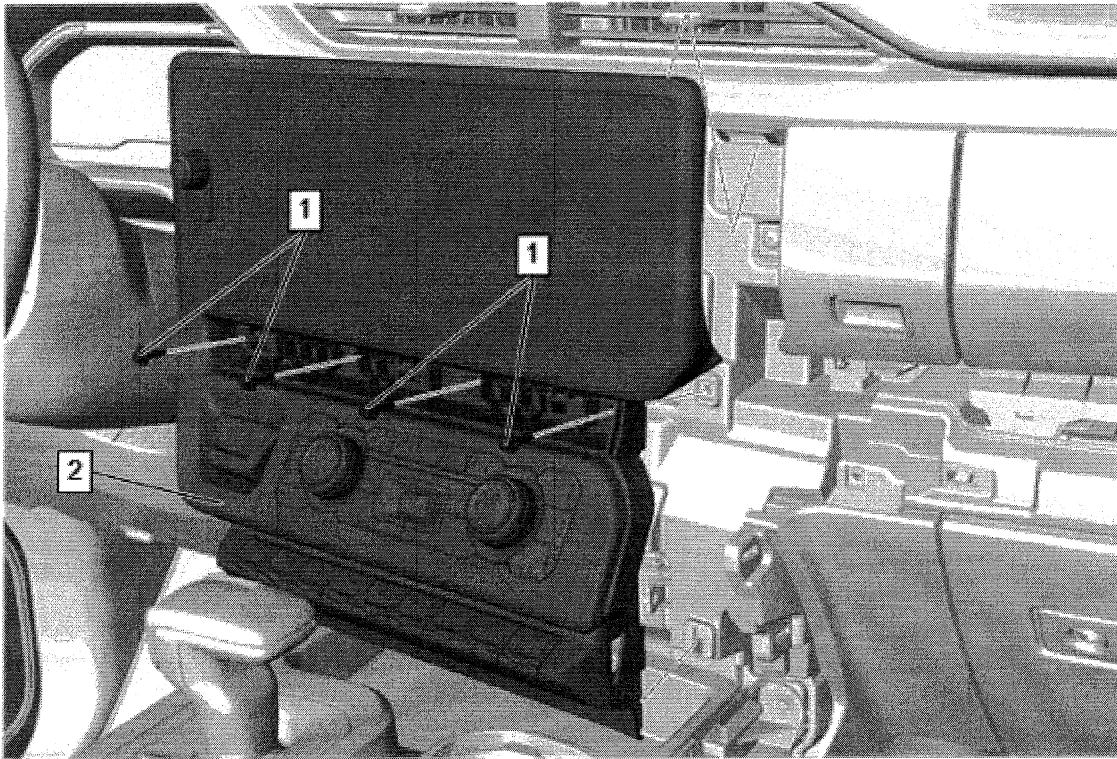
10. Radio Control Bolt (1) » Remove [4x]
11. Radio Control (2) » Remove
12. Disconnect the electrical connectors.

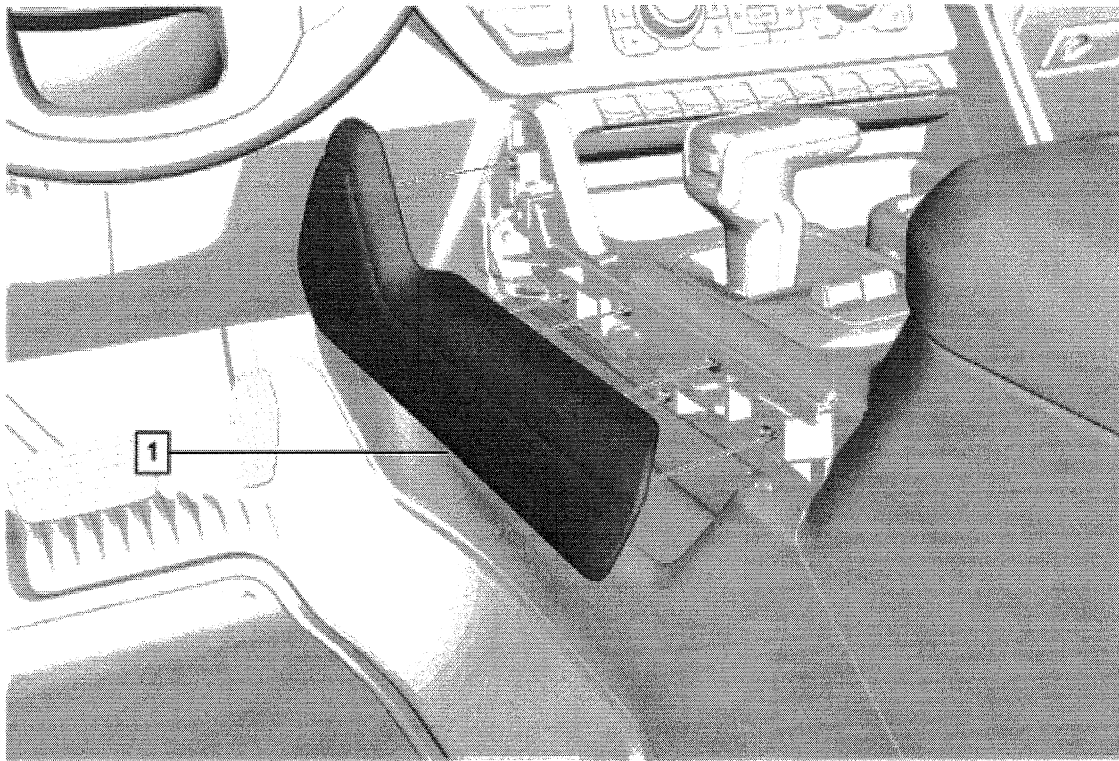
13. Using a flat-bladed plastic trim tool, release the retaining clips.

14. Front Floor Console Lower Applique - Left Side (1) » Remove

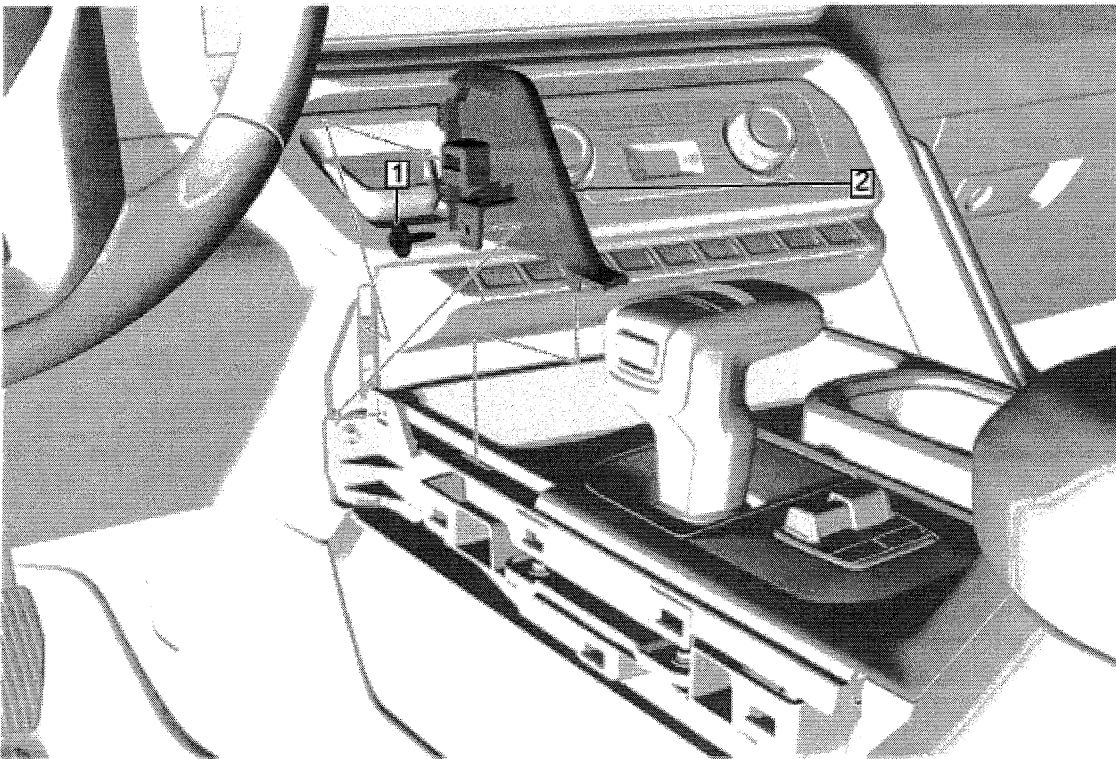
15. Front Floor Console Applique Bolt (1) » Remove

16. Front Floor Console Applique (2) » Remove

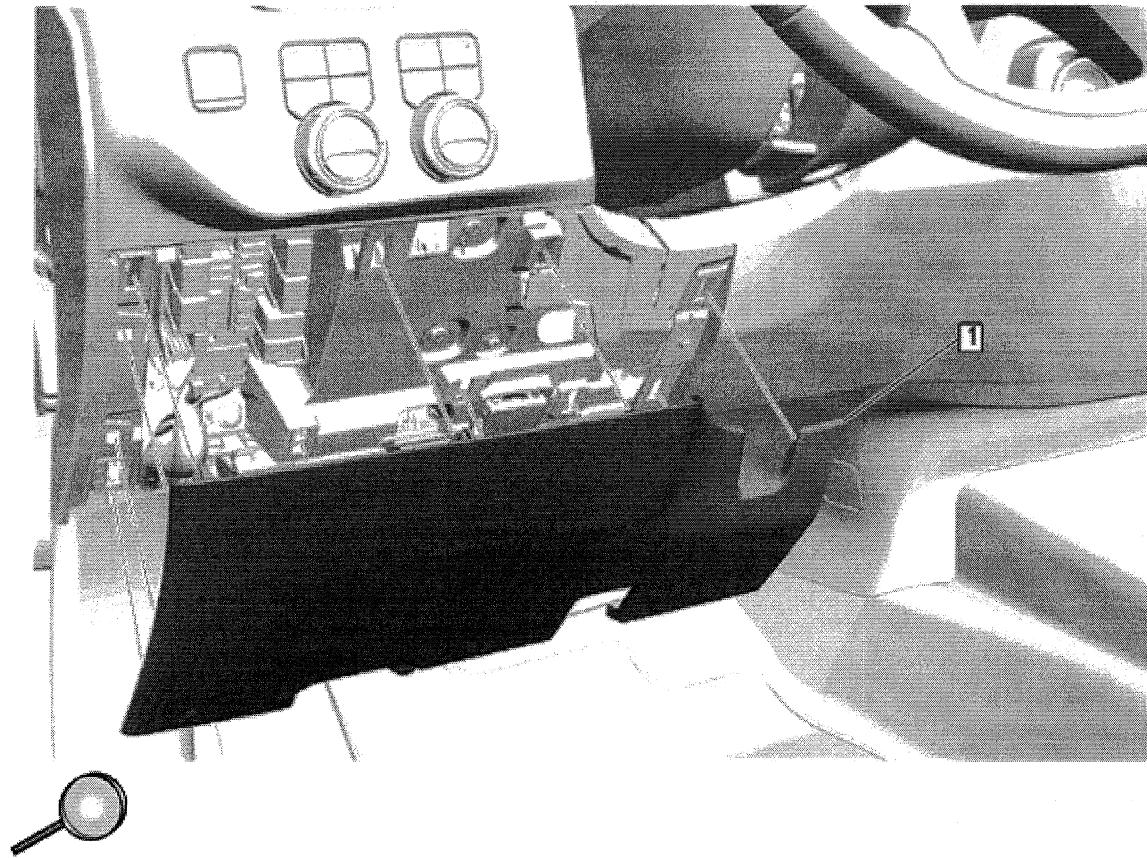
**Warning:** When removing, handling or installing this component wear protective gloves. The sharp edges on the component may be very sharp and may cause injury.

17. Using a flat-bladed plastic trim tool, release the retaining clips.

18. Instrument Panel Knee Bolster (1) » Remove

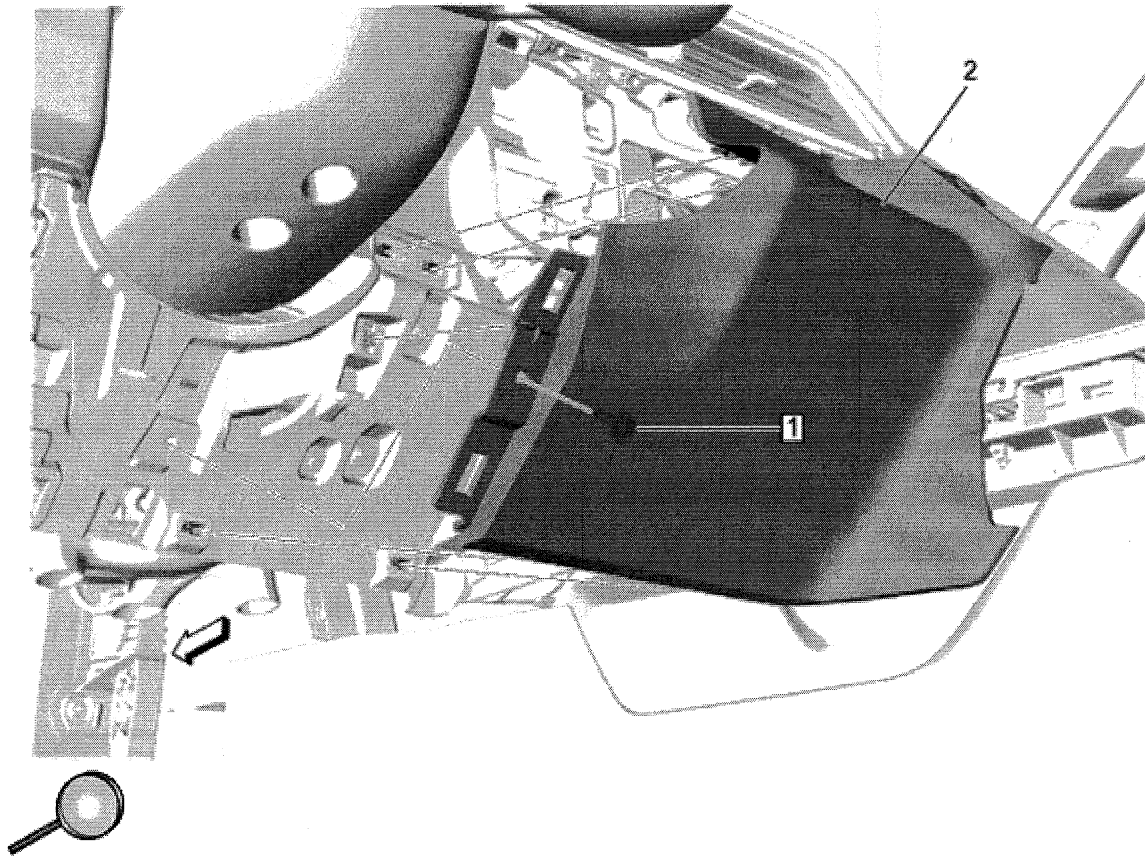
19. Instrument Panel Lower Center Trim Panel Bolt (1) » Remove

20. Using a flat-bladed plastic trim tool, release the retaining clips.

21. Instrument Panel Lower Center Trim Panel - Left Side (2) » Remove
