## UI Bulletin #113

**Subject:** Rear Lighting Junction Block Connections

**Models:** Chevrolet Silverado  
GMC Sierra

**Model Years:** 2014 and beyond

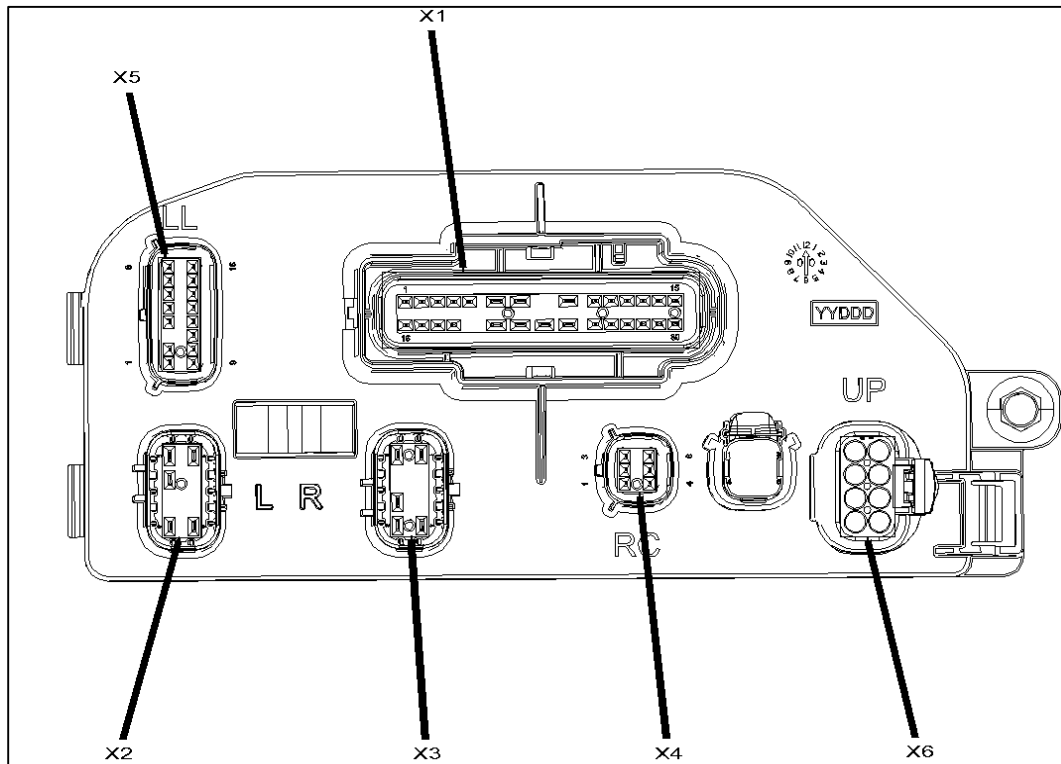
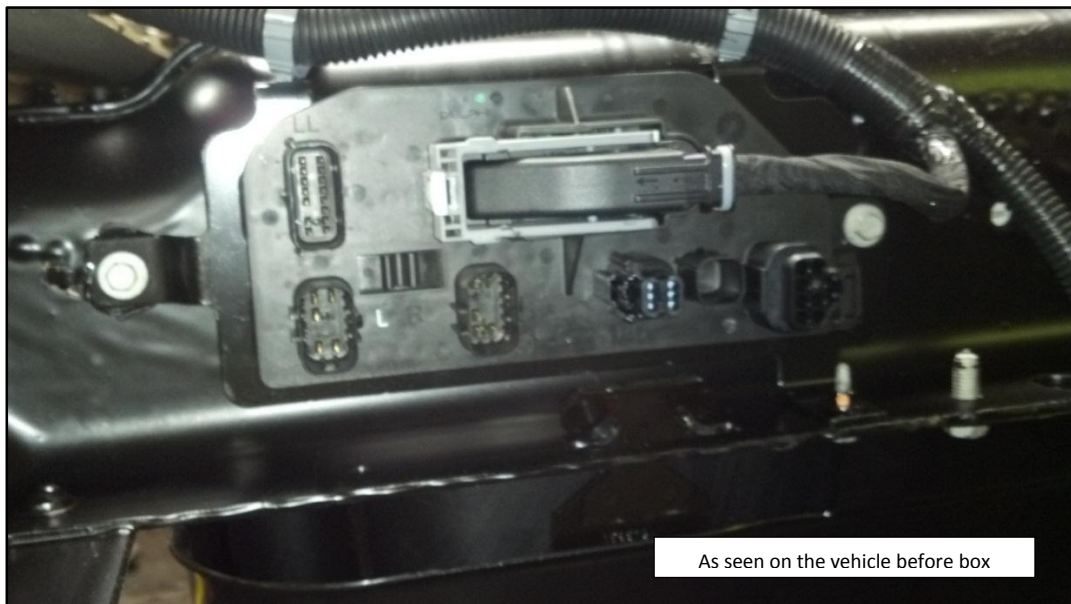
## X63A- Rear Junction Block

The rear junction for the 2014 and beyond full size trucks...no longer is the one connector to which the upfitter can disconnect for the block and plug in an adapter harness to mate the service body lighting to. In this document we provide each of the connections/circuit information for interfacing to the junction block. Also, both the GM service part numbers, as well as are the manufacture's part numbers provided.

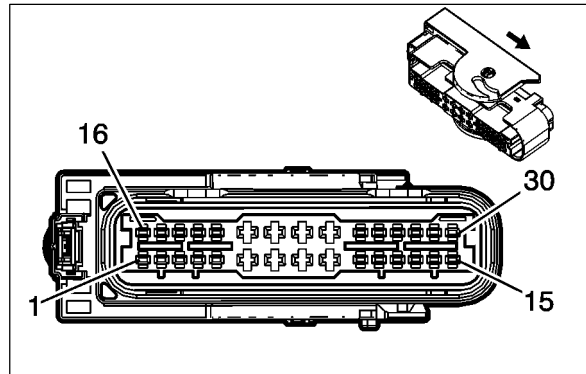
## X63A- Rear Junction Block – Connector X1

- Harness Type: Chassis
- OEM Connector: 13988318
- Service Connector: Service by Harness - See Part Catalog
- Description: 30-Way F 1.5, 2.8 Series, Sealed (BK)

**INPUT CONNECTOR-MATE IS THE JUNCTION BLOCK**

| X63A Junction Block - Rear Body X1 | | | | | | |

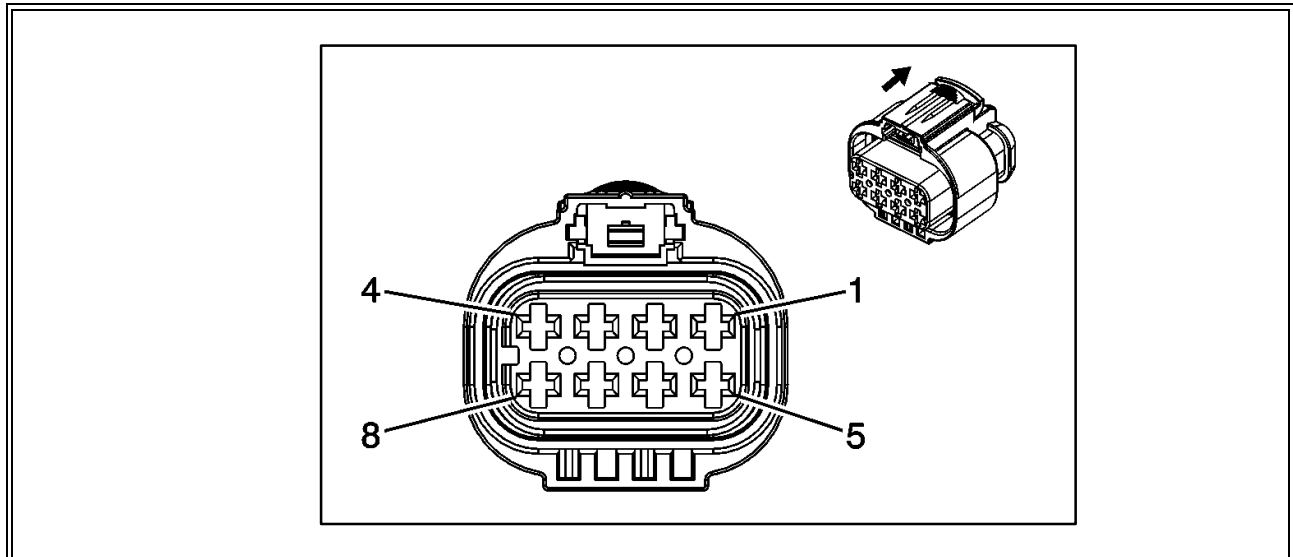
## X63A- Rear Junction Block – Connector X2

- Harness Type: Left Rear Tail lamp
- OEM Connector: 13588283
- Service Connector: **Connector X2 - GM: 13586306...Tyco 3-2109441-8 (0.75), terminal 968855, cable seal 828904-1**
- Description:
- Harness Type: Pending
- OEM Connector: Not Available
- Service Connector: Service by Harness - See Part Catalog
- Description:

| X63A Junction Block - Rear Body X2 | | | | | | |

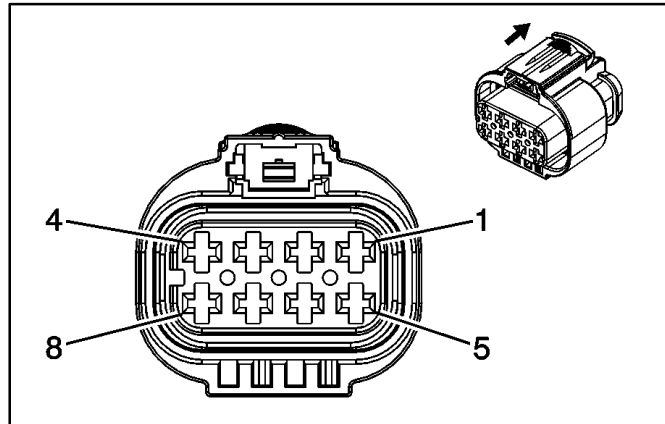
## X63A- Rear Junction Block – Connector X3

- Harness Type: Right Rear Tail lamp
- OEM Connector: 13588284
- Service Connector: **Connector X3 - GM: 13581769... Tyco 2-2109441-3 (0.75), terminal 968855, cable seal 828904-1**
- Description:
- Harness Type: Pending
- OEM Connector: Not Available
- Service Connector: Service by Harness - See Part Catalog
- Description:

| X63A Junction Block - Rear Body X3 | | | | | | |

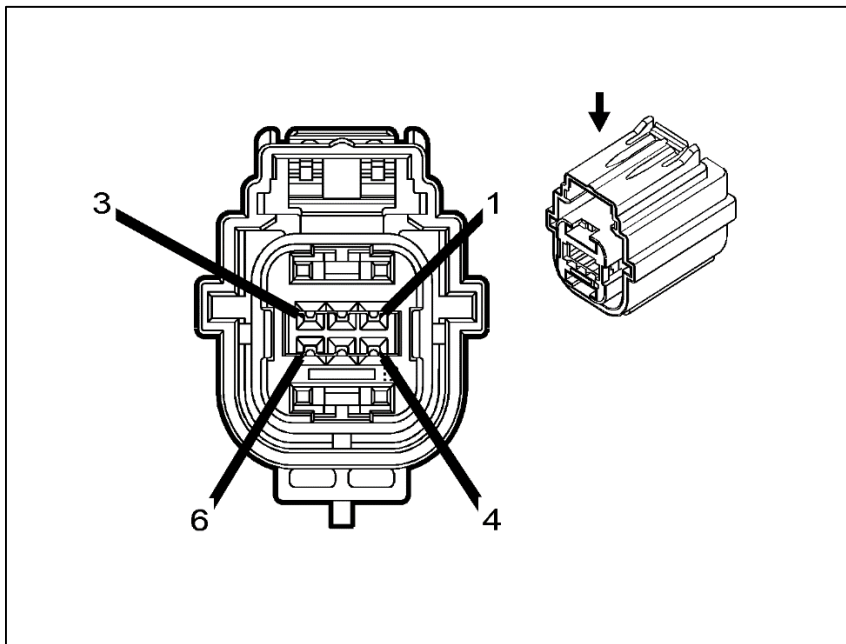
## X63A- Rear Junction Block – Connector X4

- Harness Type: Rearview Camera Jumper
- OEM Connector: 19169088
- Service Connector: [per SI] 19301402
- Per Ray Turza - X4 (Rear Camera) **Connector X4 - GM: 19178149.... Molex: 33472-0606 (0.35), terminal 033012-2003 (seal is part of assembly)**
- Description: 6-Way F 0.64 Series, Sealed (GY)

| X63A Junction Block - Rear Body X4 | | | | | | |

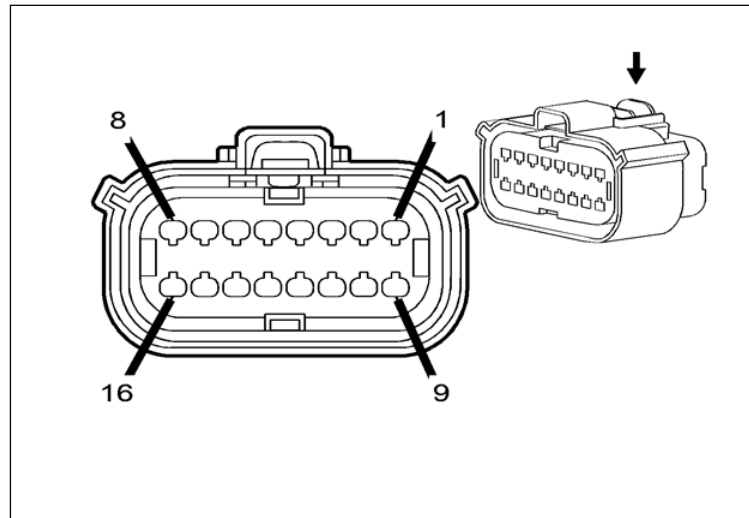
## X63A- Rear Junction Block – Connector X5

- Harness Type: Rear Bumper
- OEM Connector: 13778557
- Service Connector: . **Connector X5 – GM: 13584788 [Per power and signal – crosses to Molex 33472-1606] (0.5), terminal 033012-2002 (seal is part of assembly)**
- Description: 16-Way F 1.5 Series, Sealed (BK)

| X63A Junction Block - Rear Body X5 | | | | | | |

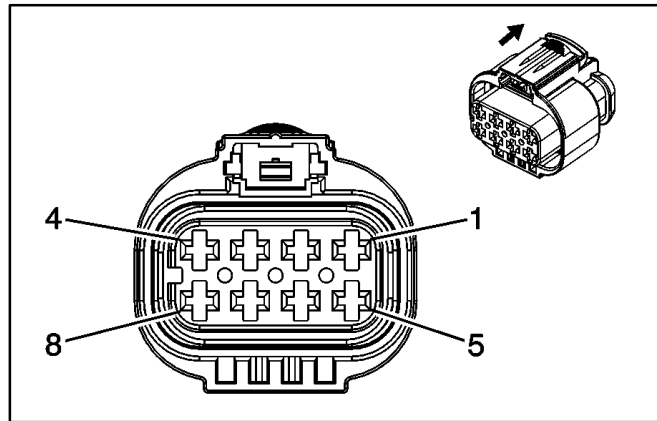
## X63A- Rear Junction Block – Connector X6

- Harness Type: Pending
- OEM Connector: 13581768
- Service Connector: **.Connector X6 - GM 13581768 per power & signal PN crosses to [TE] PN 2109441-2 (0.75) , TE terminal 968855,TE cable seal 828904-1**
- Service by Harness - See Part Catalog
- Description:

| X63A Junction Block - Rear Body X6 | | | | | | |
