Service Bulletin

Bulletin No.: 21-NA-149

Subject: Engine Wire Harness Chafing / IPC Gauges Sweep / IPC Warning Message / SES/Check Engine/MIL / No Start / No Crank / Runs Rough / Stalls / Reduced Engine Power / Various DTCs

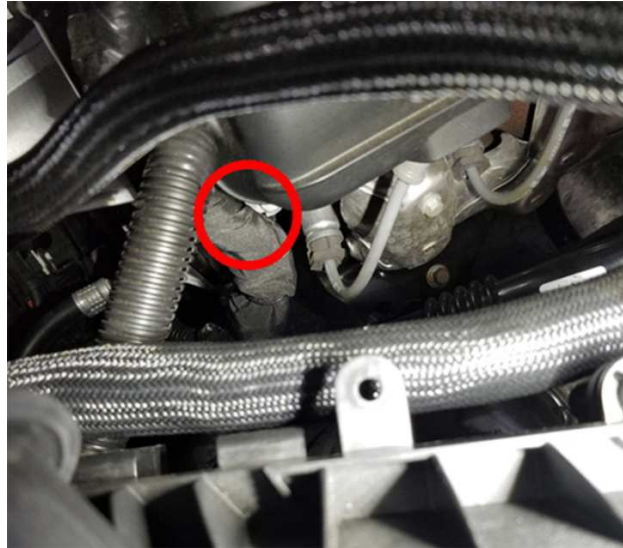
5911722

This Correction pertains to vehicles equipped with engine 4.3L, LV3 only.
Note: The first graphic below is a before, and after (2), repair example of harness chaffing at the Oil Dipstick bracket.

To correct this concern, repair the damaged wiring following the SI wire-to-wire repair procedures. Once repaired, protect and reposition the engine wiring harness to prevent future harness damage.

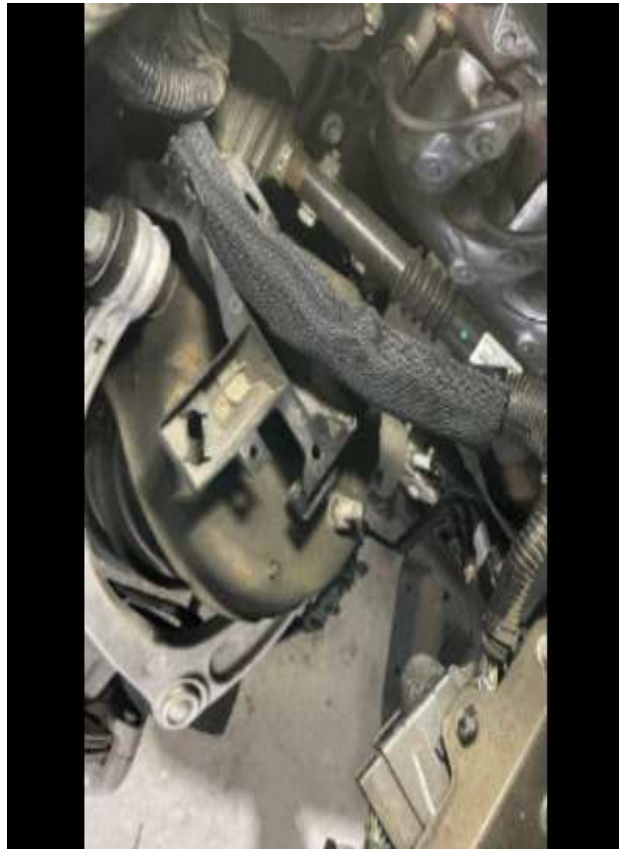
5868358

9. At the shock tower point there is a wire harness canal (1).

11. Verify the wire harness is wrapped and secured at all three points, the ECM/TCM Bracket (1), Upper Control Arm (2), and the Shock Tower (3). Then reassemble the vehicle.
12. Reinstall the front wheelhouse liner and tire and wheel. Refer to *Front Wheelhouse Liner Replacement* and *Tire and Wheel Removal and Installation* in SI.
13. Remove the support and lower the vehicle.
