# #01-08-42-001K: Exterior Lamp Condensation and Replacement Guidelines - (Feb 8, 2016)

**Subject: Exterior Lamp Condensation and Replacement Guidelines**

**Models: 2017 and Prior GM Passenger Cars and Trucks**

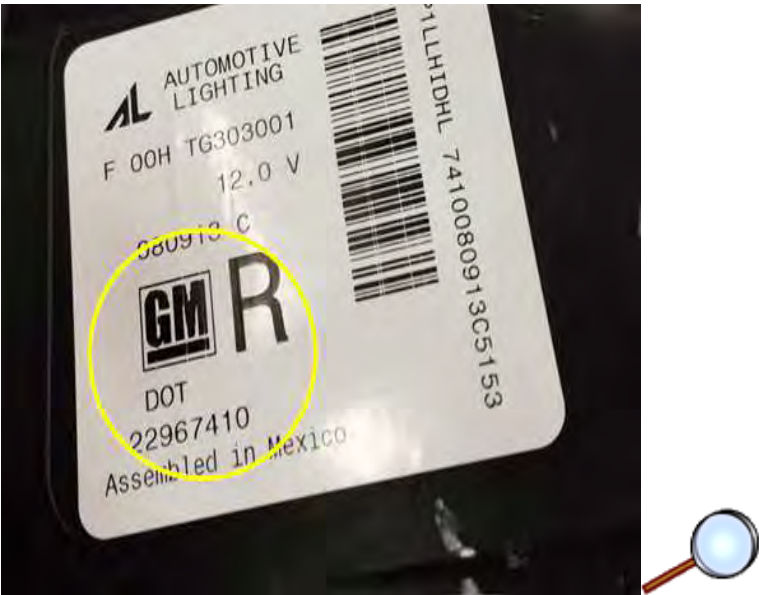
2014 Cadillac XTS

**Note: The graphics below are examples of GM Trademarks that may appear on lamp assemblies. Not all lamp assemblies currently have the trademark, however future assemblies will contain the trademark on a label affixed to the assembly.**
