#10-06-01-008G: Engine Oil Consumption on Aluminum Block/Iron Block Engines with Active Fuel Management (AFM) (Install AFM Oil Deflector and Clean Carbon from Cylinder and/or Install Updated Valve Cover) - (Jan 3, 2013)

Models: 2007-2011 Cadillac Escalade Models

2007-2011 Chevrolet Avalanche, Silverado 1500, Suburban, Tahoe

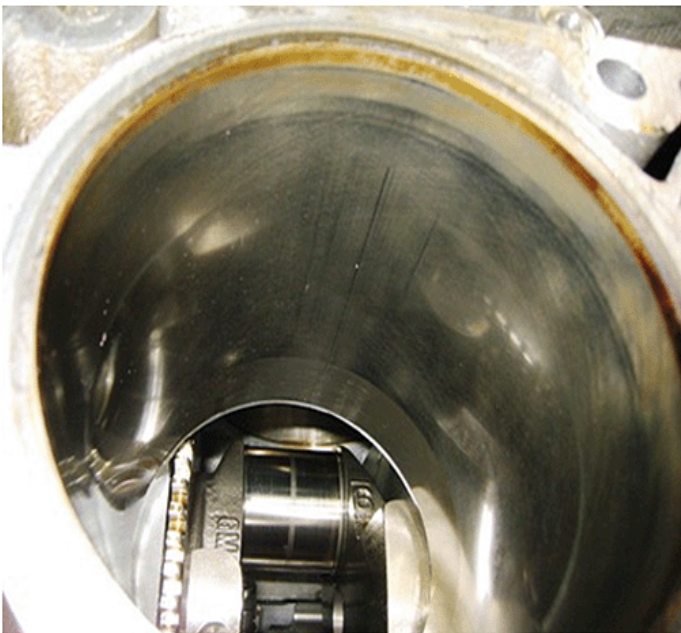
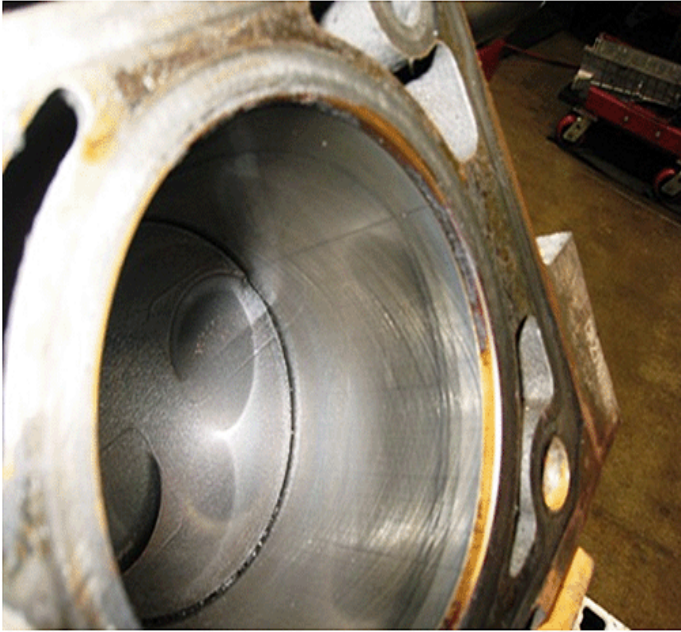
Important: Some minor scratches may be noticed on the cylinder walls during piston and ring replacement. If the scratch cannot be felt when running your finger nail over it, the scratch is considered normal wear and the block or engine should not be replaced.

Note: It is not necessary to hone or deglaze the cylinder walls. Honing may induce unnecessary cylinder wall and / or piston ring damage if it is done incorrectly and/or not cleaned thoroughly. Cylinder walls should be cleaned thoroughly with brake cleaner before installation of the new pistons and rings. Numerous engines replaced for oil consumption have been inspected. The cross hatch has been consistently good and is in specification. As a result, it should not be necessary to measure the cylinders if they pass the visual inspection.

Note: After the piston/ring replacement, it will take 2000-3000 miles for the new rings to seat. Adequate break time is necessary prior to rechecking the oil consumption level.
