Body Side Rear Window Garnish Molding Replacement

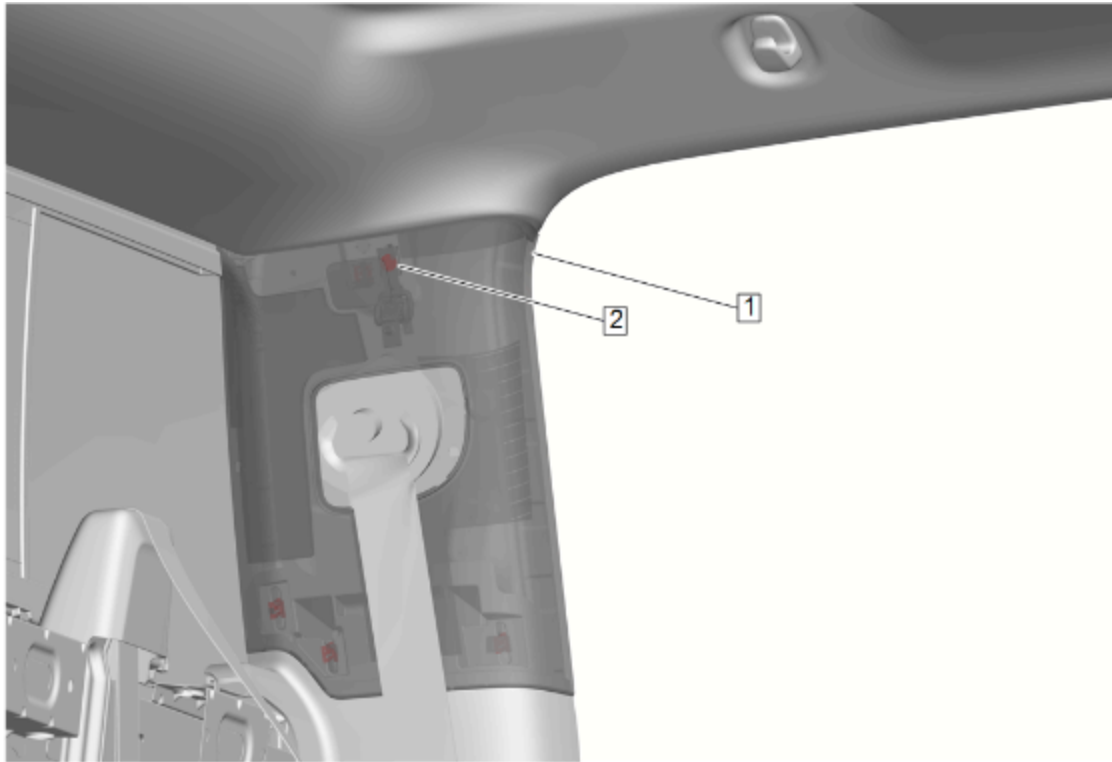
Callout	Component Name
<p>Caution: If a vehicle is equipped with a head curtain inflator module ensure that the inflator module and tether are undamaged. If tether or curtain airbag are damaged in any way, they must be replaced.</p>	
<p>Caution: Use care when working around the head curtain inflator module. Sharp tools may puncture the curtain airbag. If the head curtain inflator module is damaged in any way, it must be replaced.</p>	
<p>Preliminary Procedures</p> <ol style="list-style-type: none"> 1. Disable the SIR system. SIR Disabling and Enabling 2. Remove the rear seat belt retractor anchor plate bolt. Rear Seat Belt Retractor Replacement

Callout	Component Name
1	<p>Body Side Rear Window Garnish Molding</p> <p>Procedure</p> <p>Pull the body side rear window garnish molding rearwards to release the tether from the body side inner frame.</p>
2	<p>Quarter Window Trim Finish Panel Bolt</p> <p>Caution: Fastener Caution</p> <p>Note: Tether and Bolt are integral to the Body Side Rear Window Garnish Molding.</p> <p>Procedure</p> <ol style="list-style-type: none">1. Access the bolt which is located on the backside of the garnish molding and secures the tether to the body side inner frame.2. Disconnect the electrical connector.3. Enable the SIR System. SIR Disabling and Enabling <p>Tighten</p> <p>2.5 Y (22 lb in)</p>
