#20-NA-218: Possible Crank No Start or Extended Crank with DTC P12A6 - (May 19, 2022)

Subject: Possible Crank No Start or Extended Crank with DTC P12A6

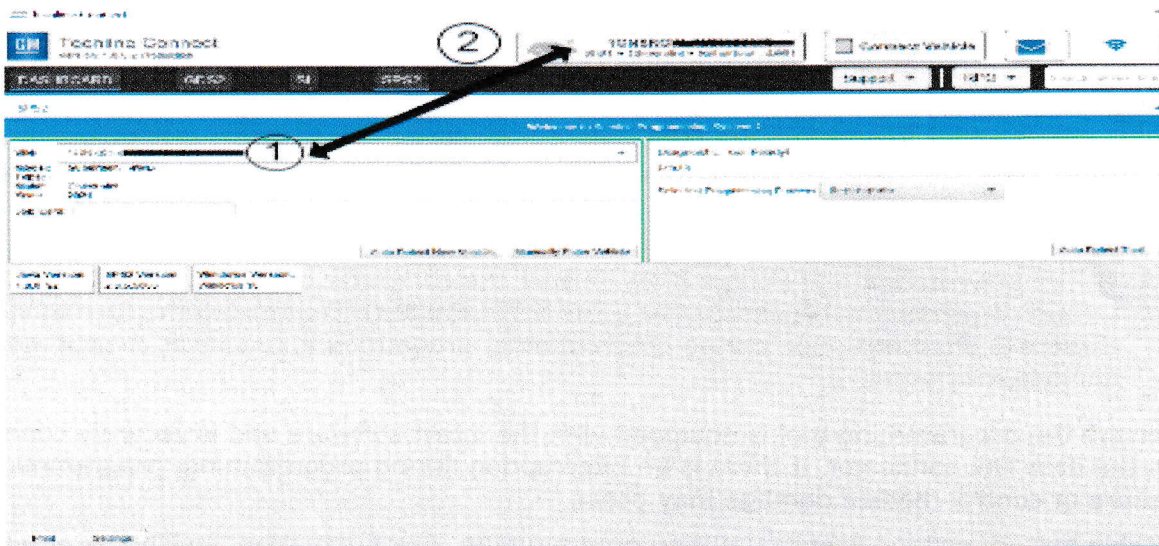
Caution: Be sure the VIN selected in the drop down menu (1) is the same as the vehicle connected (2) before beginning programming.
