2022 Chevy Truck Silverado 1500 LTD 4WD L4-2.7L Turbo

## L3B TURBOCHARGER WASTEGATE SERVICE CALIBRATION

## #24-NA-091: L3B Turbocharger Wastegate Service Calibration - (Jun 20, 2024)

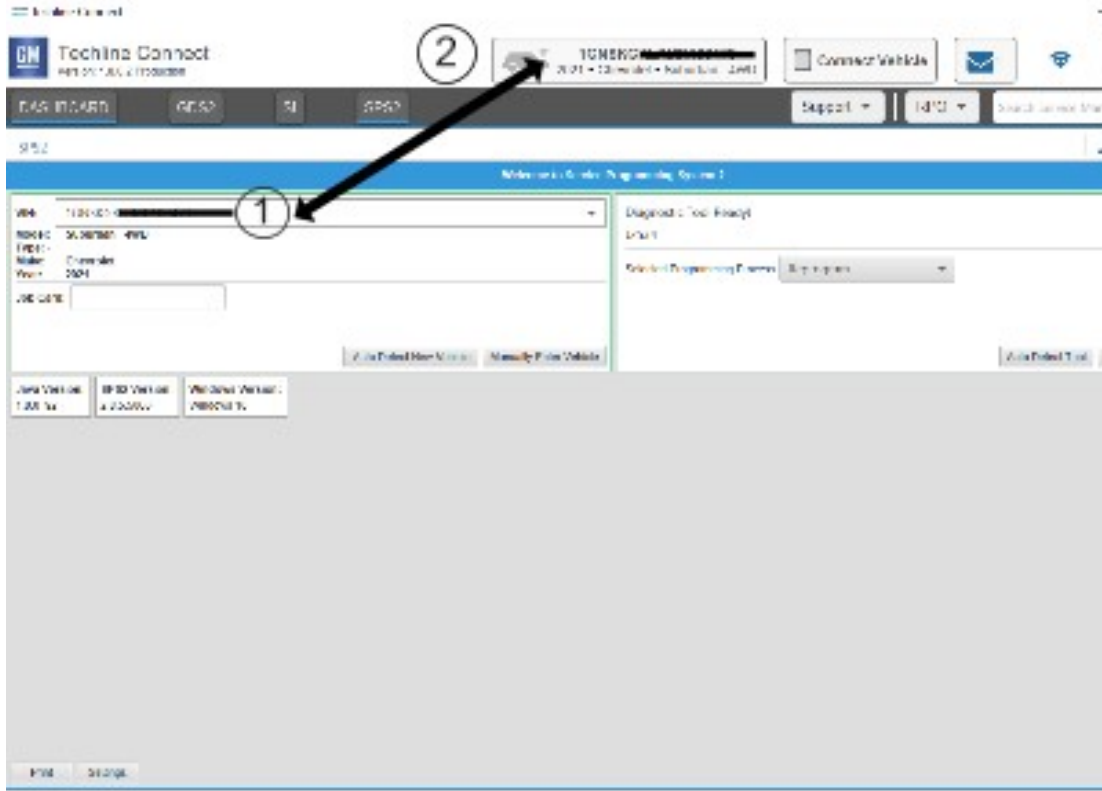
**Caution:** Be sure the VIN selected in the drop down menu (1) is the same as the vehicle connected (2) before beginning programming.

**Important:** Techline Connect screens shown above.

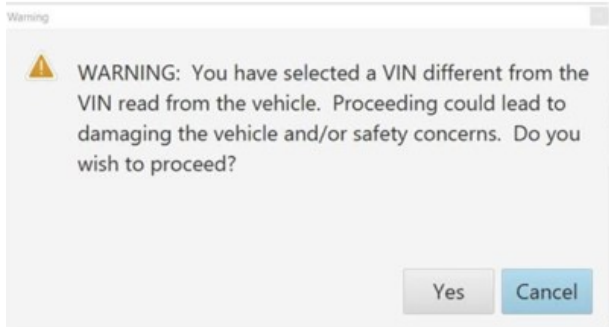
**Important:** If the vehicle VIN DOES NOT match, the message below will be shown

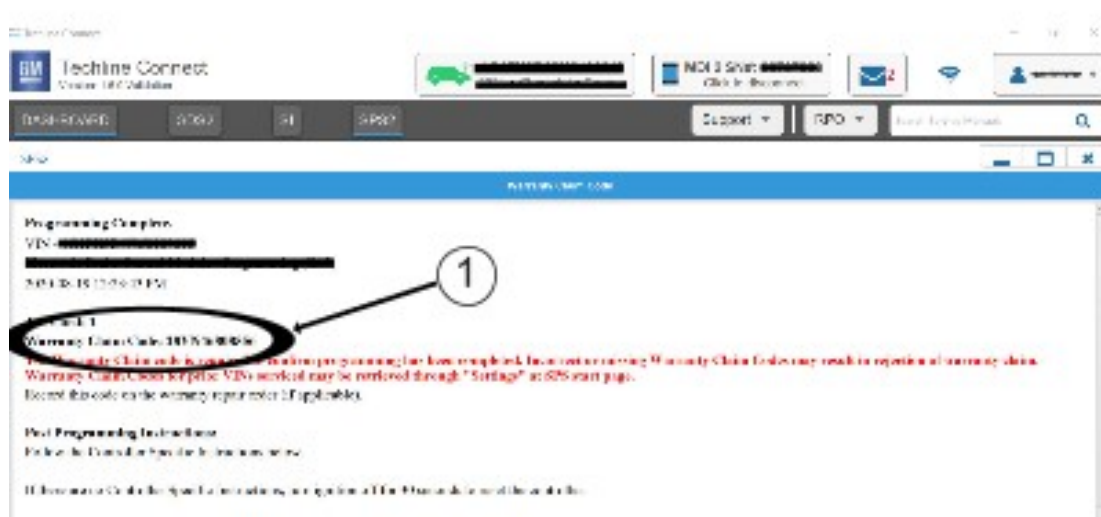
**Note:** The screenshot above is an example of module programming and may not be indicative of the specific module that is being programmed. Module selection and VIN information have been blacked out.

**Important:** To avoid warranty transaction rejections, you MUST record the warranty claim code provided on the Warranty Claim Code (WCC) screen shown above on the job card. Refer to callout 1 above for the location of the WCC on the screen.

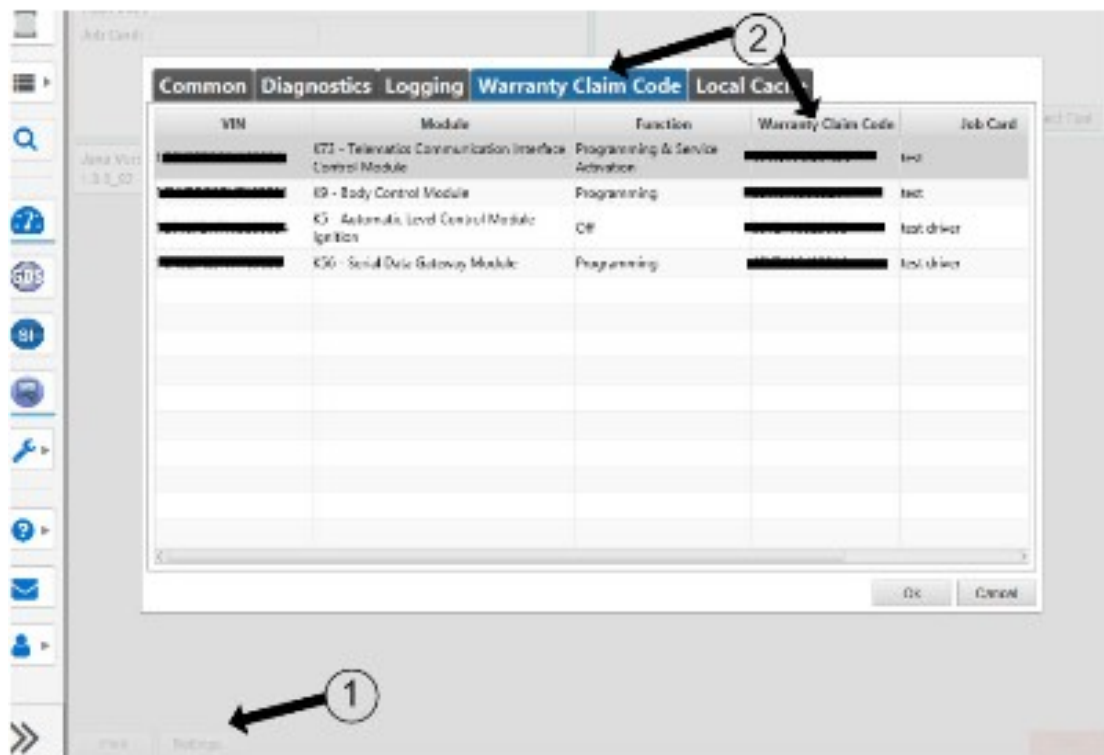
**Warranty Claim Code Information Retrieval**

If the Warranty Claim Code was not recorded on the Job Card, the code can be retrieved in the SPS2 system as follows:

1. Open TLC on the computer used to program the vehicle.
2. Select and start SPS2.
3. Select Settings (1).
4. Select the Warranty Claim Code tab (2).

The VIN, Warranty Claim Code and Date/Time will be listed on a roster of recent programming events. If the code is retrievable, dealers should resubmit the transaction making sure to include the code in the SPS Warranty Claim Code field.
