**2002 Chevrolet Chevy K Silverado - 4WD**  
**2GCEK19T221230343**

# Knock Sensor (KS) Replacement

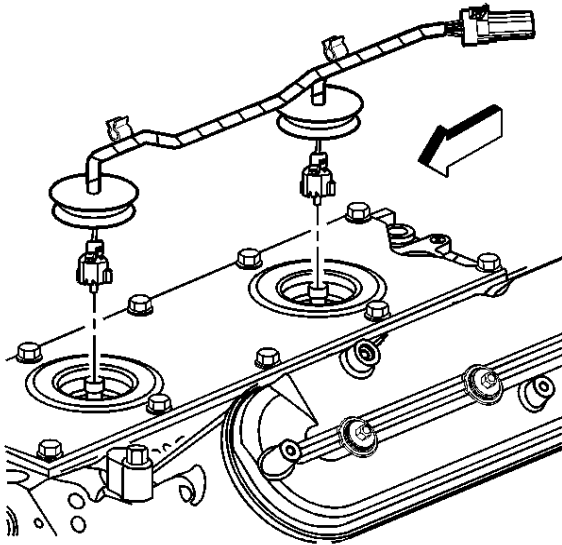
1. Remove the intake manifold. Refer to [Intake Manifold Replacement](#) in Engine Mechanical-4.8L, 5.3L, and 6.0L.
2. Gently pry up the rubber covers.
3. Disconnect the knock sensor electrical connectors.

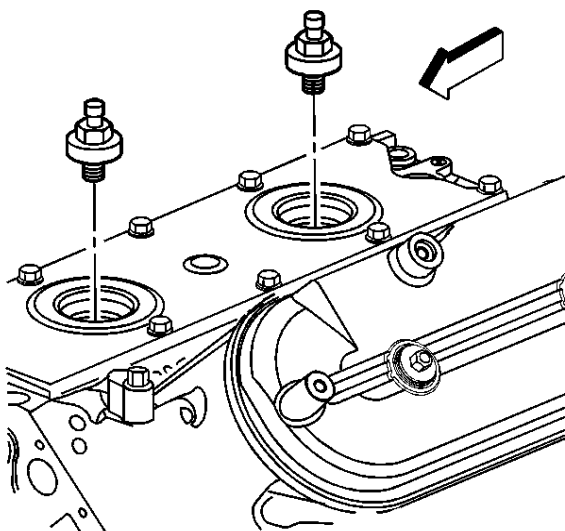
4. Remove the knock sensors.

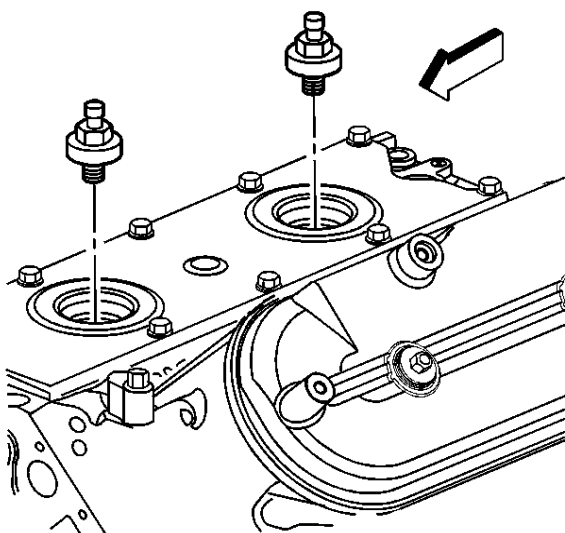
1. Install the knock sensors.

Tighten the sensor to 20 N·m (15 lb ft).

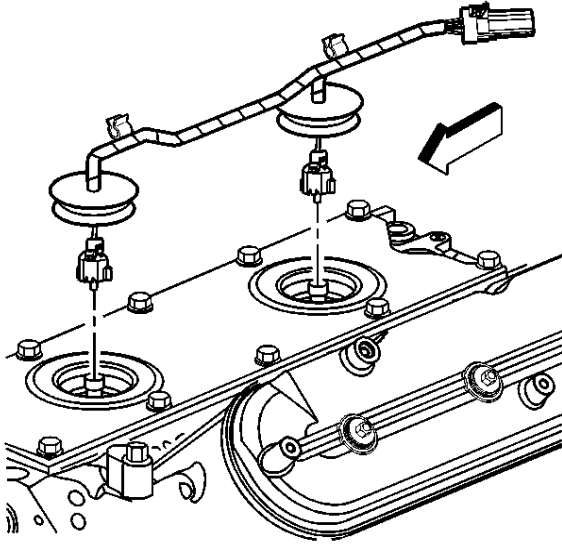
2. Connect the knock sensor electrical connectors.
3. Push down the rubber covers.
4. Install the intake manifold. Refer to [Intake Manifold Replacement](#) in Engine Mechanical-4.8L, 5.3L, and 6.0L.
