## Center Pillar Upper Trim Panel Replacement

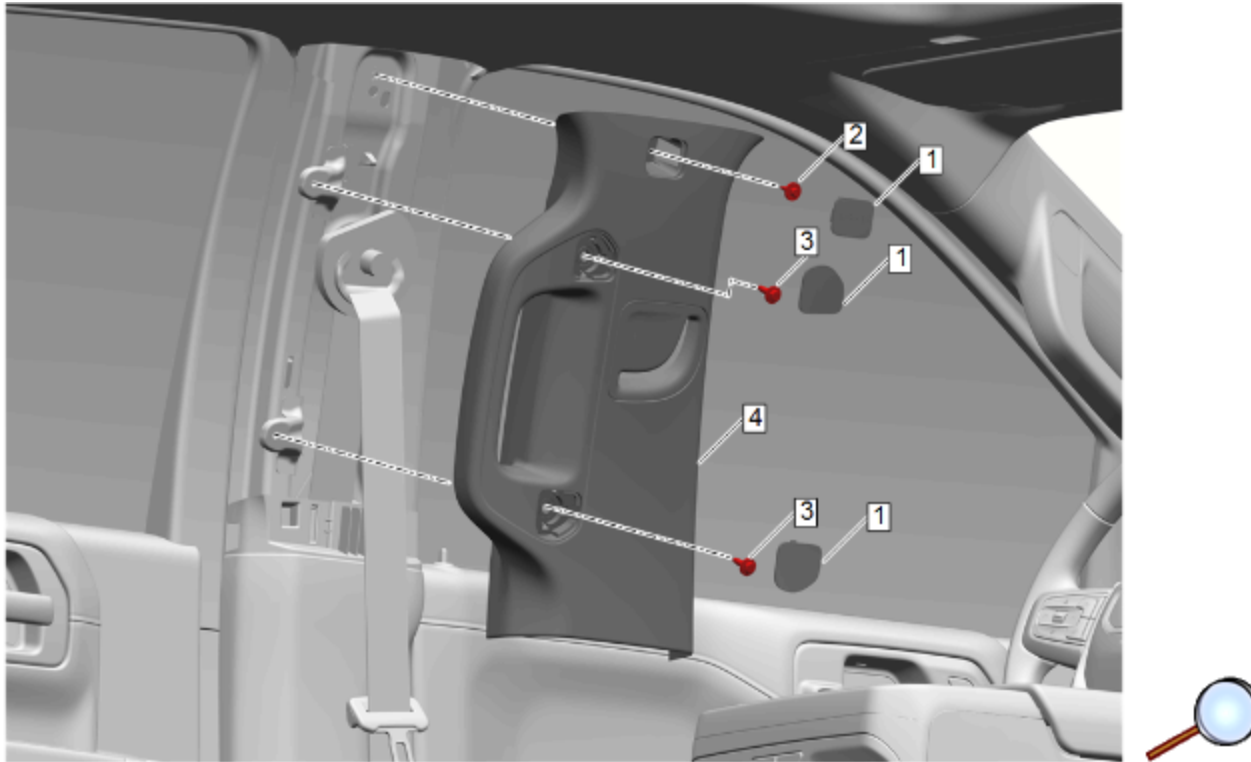
Callout	Component Name
	<p><b>Caution:</b> Use care when working around the head curtain inflator module. Sharp tools may puncture the curtain airbag. If the head curtain inflator module is damaged in any way, it must be replaced.</p> <p><b>Preliminary Procedures</b></p> <ol style="list-style-type: none"> <li>1. Disable the SIR system. <a href="#">SIR Disabling and Enabling</a></li> <li>2. Remove the driver or passenger seat belt anchor plate tensioner cover and bolt. <a href="#">Front Seat Belt Anchor Plate Tensioner Replacement</a></li> </ol>

Callout	Component Name
1	Center Pillar Upper Trim Panel Bolt Cap [3x] <b>Procedure</b> Use a small flat - bladed tool to open the bolt caps to gain access to the bolts.
2	Center Pillar Upper Garnish Molding Bolt <b>Caution:</b> Refer to <a href="#">Fastener Caution</a> . <b>Tighten</b> 2.5 N•m (22 lb in)
3	Center Pillar Assist Handle Bolt [2x] <b>Tighten</b> 9 N•m (80 lb in)
4	Center Pillar Upper Trim Panel <b>Procedure</b> <ol style="list-style-type: none"> <li>1. Pull the trim panel toward the inside of the vehicle to disengage the retainers.</li> <li>2. When replacing the center pillar upper trim panel, feed the seat belt through the panel.</li> <li>3. Enable the SIR System. <a href="#">SIR Disabling and Enabling</a></li> </ol>
