**X83 Auxiliary Audio Input X1 (AE7/AZ3)**

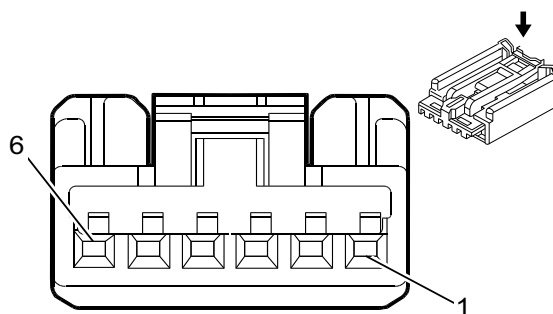
1862240

Harness Type: Center Seat  
 OEM Connector: AIT2PB-06-1AK  
 Service Connector: Service by Harness - See Part Catalog  
 Description: 6-Way F 0.64 Kaizen Series (BK)

Pin	Size	Color	Circuit	Function	Terminal Type ID	Option
1	0.35	GY	5839	Left Auxiliary Audio Signal 2	I	—
2	0.35	GN	5841	Right Auxiliary Audio Signal 2	I	—
3	0.35	VT	5843	Auxiliary Audio Common Signal	I	—
4	0.35	BK	2550	Ground	I	—
5	0.35	BU	2060	Auxiliary Detection Signal	I	—
6	0.75	RD/VT	340	Battery Positive Voltage	I	—
