## Headlining Trim Panel Replacement (Crew Cab with CF5)

### Removal Procedure

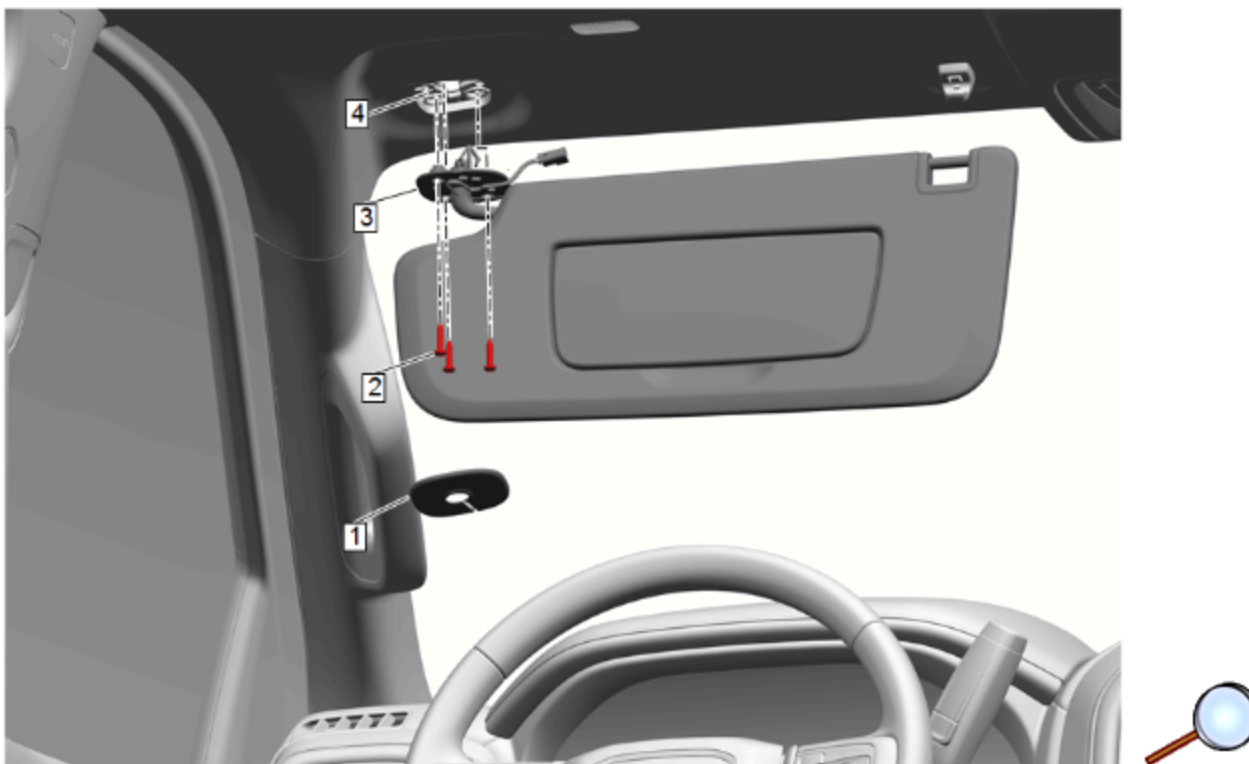
2. Sunshade (3) » Remove [2x] — [Sunshade Replacement](#)

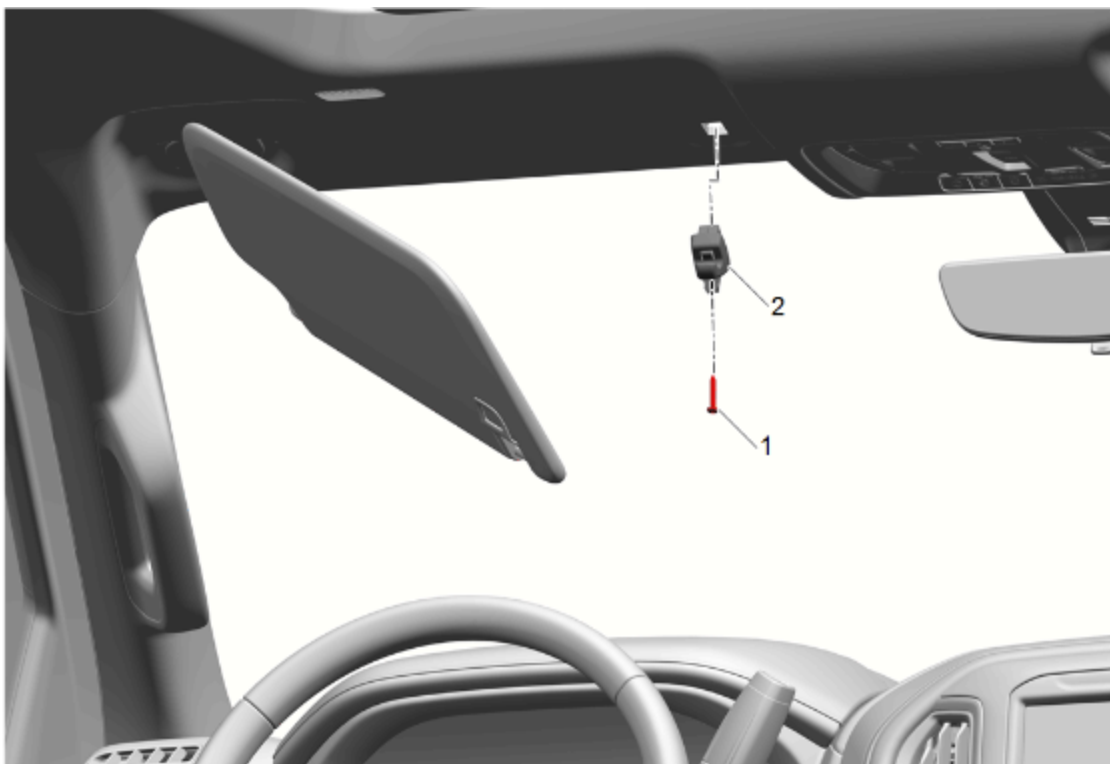
3. Sunshade Support (2) » Remove [2x] — [Sunshade Support Replacement](#)

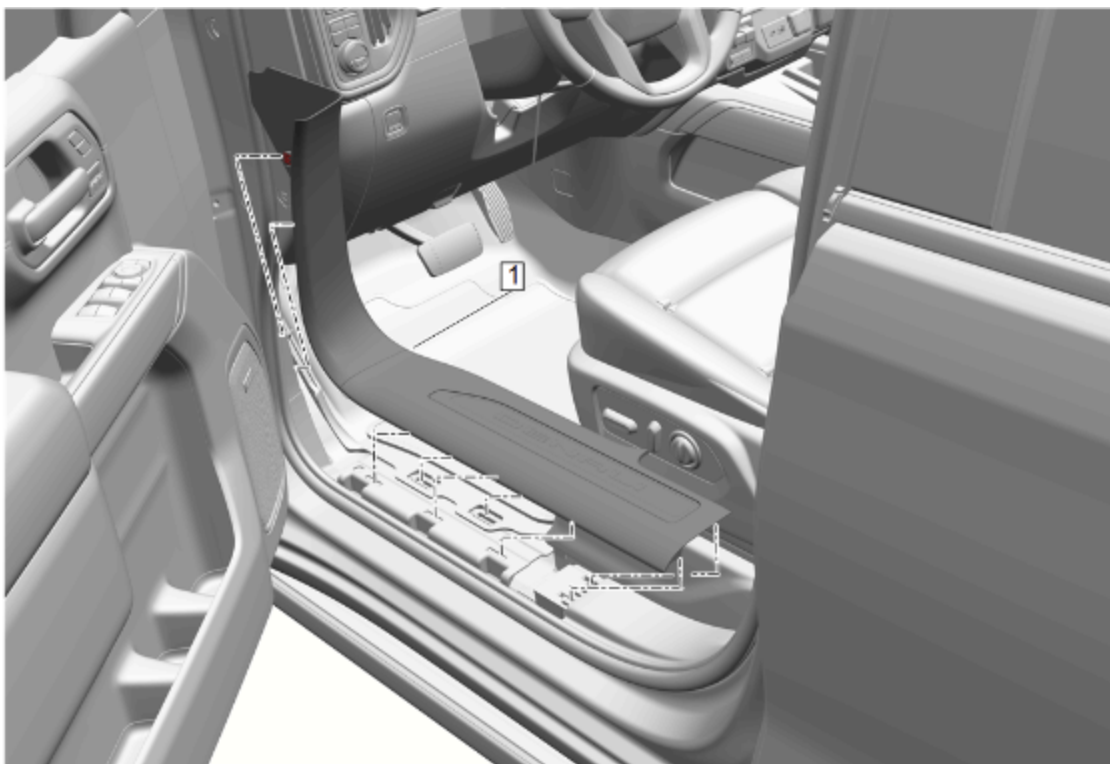
8. Front Side Door Sill Garnish Molding (1) » Remove — [Front Side Door Sill Garnish Molding Replacement](#)

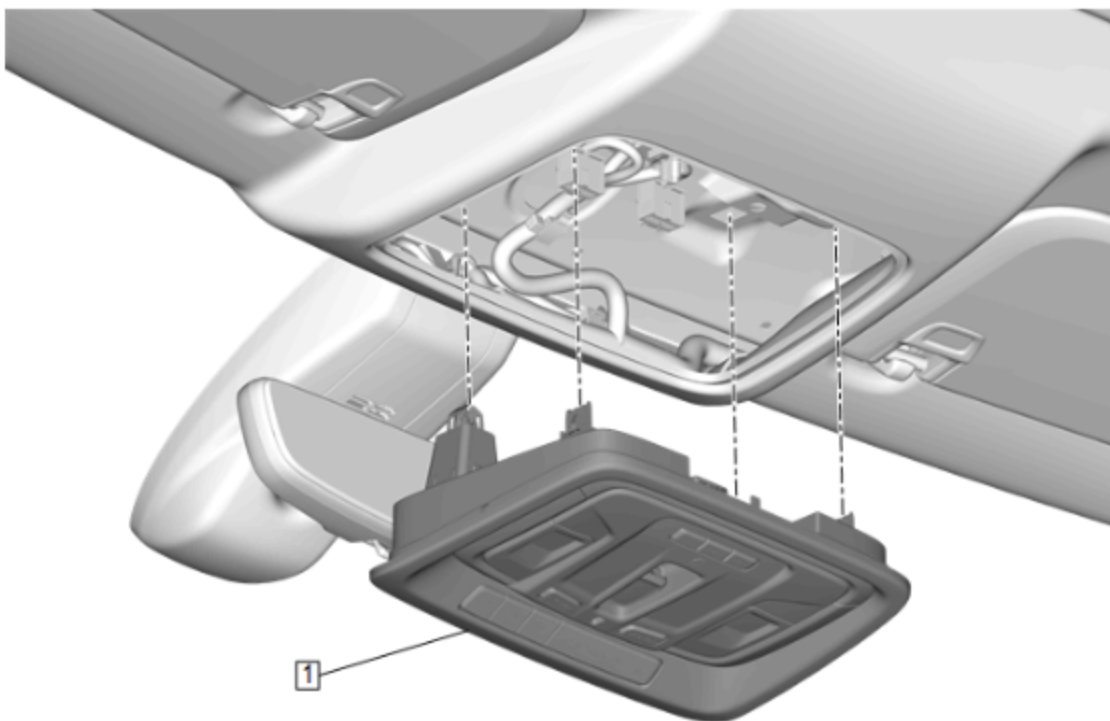
8. Roof Console (1) » Install — [Roof Console Replacement](#)

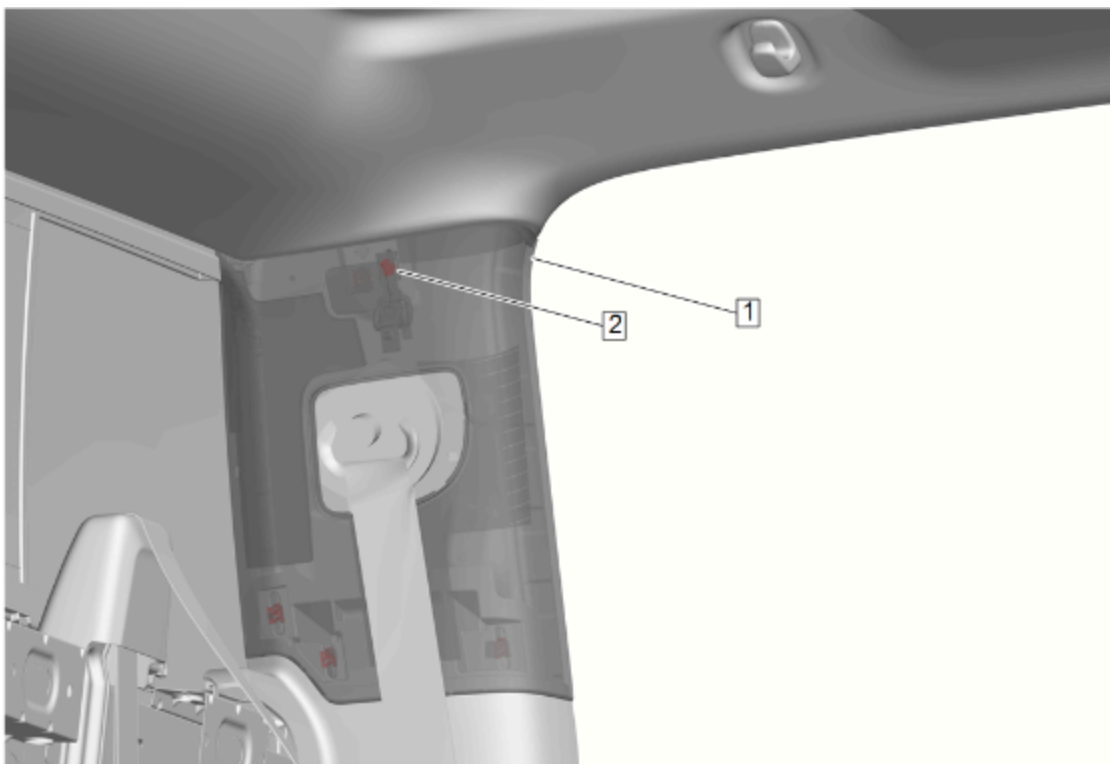
9. Body Side Rear Window Garnish Molding (2) » Install — [Body Side Rear Window Garnish Molding Replacement](#)

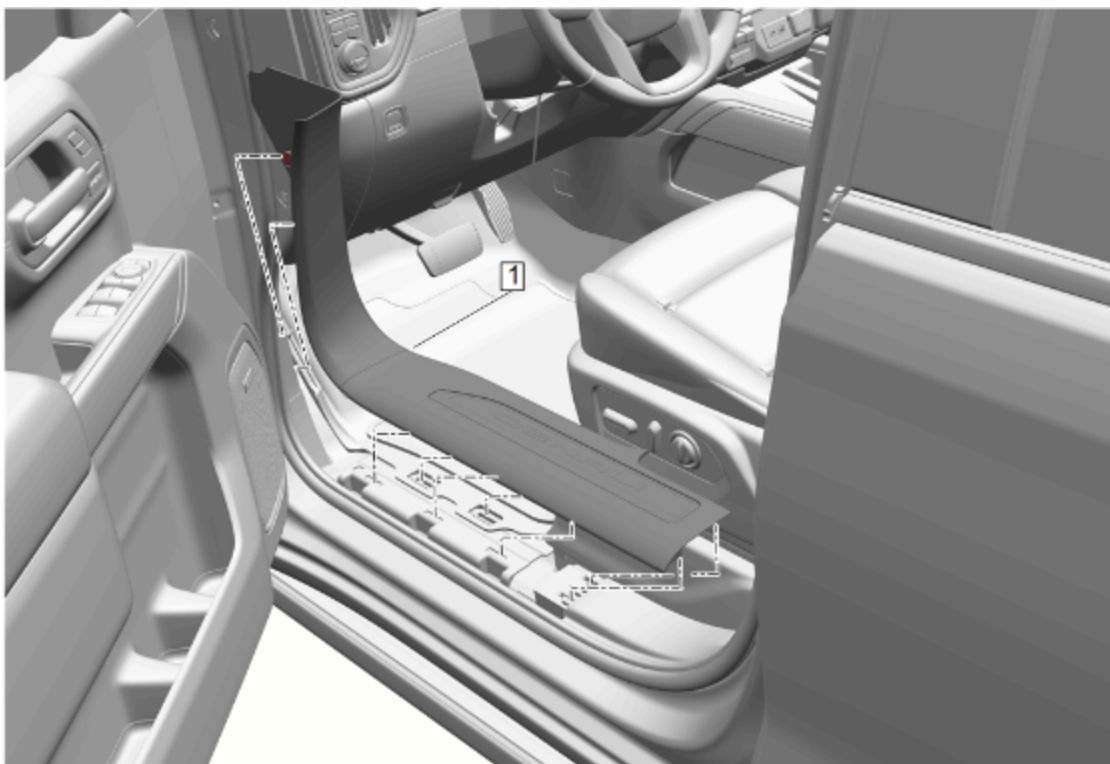
11. Front Side Door Sill Garnish Molding (1) » Install — [Front Side Door Sill Garnish Molding Replacement](#)

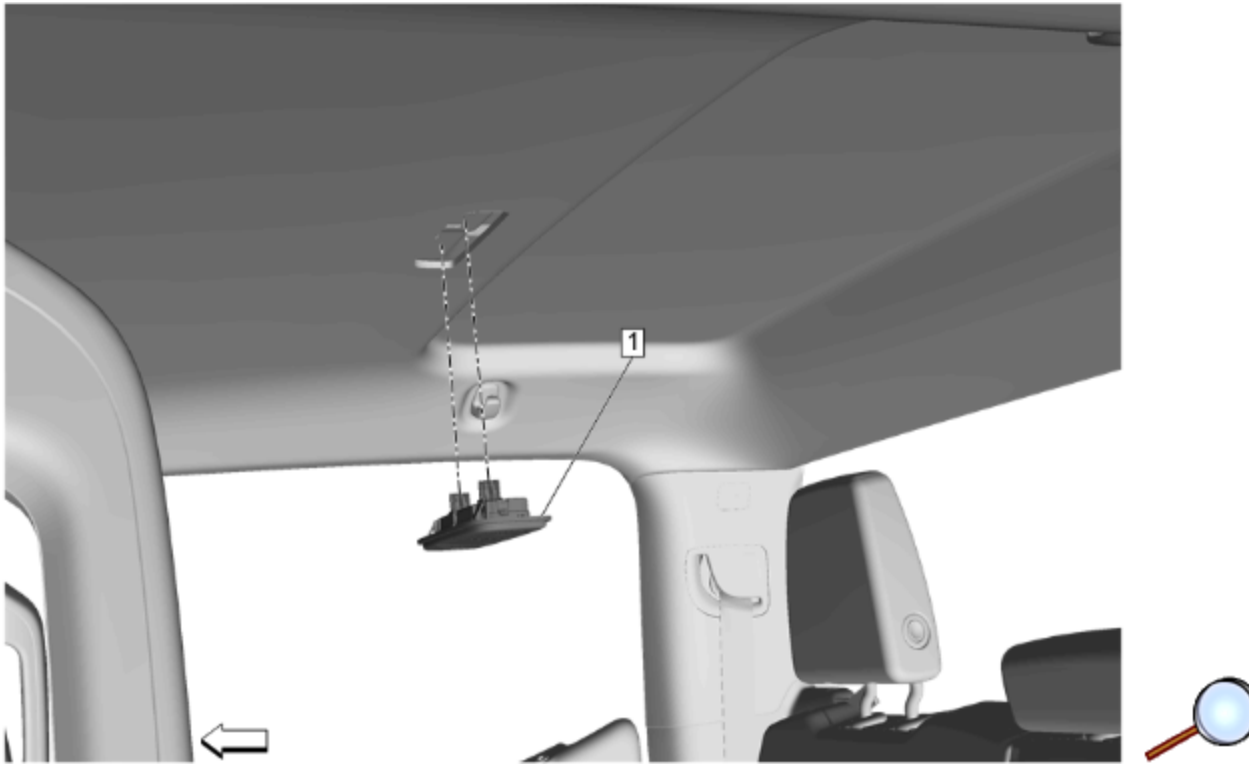
14. Rear Seat Position Center Reading and Courtesy Lamp (1) » Install — [Rear Seat Position Center Reading and Courtesy Lamp Replacement](#)

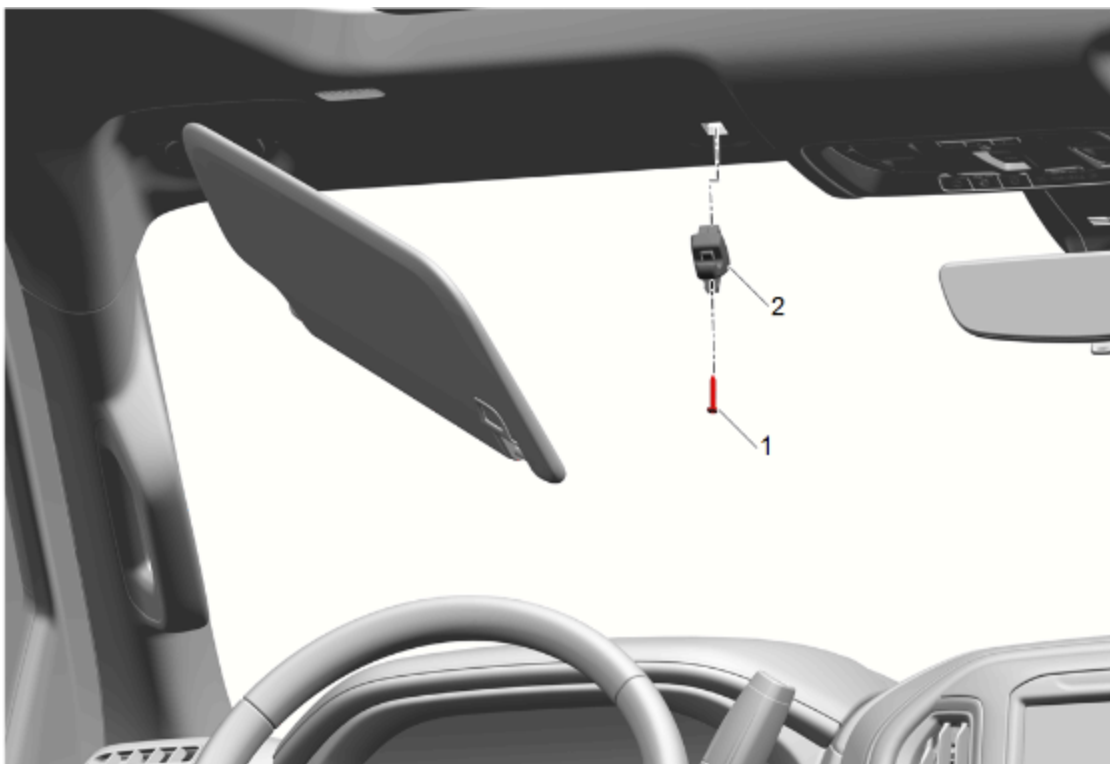
16. Sunshade Support (2) » Install [2x] — [Sunshade Support Replacement](#)

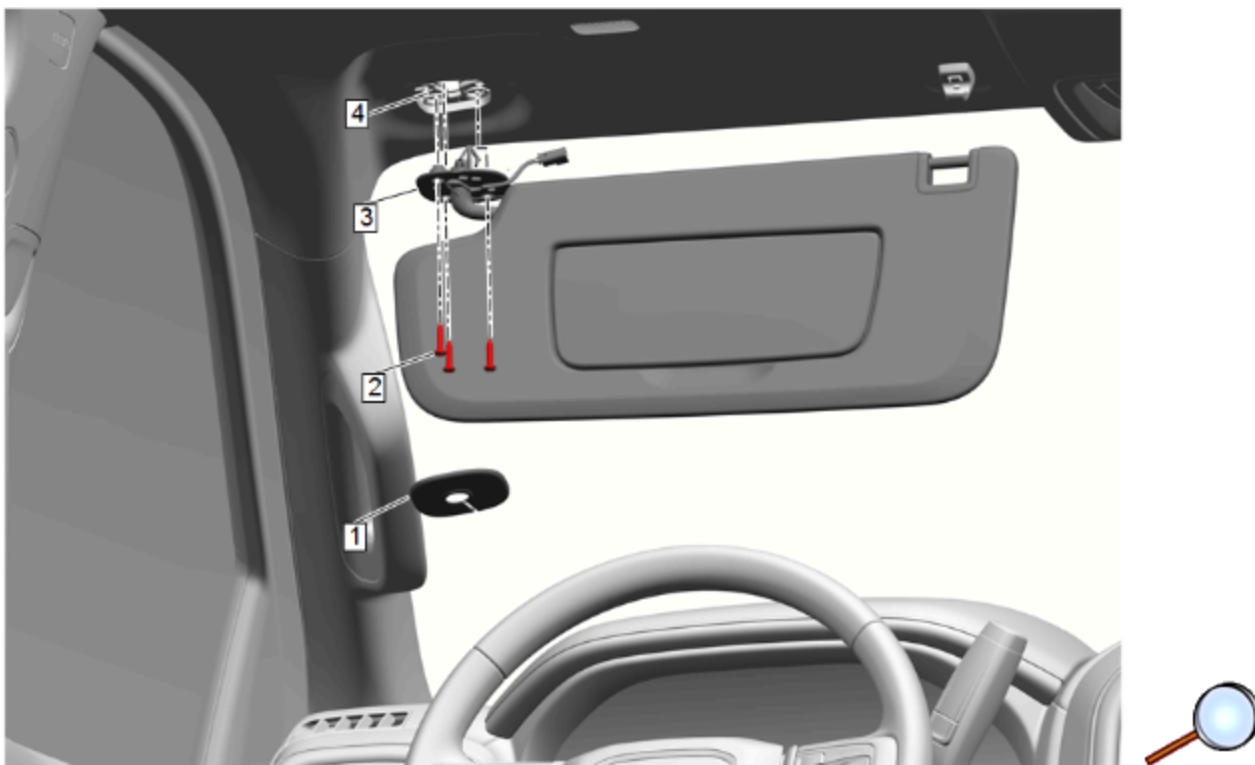
17. Sunshade (3) » Install [2x] — [Sunshade Replacement](#)
18. Enable the SIR System. [SIR Disabling and Enabling](#)
