Document ID# 723625  
2002 Chevrolet Tahoe - 2WD

## Steering Column Trim Covers - Disassemble - Off Vehicle Column Shift Snap On Shrouds

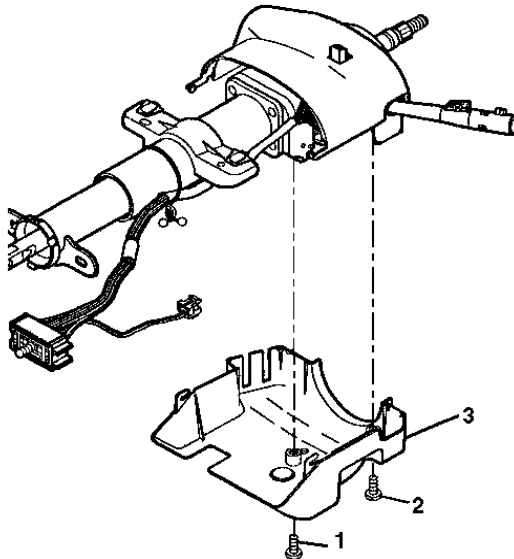
1. Disable the inflatable restraint steering wheel module. Refer to [Disabling the SIR System](#) in SIR.
2. Remove the steering wheel from the column. Refer to [Steering Wheel Replacement](#) .
3. Remove the tilt lever from the lower trim cover. Refer to [Tilt Lever Replacement - On Vehicle](#) .

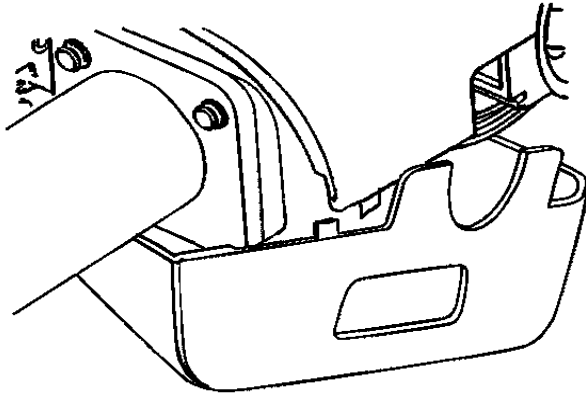
You must check for 2 pan head tapping screws (1,2) in the lower trim cover before removal.

4. If necessary, remove the 2 pan head tapping screws (1,2) from the lower trim cover (3). Remove the lower trim cover (3).

If screws are not present in the lower trim cover, proceed to the next step.

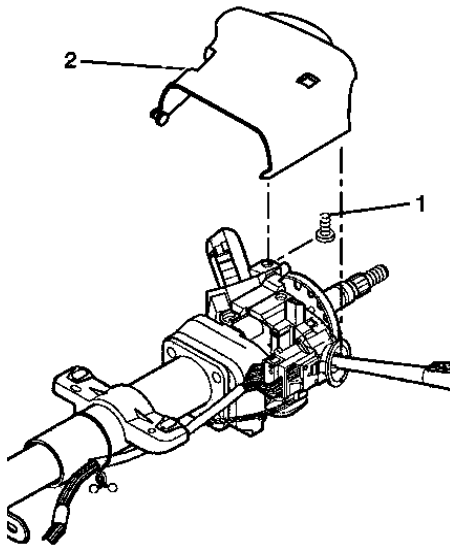
You must check for 2 pan head tapping screws (1,2) in the lower trim cover (3) before removal.

6. If necessary, remove 1 TORX® head screw (1) from the upper trim cover (2).  
If a screw is not present, remove the upper trim cover (2).
